CAPE COD  
COMMISSION

## Route 6 Hydroplaning Crash Analysis and Alternatives Development

Bourne, Sandwich, Barnstable, Yarmouth,  
Dennis, Harwich, Brewster and Orleans

October 2013

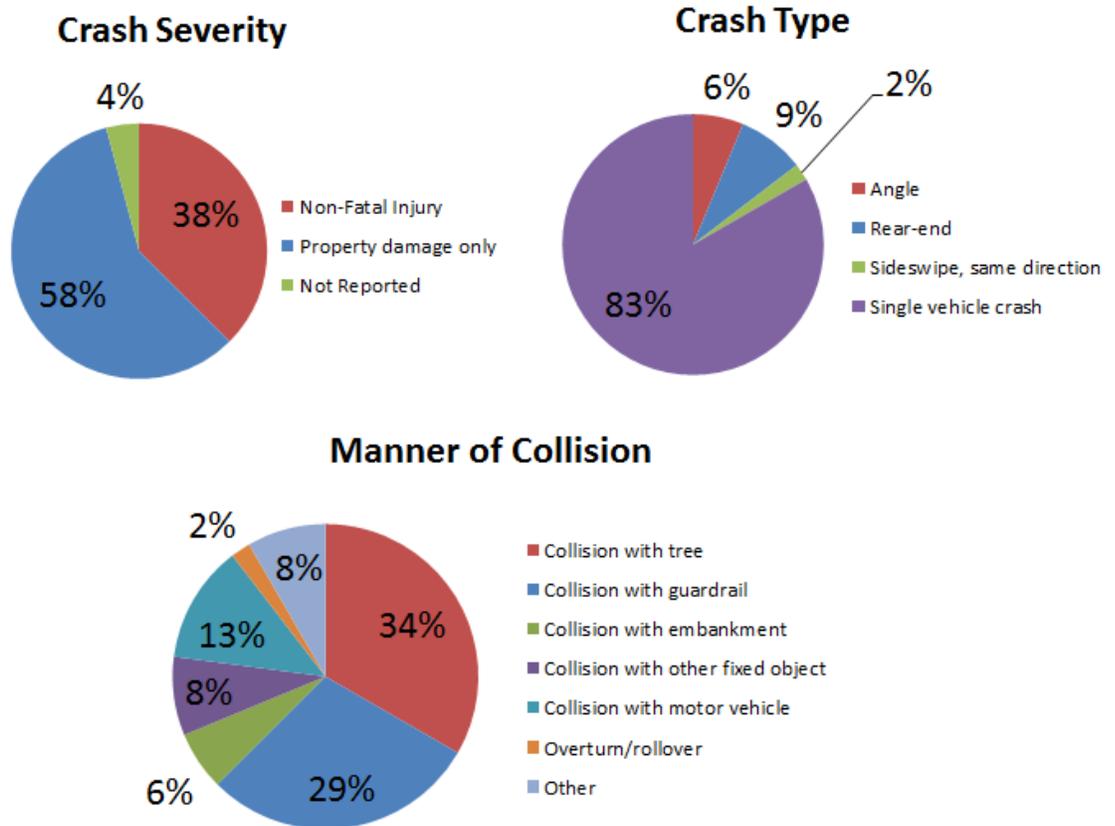
The most common crash type among the 48 crashes not occurring near ramps was a single vehicle run-off-the road crash that resulted in a collision with a tree, guardrail, embankment, or other roadside feature. Key characteristics of these crashes are shown in Figure 3. Of great concern is the high number of injury crashes among this set of crashes.

FIGURE 3: ANALYSIS OF WET WEATHER CRASHES UNRELATED TO RAMP TRAFFIC

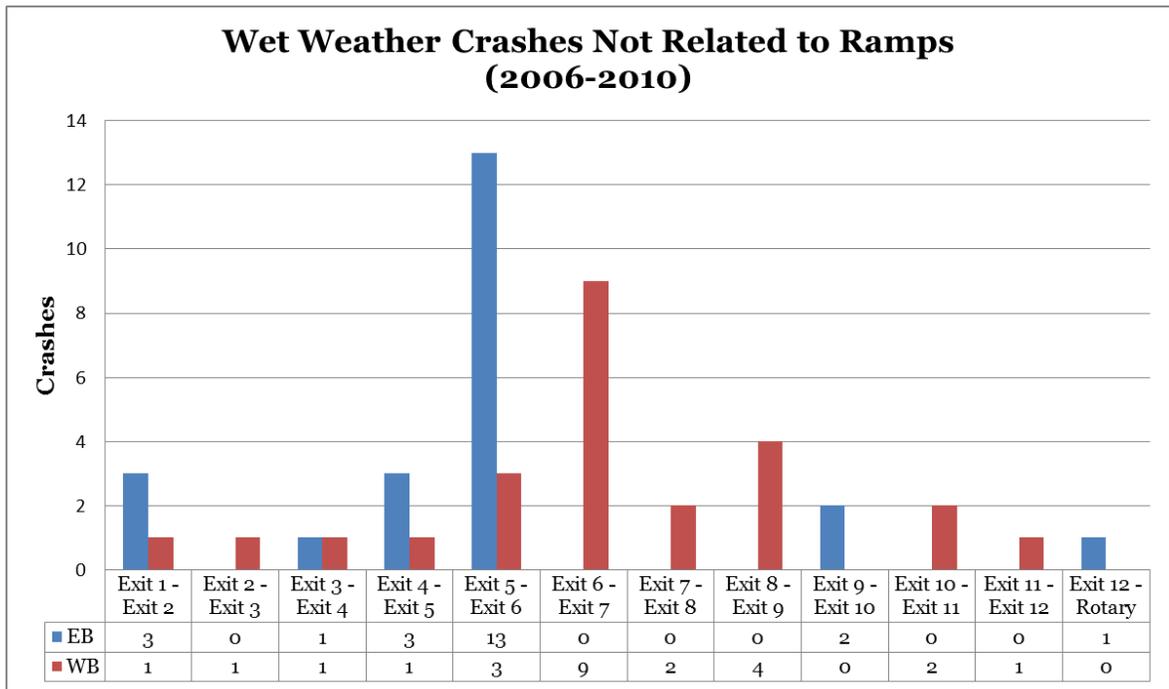
Looking at the locations of the wet weather crashes not related to on or off ramps a number of high crash segments are clearly identifiable. As shown in Figure 4, the segment of Route 6 eastbound between Exits 5 and 6 has the highest number of crashes with 13 crashes, and the eastbound segment of Route 6 between Exits 6 and 7 being the next highest with nine crashes. It should be noted that the lack of crashes on a segment does not necessarily suggest there is not a hydroplaning problem on the segment of Route 6. Factors such as design elements of the specific roadway could result in drivers being able to recover from hydroplaning incidents without ever being involved in a crash.

FIGURE 4: LOCATION OF WET WEATHER CRASHES UNRELATED TO RAMP TRAFFIC

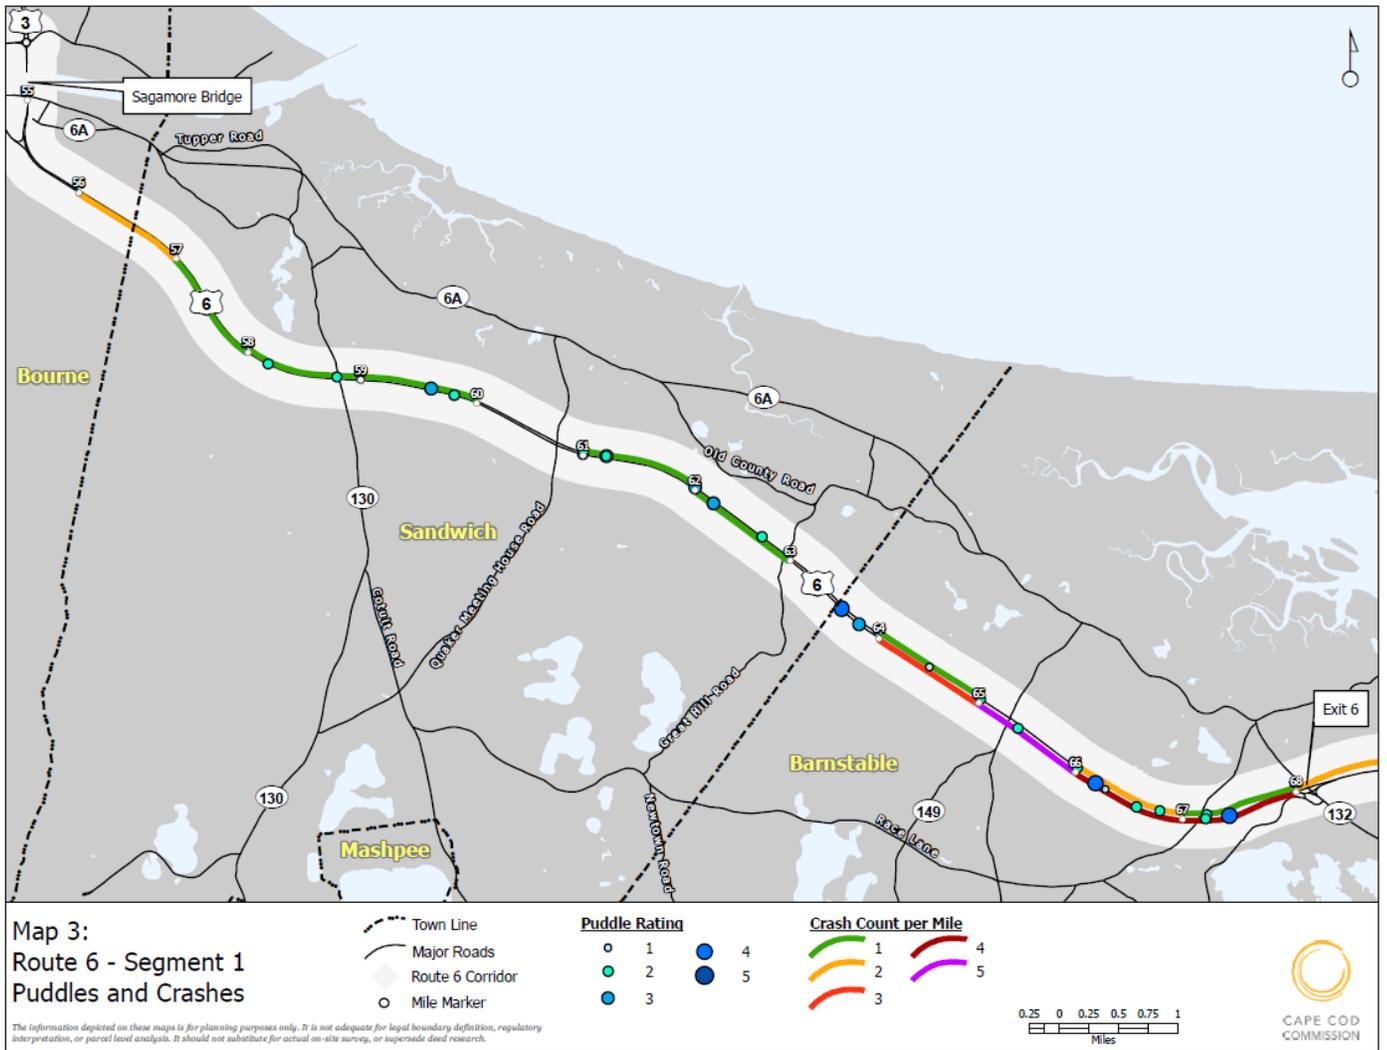
Figures 7 – 9 depict a summation of crashes per mile long stretch of roadway (both east and west bound) and roadway puddles locations and ratings. Puddle ratings, discussed in Appendix B, determine the severity of the puddle with respect to puddle location and width across the roadway and any noticeable effect on traffic.

FIGURE 7: ROUTE 6 - SEGMENT 1: CRASH AND PUDDLE ANALYSIS

**ROADWAY IMPROVEMENTS:** Improper stormwater controls and lack of maintenance contribute to inadequate stormwater management. Due to the high number of crashes between Exits 5-6 eastbound, the primary goal is to eliminate stormwater runoff from the road surface through removal of curbing and berming (Alternative 2). In the absence of removal of curbing/berming, minimizing stormwater drainage path lengths (Alternative 4) with curb cuts in lieu of or in addition to catch basins would facilitate reduction in stormwater. As mentioned in the discussion of Alternatives above, expanded shoulders in areas of high crash risk would facilitate movement of stormwater off the roadway, and greatly improve safety.

**ENVIRONMENTAL IMPACT:** The primary recommendations for the Segment 1 area include Alternative 2: Remove Curbing, Alternative 4: Minimize Path Lengths, and Alternative 1: Expand Road Shoulder. Alternatives 2 and 4 will have a very minor footprint of disturbance as they involve alterations within the existing road surface area. Consequently, these alternatives will have little adverse impact on the environment. Alternative 1, Expand Road Shoulder, is a recommended alternative for this segment, but only in areas where additional roadside clearing and grading can be minimized and/or will not adversely affect the existing environment. Careful consideration of appropriate areas to expand the shoulder will minimize impacts to the environment and neighboring residences. Considerations for siting shoulder expansions should include: nearby wetlands, water bodies, rare species habitat, extremes in topography, and vegetated buffers to residences.

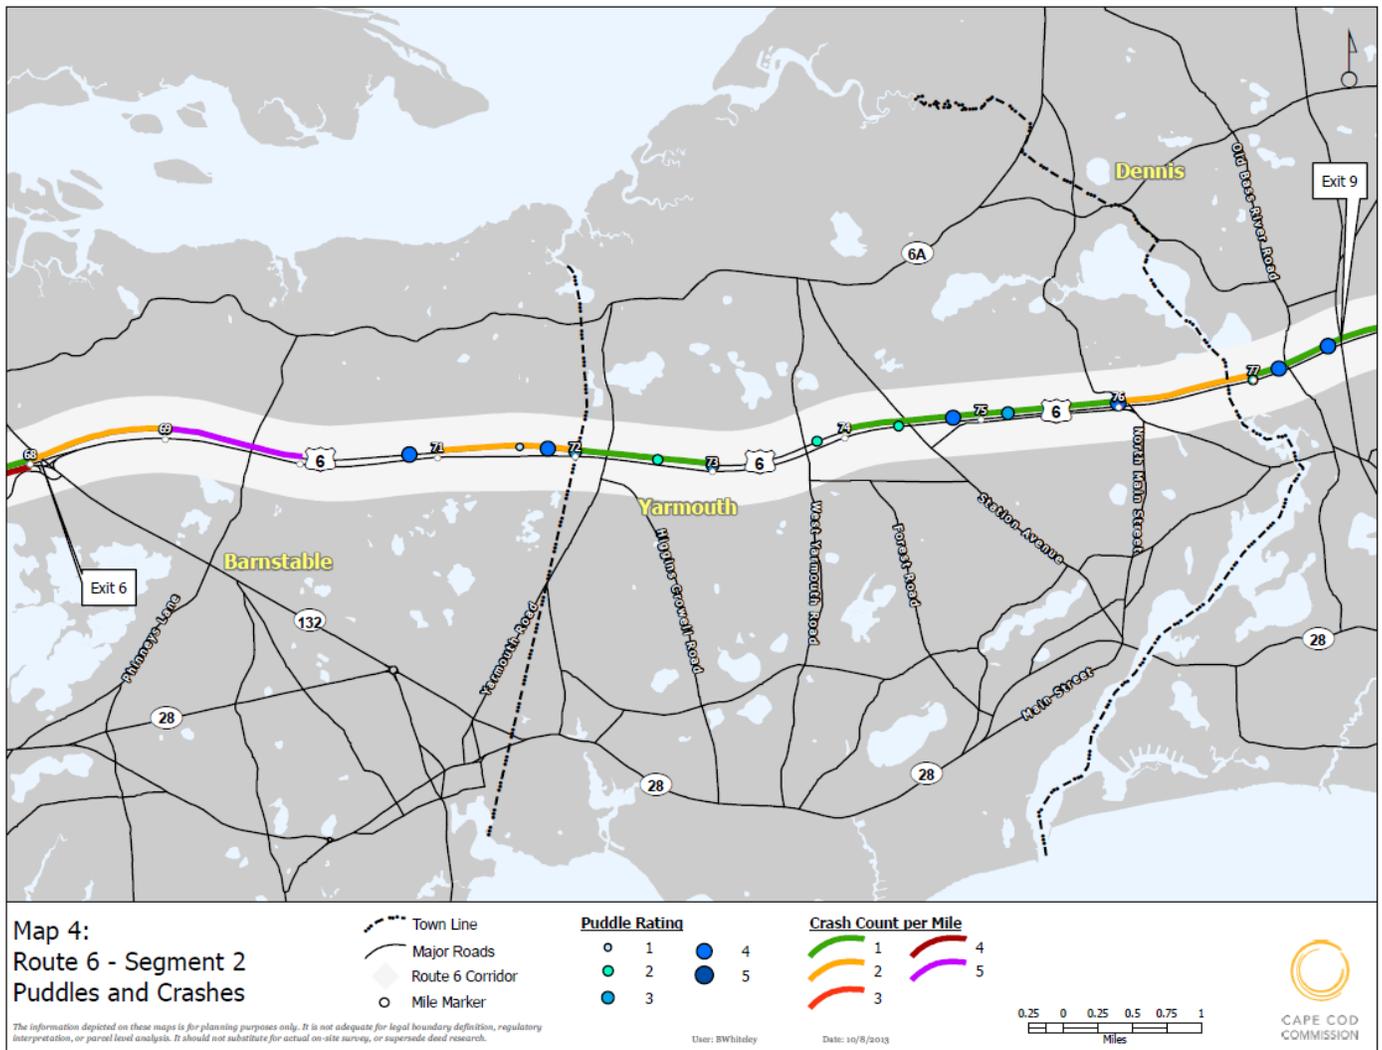
FIGURE 8: ROUTE 6 - SEGMENT 2: CRASH AND PUDDLE ANALYSIS

**ROADWAY IMPROVEMENTS:** A primary recommendation is facilitating country drainage through removal of curbing and berming (Alternative 2). In the absence of removal of curbing/berming, minimizing stormwater path lengths with curb cuts in lieu of or in addition to catch basins would facilitate reduction in stormwater (Alternative 4). As mentioned in the discussion of Alternatives above, creating or expanding paved shoulders in areas of high crash risk, or taking advantage of areas where the road shoulder is already cleared to create a paved shoulder, could facilitate movement of stormwater off the roadway and greatly improve safety (e.g. on the north side of the westbound travel lane between Exits 7 and 6). Segment 2, with the second highest number of crashes in this study, should utilize an expanded shoulder (Alternative 1) where possible to address safety concerns. As discussed in the Environmental Impacts section from Segment 1, Alternative 1 should only be implemented where expanded shoulders will not adversely affect the environment and neighboring residences.

**ENVIRONMENTAL IMPACTS:** The primary recommendations for the Segment 2 area include Alternative 9: Nutrient Management, Alternative 2: Remove Curbing, Alternative 4: Minimize Path Lengths, and Alternative 1: Expand Road Shoulder. Alternatives 2 and 4 will have a very minor footprint of disturbance as they involve alterations within the existing road surface area. Consequently, these alternatives will have little adverse impact on the environment. Alternative 1: Expand Road Shoulder is a recommended alternative for this segment, but only in areas where additional roadside clearing and grading can be minimized and/or will not adversely affect the existing environment. Careful consideration of appropriate areas to expand the shoulder will minimize impacts to the environment and neighboring residences. Considerations for siting shoulder expansions should include: nearby wetlands, water bodies, rare species habitat, extremes in topography, and vegetated buffers to residences.

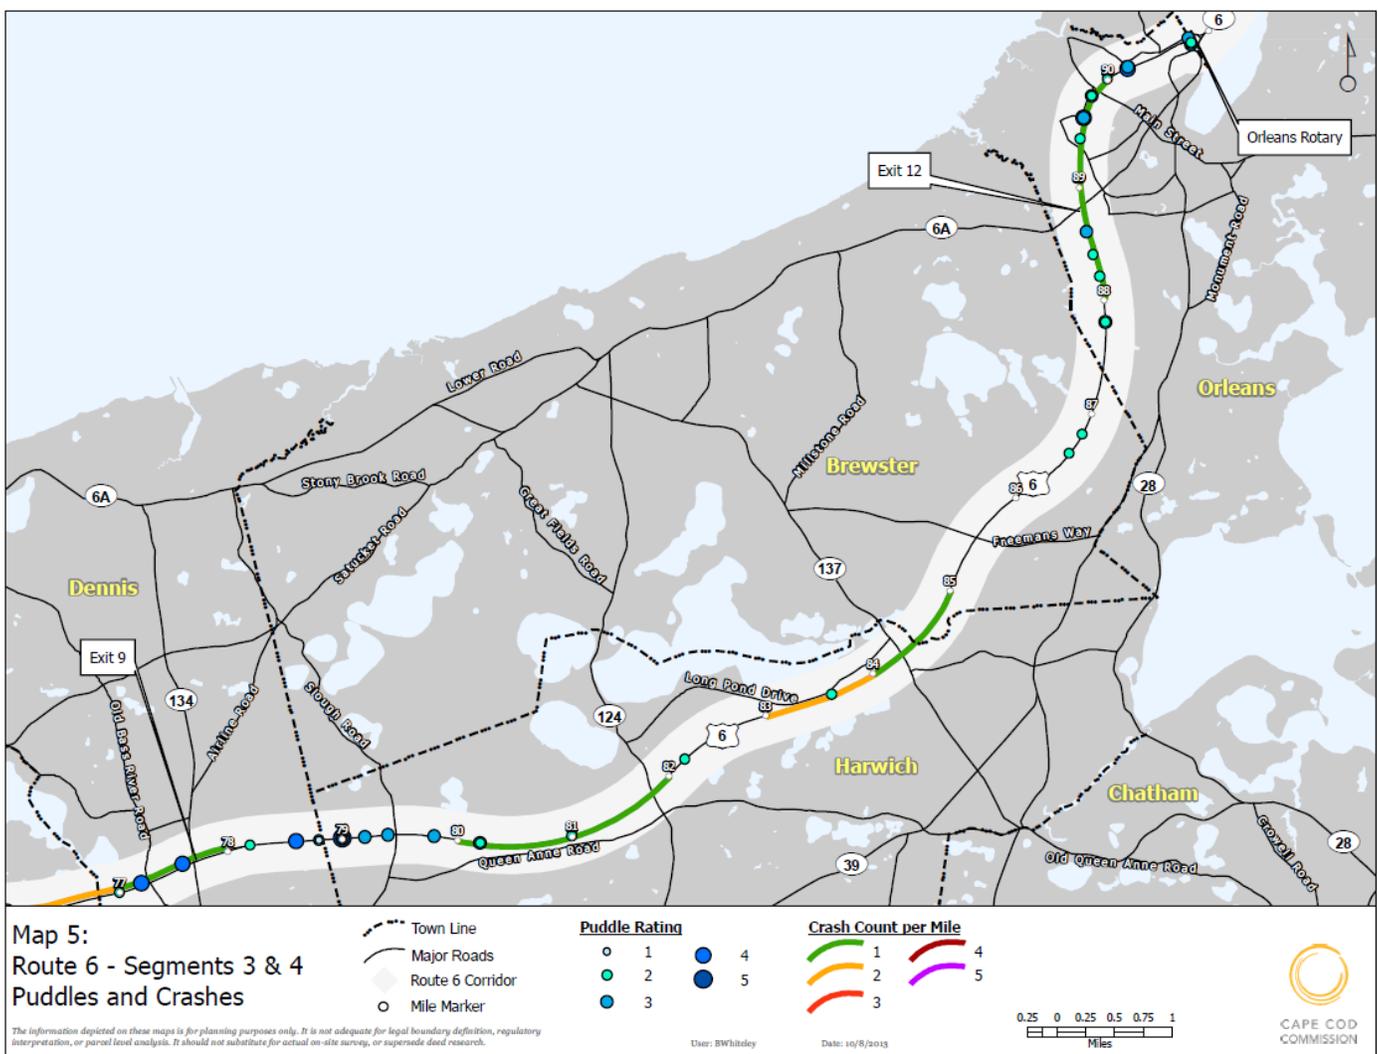
FIGURE 9: ROUTE 6 - SEGMENT 3-4: CRASH AND PUDDLE ANALYSIS

**ENVIRONMENTAL IMPACTS:** The primary recommendations for the Segment 3 area include Alternative 2: Remove Curbing, and Alternative 3: Create Drainage Swales. Alternative 2 will have a very minor footprint of disturbance as it involves alterations within the existing road surface area. Consequently, this alternative will have little adverse impact on the environment. Alternative 3: Create Drainage Swales is a recommended alternative for this segment, but only in areas where additional roadside clearing and grading can be minimized and/or will not adversely affect the existing environment. Careful consideration of appropriate areas to create swales will minimize impacts to the environment and neighboring residences. Considerations for siting swales should include: nearby wetlands,

**ENVIRONMENTAL IMPACTS:** The primary recommendations for the Segment 4 area include Alternative 2: Remove Curbing, and Alternative 3: Create Drainage Swales. Alternative 2 will have a very minor footprint of disturbance as it involves alterations within the existing road surface area. Consequently, this alternative will have little adverse impact on the environment. As Segment 4 has limited ability to expand Alternative 3 is a recommended alternative where sections of the roadway have sufficient shoulder and buffer to adjacent properties. Considerations for siting swales should include: nearby wetlands, water bodies (i.e. Cedar Pond), rare species habitat, extremes in topography, and vegetated buffers to residences.

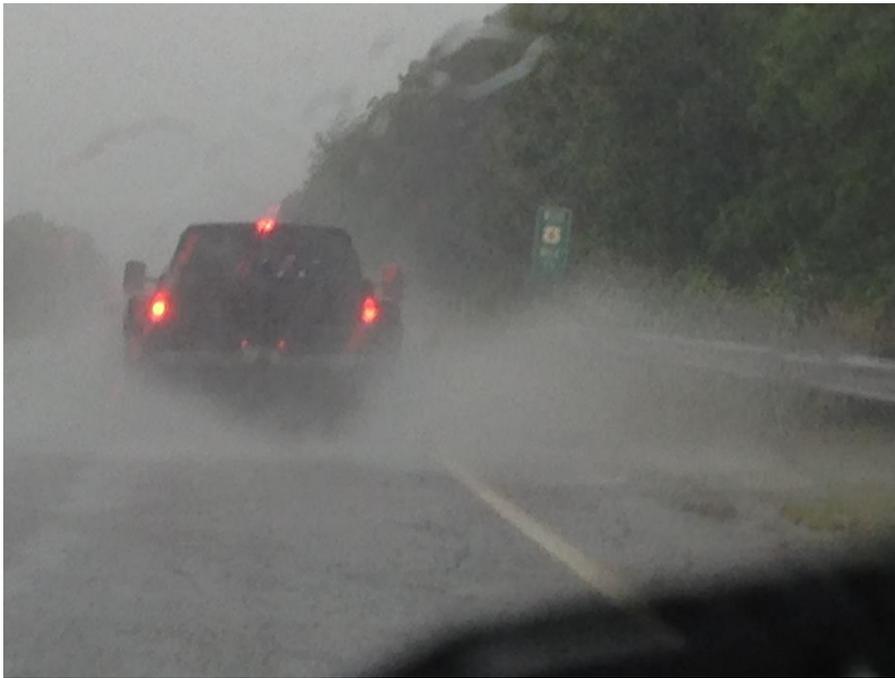
The main issue for this Segment is to address locations of severe ponding. As noted by field technicians the largest puddle in the entire study area spans the roadway between exits 10 and 11. Crash data shows that fewer crashes occur in this segment of the roadway, yet puddle and anecdotal data shows the highest quantity and intensity of puddles of any segment along Route 6. The design and character of this segment of the roadway changes significantly from previous segments, requiring a reduction in normal travel speeds due to the two lane road layout and absence of a vegetated median. Travelers familiar with the roadway may naturally reduce their speeds in poor travel conditions due to awareness of the potentially hazardous conditions.

FIGURE 10: EAST OF EXIT 9 IN WESTBOUND LANE. PUDDLE COVERING ENTIRE DRIVING LANE.

**ROADWAY IMPROVEMENTS:** In areas with adequate Rights of Way and suitable topography, removal of curbing (Alternative 2) facilitating runoff to a receiving water quality conveyance swale (Alternative 3) will take advantage of country drainage and decrease risk of hydroplaning. Certain locations with extreme puddle formations (Figure 10) should be prioritized for consideration.
