Framingham, MA
**Grant Street
Safety Evaluation**

CRASH ANALYSIS

Prepared by: BETA GROUP, INC.

Prepared for: City of Framingham, Massachusetts

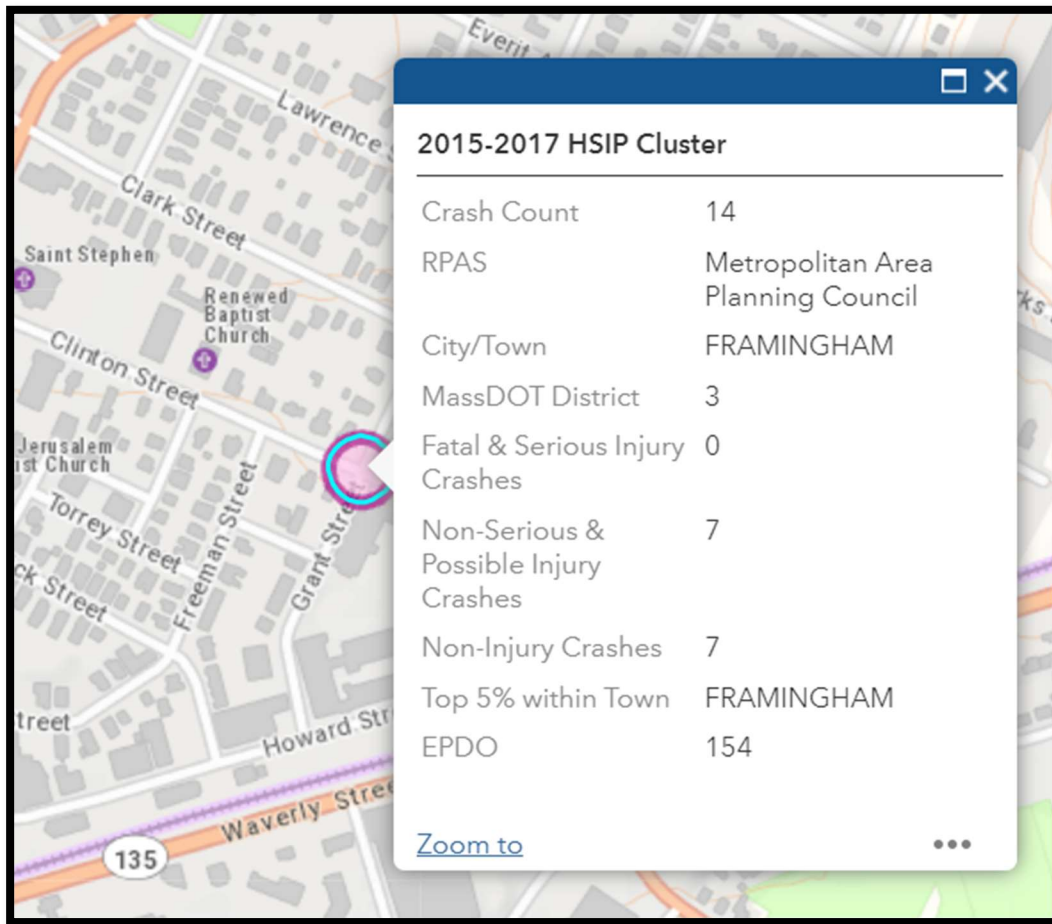
Figure 6 – Clinton Street HSIP Cluster

A review of MassDOT's Top Crash Locations portal revealed that the Clinton Street intersection was identified as a Highway Safety Improvement Program (HSIP) cluster for the 2015 to 2017 timeframe. This means that it ranked within the top 5% of all locations within the region with regards to crashes. The ranking is based on factors beyond just number of crashes, and puts significant emphasis on crash severity, such as injuries and/or fatalities. **Figure 6** provides an illustration of the information included in the online portal, which shows that the Clinton Street intersection experienced 14 crashes between 2015 and 2017, with 7 of them resulting in injuries.

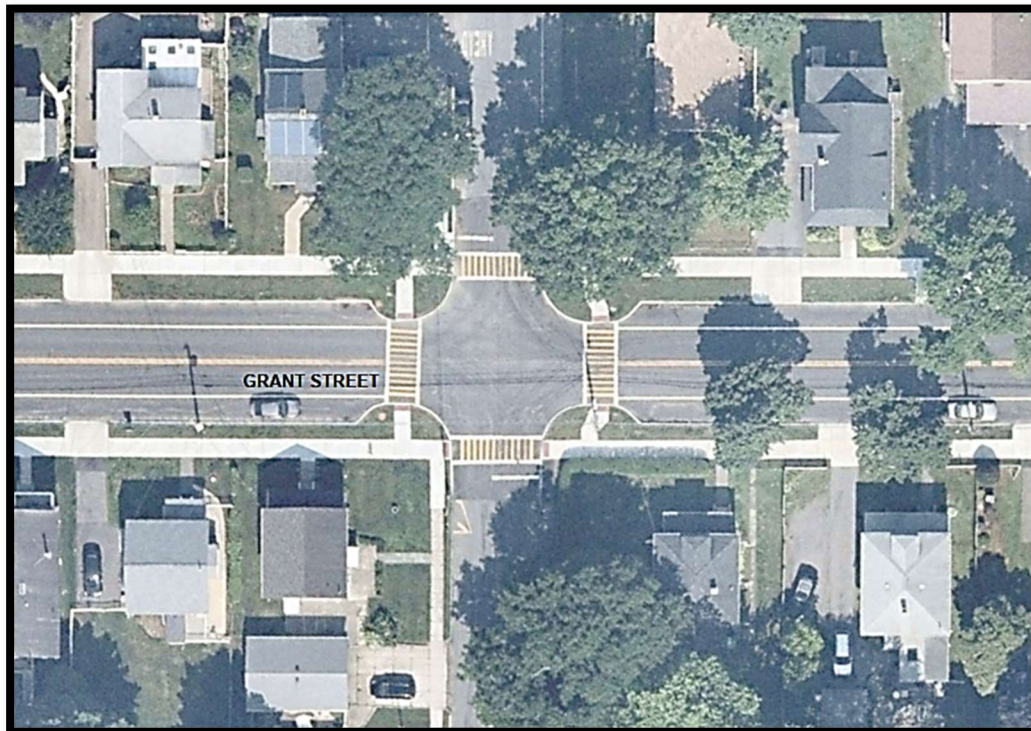
Figure 7 – Example of New Crosswalks Across Grant Street

Regarding the crosswalks installed across Grant Street throughout the corridor, **Figure 7** illustrates these changes at the Mansfield Street intersection. The concern is that although the implementation of the crosswalks is an enhancement for pedestrians, they may be creating the appearance of an All-Way stop controlled intersection to motorists. Particularly, to those that are not familiar with area, as mentioned above.

- Change the traffic control operations at the Mansfield Street intersection to an All-Way stop. Per the MUTCD, a multi-way stop should be considered at a location that has experienced five or more reported crashes in a 12-month period that are susceptible to correction by a multi-way stop installation. The Mansfield Street intersection has experienced 18 crashes over the last 3.5 years, and all but one was a right-angle collision. Angle collisions are considered to be correctible by an All-Way stop.
- Install Pedestrian Warning signs at all uncontrolled Grant Street crosswalks. Not only will these signs enhance the awareness of motorists that there is a crosswalk, but will also help reinforce that these locations are not all-way stop controlled. These signs should also be supplemented with the downward arrow plaque to provide motorists additional information.

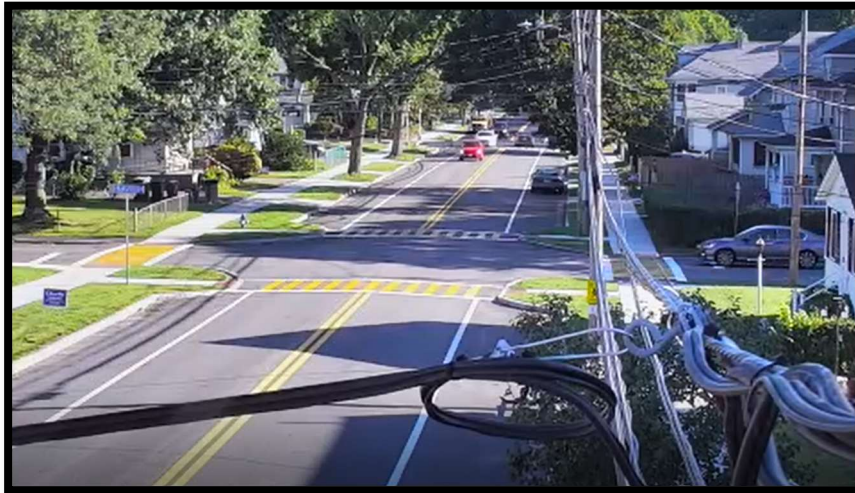
Figure 8 – Video Monitoring of Mansfield Street Intersection

Vehicle approaches Grant Street along the Mansfield Street westbound approach.

These images from the video footage reveal that the motorists on Mansfield Street was likely confused when the northbound Grant Street vehicle slowed down in advance of the intersection, possibly misinterpreting this decision as an indication that vehicles on Grant Street must stop at the intersection, or that it is under All-Way Stop control. This misunderstanding ultimately led to the collision.

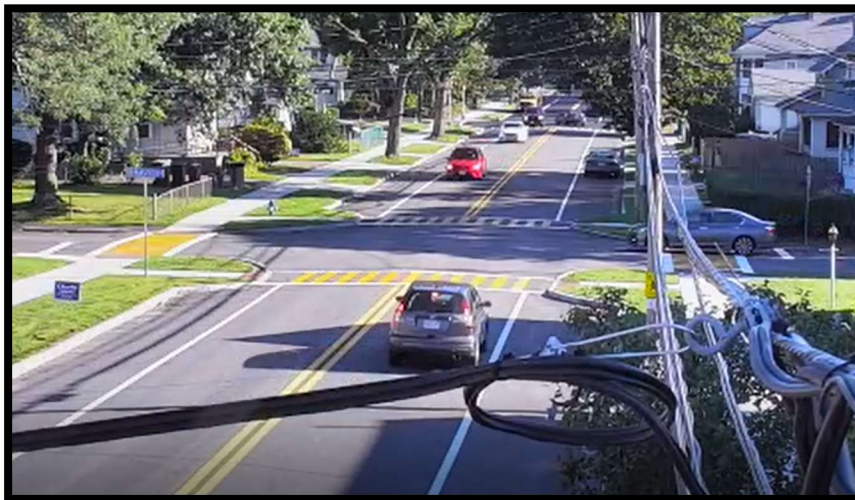
Mansfield Street vehicle begins to enter intersection as vehicles approach the intersection from both directions of Grant Street. Northbound vehicle appears to slow down in advance of recently installed crosswalk.

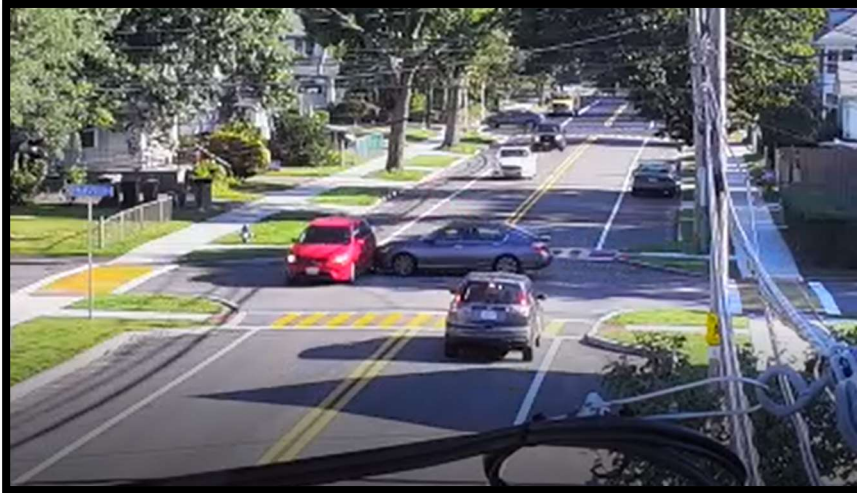
Northbound Grant Street vehicle comes to a stop, Mansfield Street vehicle fully enters the intersection, striking the Grant Street southbound vehicle that did not stop.

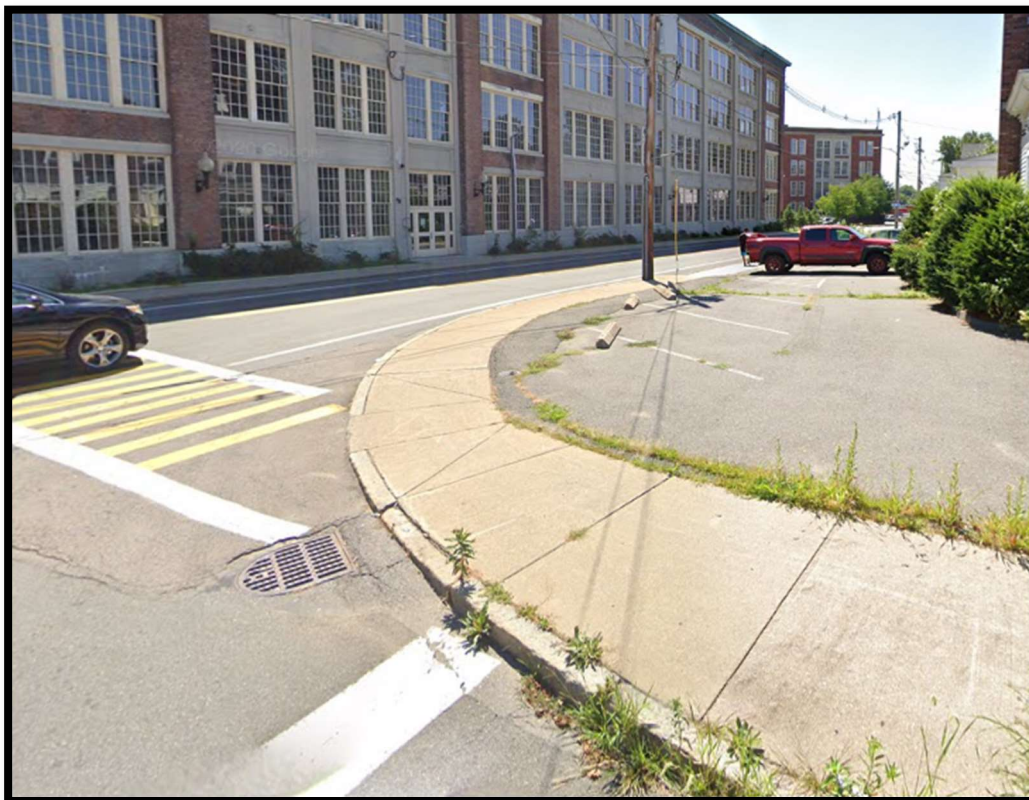
Figure 9 – Sight Distance, Clinton Street Intersection

Regarding sight distance at the intersections, only two locations appeared to have conditions that were potentially creating obstructions. At Clinton Street intersection, there is a small parking lot on the southwest corner of the intersection that allows vehicles to be parked right along the back edge of the sidewalk. As shown in **Figure 9**, vehicles parked in this lot can hinder the sight distance of eastbound motorists stopped at the intersection.

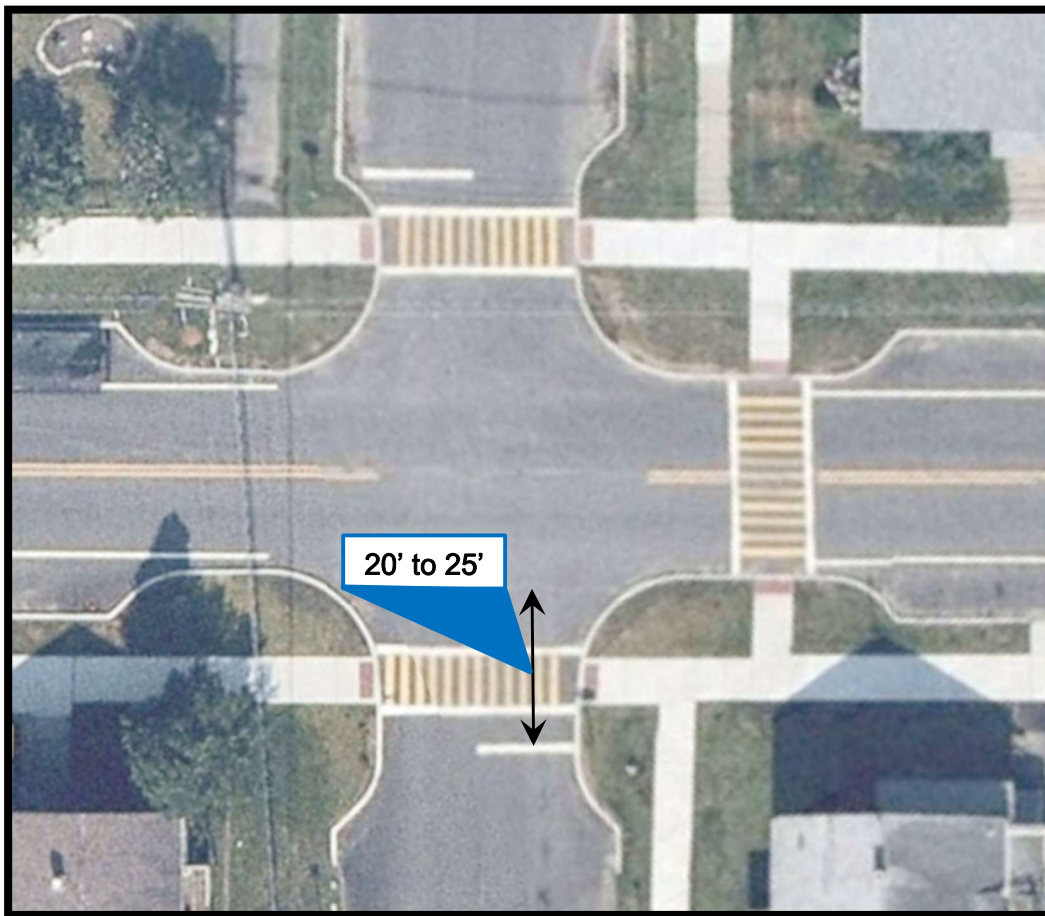
Figure 10 – Location of Stop Lines Relative to the Intersection

Figure 10 shows the location of the stop lines for both approaches to Grant Street at the Lawrence Street intersection, which is consistent at each intersection throughout the corridor. Per design standards established by the American Association of State Highway and Transportation Officials (AASHTO), MassDOT and the MUTCD, the stop lines must be located in advance of the crosswalks, so they are required to be installed as shown. However, throughout the corridor this puts the stop lines on the side streets approximately 20-feet to 25-feet from the travel lane on Grant Street, which approximates a whole vehicle length.

- Install Guide or Extension Lines for the white edge lines across all intersection streets along the corridor. This is recommended primarily to provide a visual marker of the edge of the Grant Street travel way for motorists approaching from one of the side streets, which will provide a better understanding where vehicles can yield prior to entering an intersection.
