Inspection Report for North Sturbridge Road Solar Facility

NPDES ID No.: MAR10031G

Inspection Date: 07/28/2021

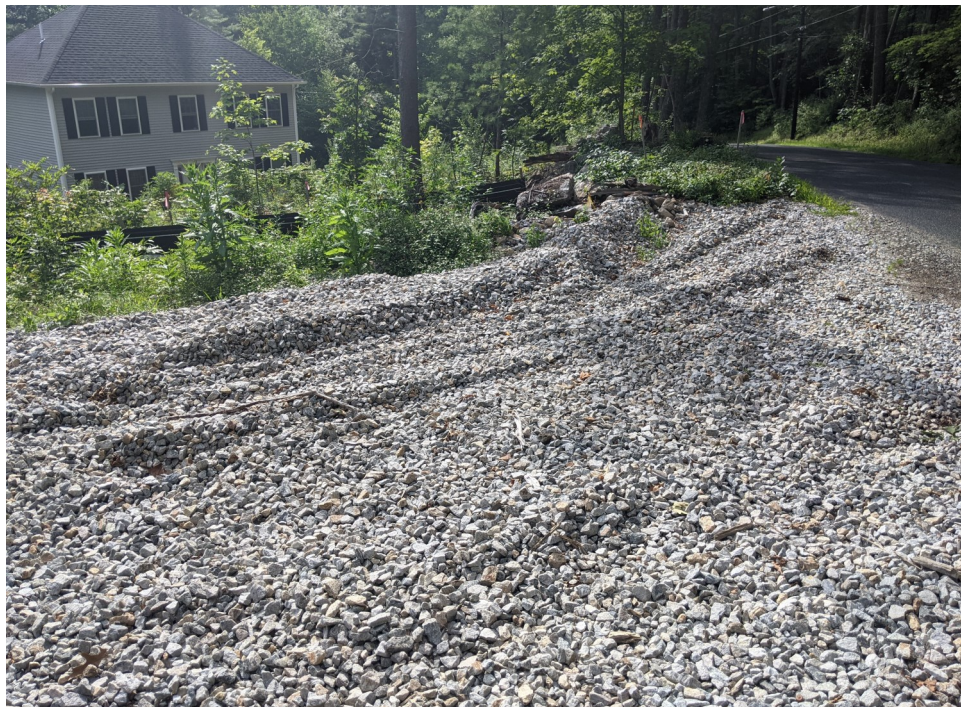
Photo 1

2. Stabilized Construction Entrance (Site Entrance – Access Road)	Yes	Yes	7/22/2021	Ruts have formed within the construction track out pad at the entrance to the Site and should be smoothed out.

View of the stabilized construction entrance—facing west.

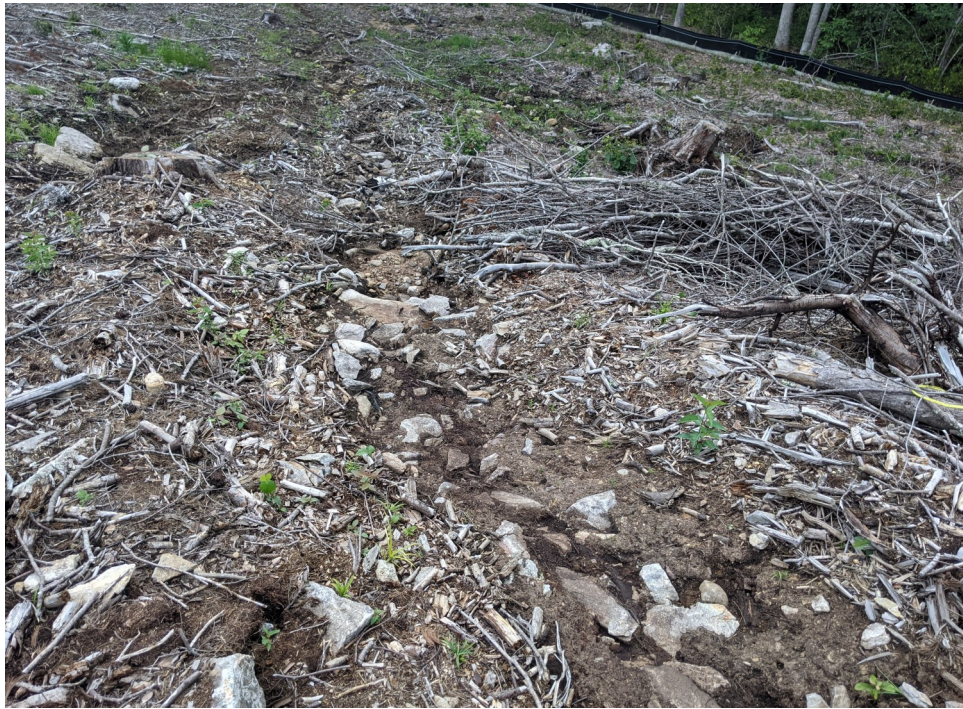
Photo 3

2. Access road along northern portion of the Site	Straw mulch or hydroseed	<input checked="" type="checkbox"/> Yes [Enter date] <input type="checkbox"/> No	The informal access road along the northern portion of the Site is in need of stabilization if there is a cessation of work at the Site. Erosion gullies are beginning to form upgradient of this access road. Erosion is currently confined to the limits of work. The contractor indicated that stabilization by smoothing out soils and seeding or spreading mulch would occur on 7/30/2021.

View erosion gullies beginning to form upgradient of the informal northern access road—facing northwest.

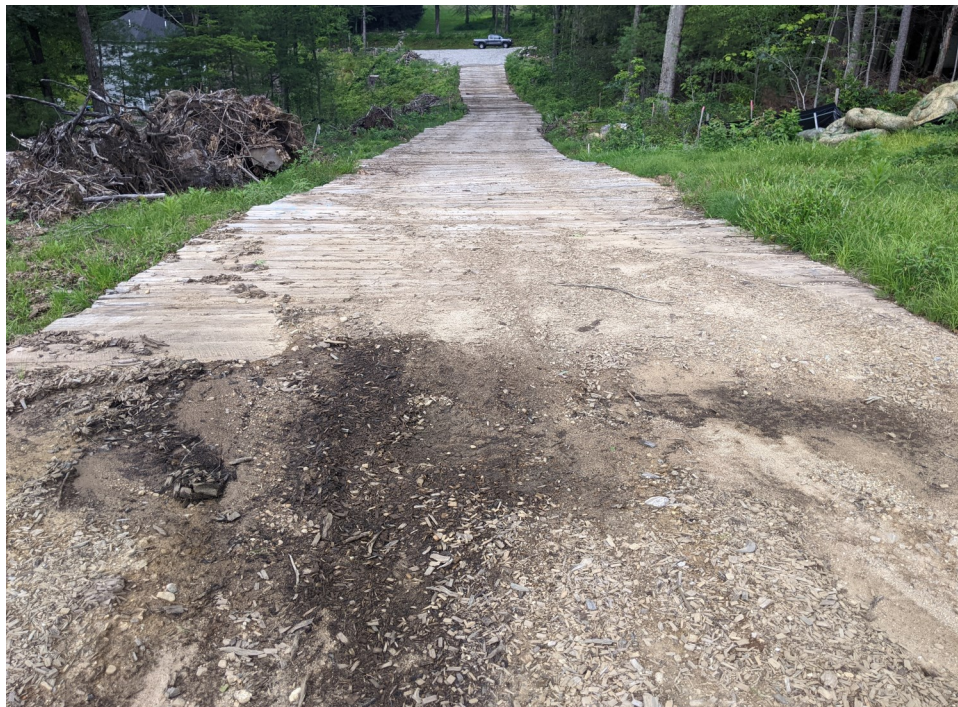
Photo 4

3. Stump and Soil Stockpile Area	Yes	Yes	7/22/2021	The portion of the access road in the vicinity of the north side of the soil stockpile area is in need of stabilization while there is a cessation of work at the Site. Uncontrolled runoff from this access road likely contributed to the issue raised in Item #1.

Stabilization Area [insert additional rows if applicable]	Stabilization Method	Have You Initiated Stabilization?	Notes
1. Access road leading to stockpile area	Straw mulch or hydroseed	<input checked="" type="checkbox"/> Yes [Enter date] <input type="checkbox"/> No	The access road leading to the stockpile area is in need of stabilization if there is a cessation of work at the Site. The access road is contributing stormwater discharge to an area where erosion controls were breached. The contractor indicated that stabilization by smoothing out soils and seeding or spreading mulch would occur on 7/30/2021.

View of erosion within the access road to the north of the stockpile area—facing north.
