**PHOTOGRAPHIC DOCUMENTATION**

North Sturbridge Road Solar Facility

Charlton, Massachusetts

Photographs Documented 07.28.2021

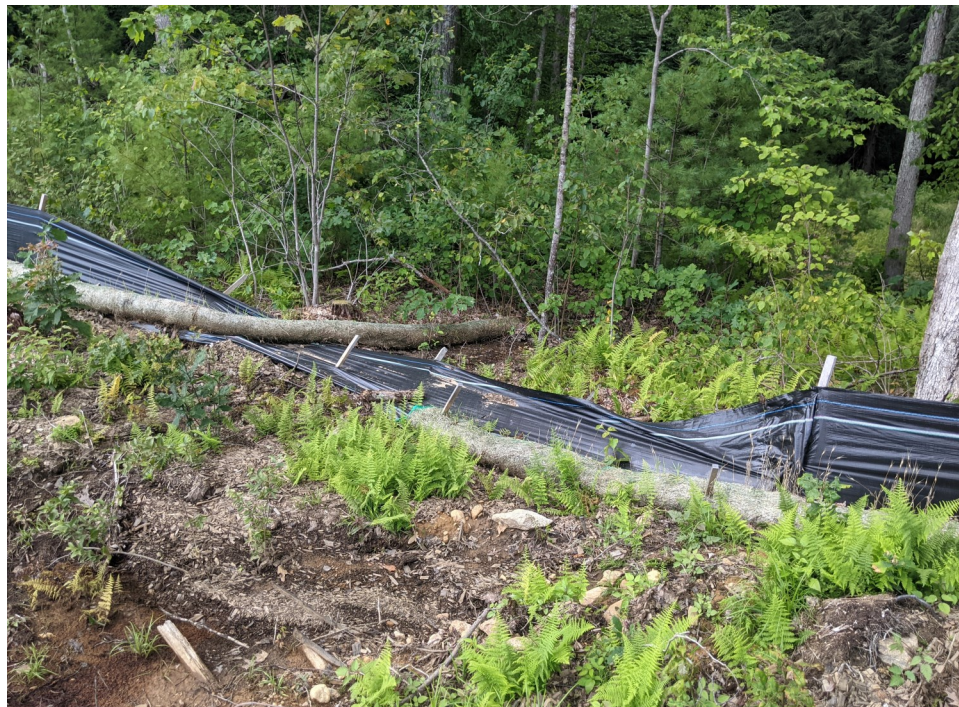
**Photo 2**

View of the erosion control breach—facing northwest.

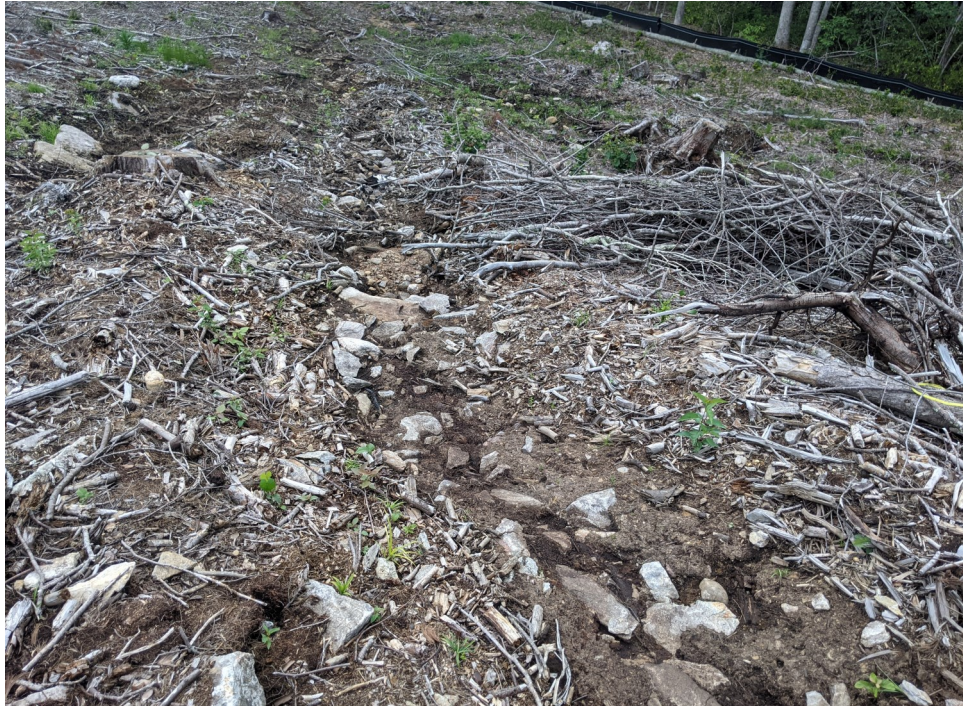
**Photo 3**

View erosion gullies beginning to form upgradient of the informal northern access road—facing northwest.

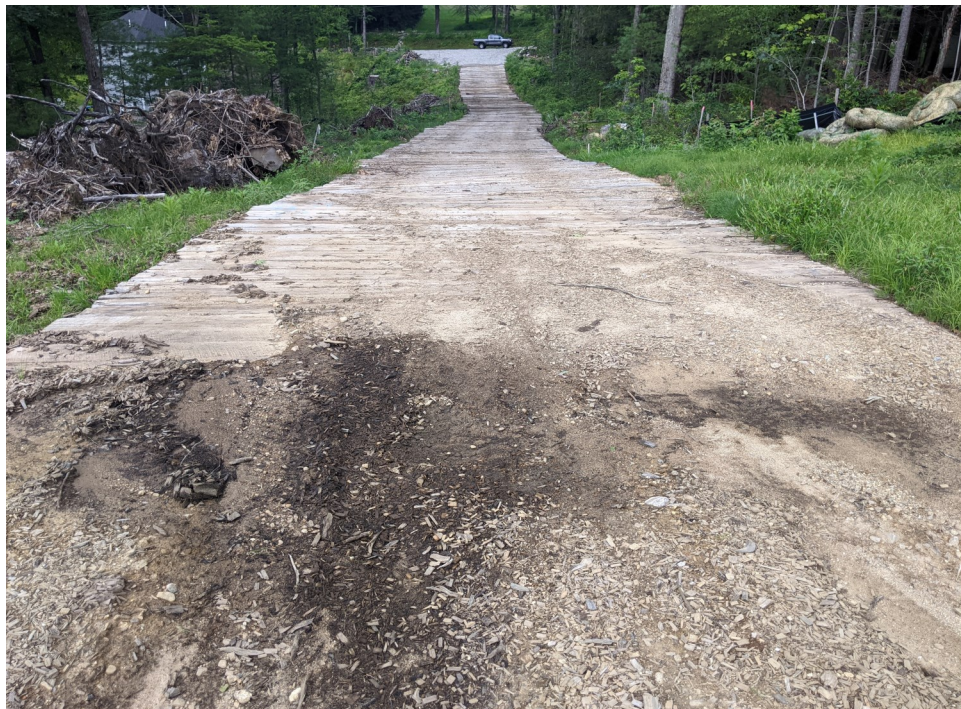
**Photo 4**

View of erosion within the access road to the north of the stockpile area—facing north.
