Inspection Report for North Sturbridge Road Solar Facility

NPDES ID No.: MAR10031G

Inspection Date: 08/11/2021

PHOTOGRAPHIC DOCUMENTATION

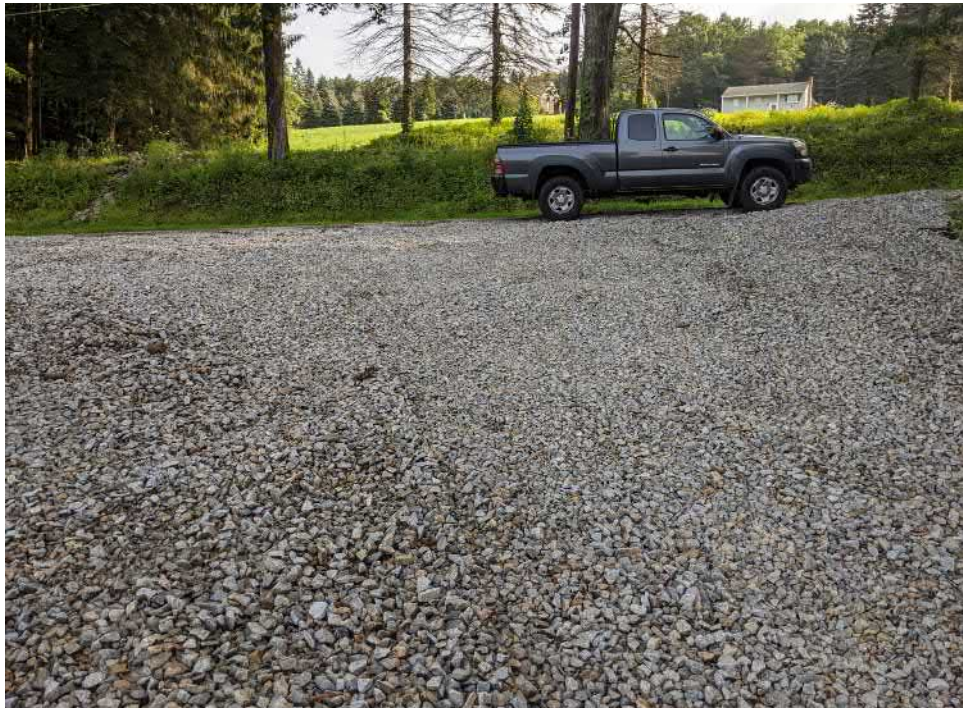
Photo 1

2. Stabilized Construction Entrance (Site Entrance – Access Road)	No	No		The requested maintenance of the ruts within the stabilized construction entrance has been completed.

View of the recently maintained construction entrance—facing north.

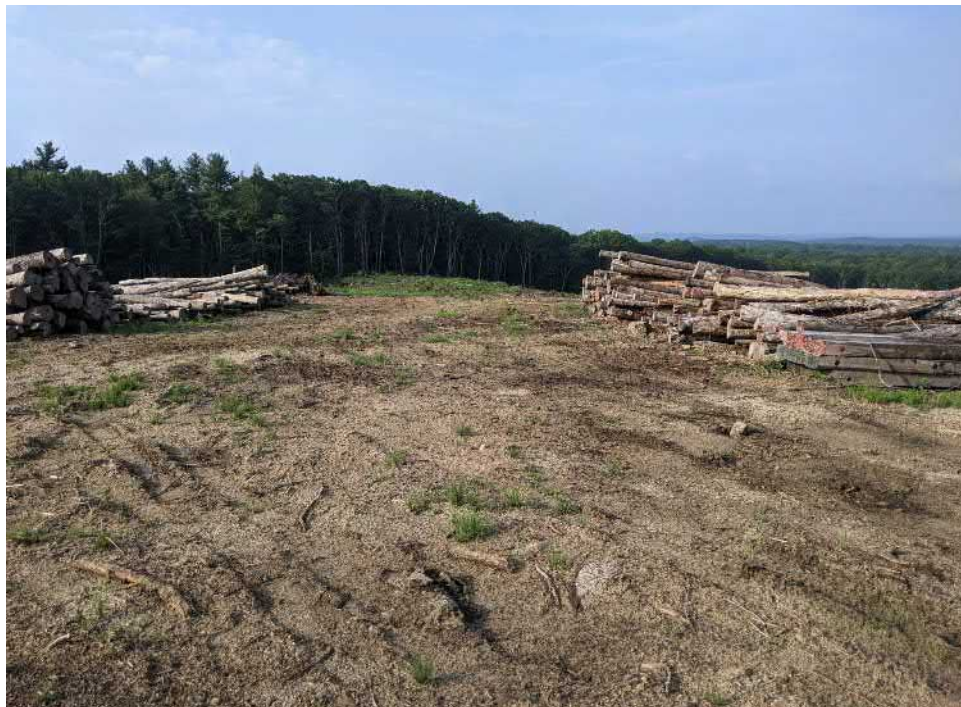
Photo 2

3. Stump and Soil Stockpile Area	No	No		Stabilization of this area was observed to have commenced prior to the 8/11/2021 inspection.

View of hydroseed within the stockpile area—facing southwest.

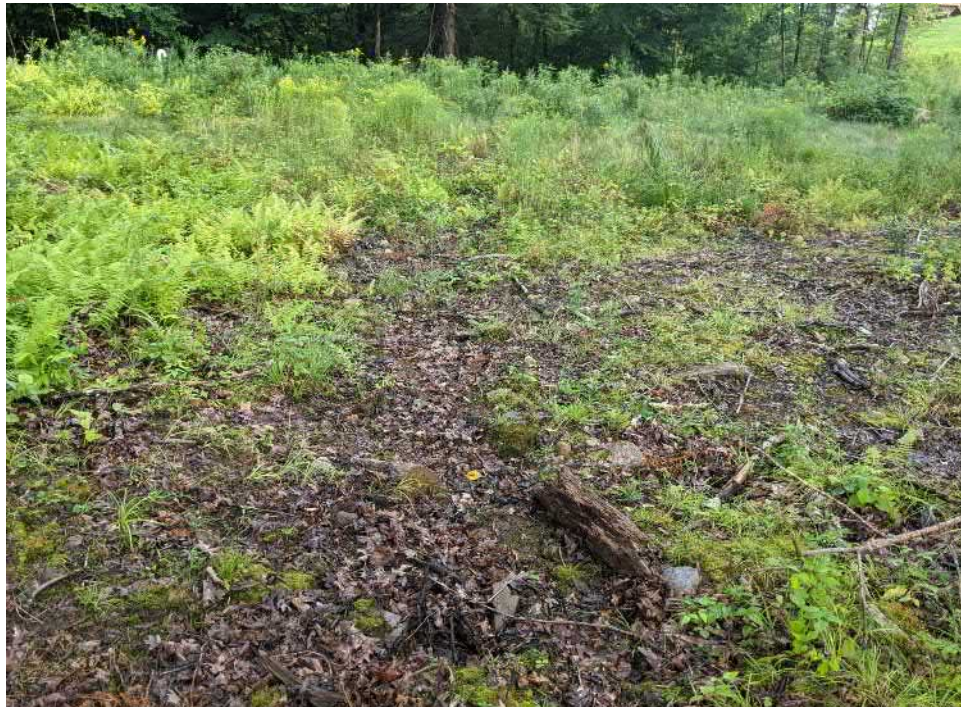
Photo 6

3. Area beyond the limits of work at the former erosion control maintenance area	Hand application of seed	<input checked="" type="checkbox"/> Yes 7/30/2021 <input type="checkbox"/> No	Sediment deposit has been removed from beyond the limits of work and the area has been seeded. No sediment migrated within 50 feet of a "water of the US".

View of an area where sediment was removed from beyond the limits of work and seed was applied—facing north.

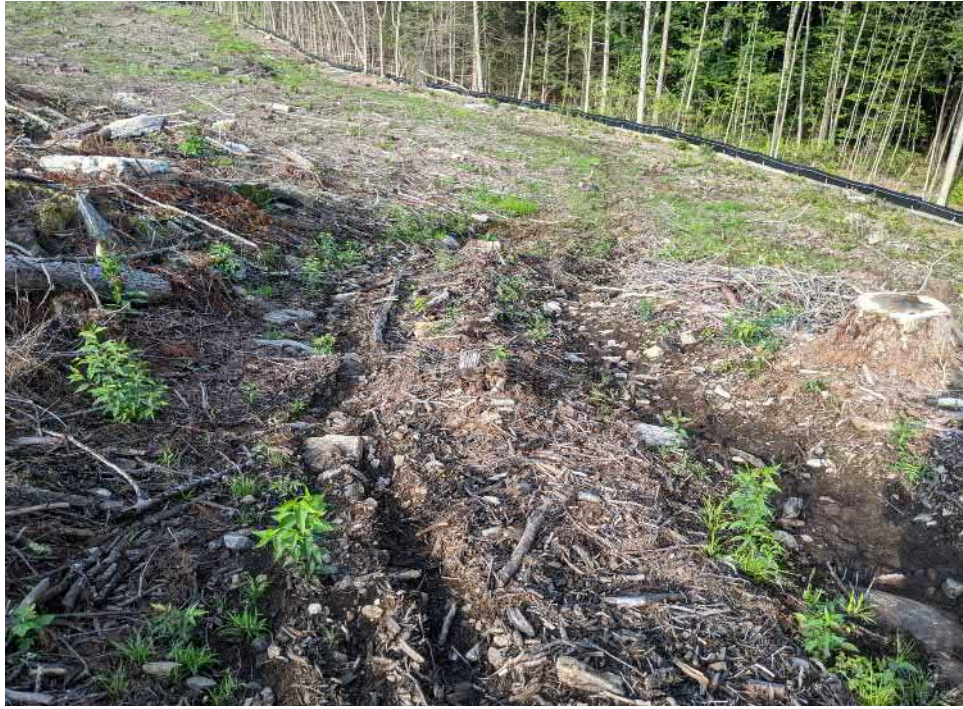
Photo 7

2. Informal access road along northern portion of the Site	Straw mulch or hydroseed	<input type="checkbox"/> Yes [Enter date] <input checked="" type="checkbox"/> No	The informal access road along the northern portion of the Site requires stabilization if there is a cessation of work at the Site. Erosion channels are beginning to form within upgradient portions of this access road. Erosion is currently confined to the limits of work. The contractor indicated that stabilization by smoothing out soils and seeding or spreading mulch would occur on 7/30/2021. Stabilization of this area has not been initiated.

View of erosion channels and exposed soils within and along the equipment tracks present at the informal access road near the northern limits of work—facing northwest.
