PHOTOGRAPHIC DOCUMENTATION

North Sturbridge Road Solar Facility

Charlton, Massachusetts

Photographs Documented 08.11.2021

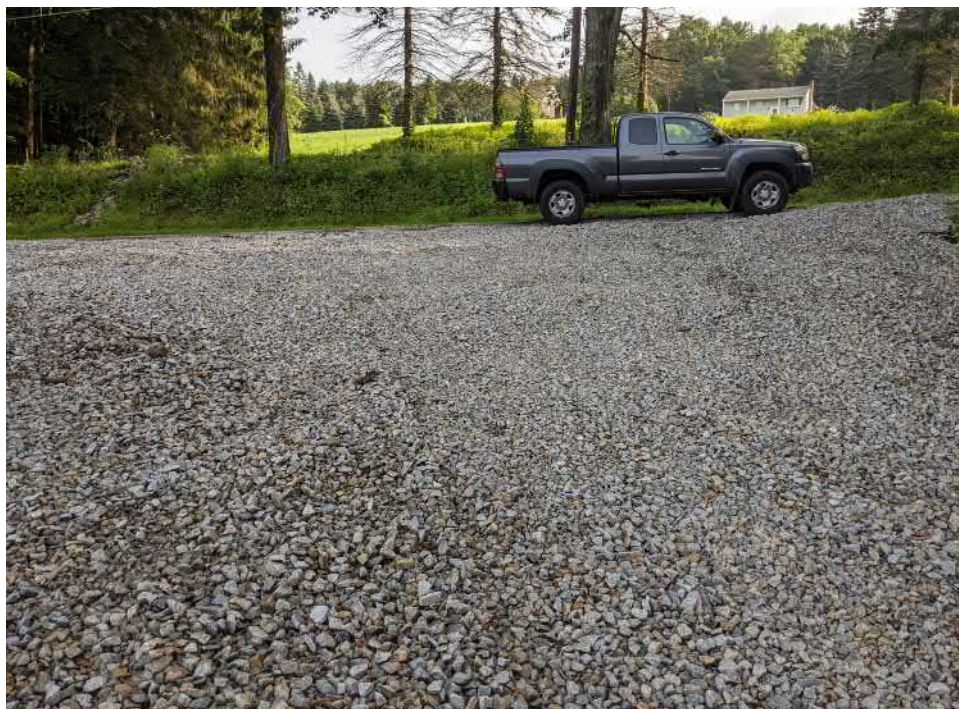
Photo 1

View of the recently maintained construction entrance—facing north.

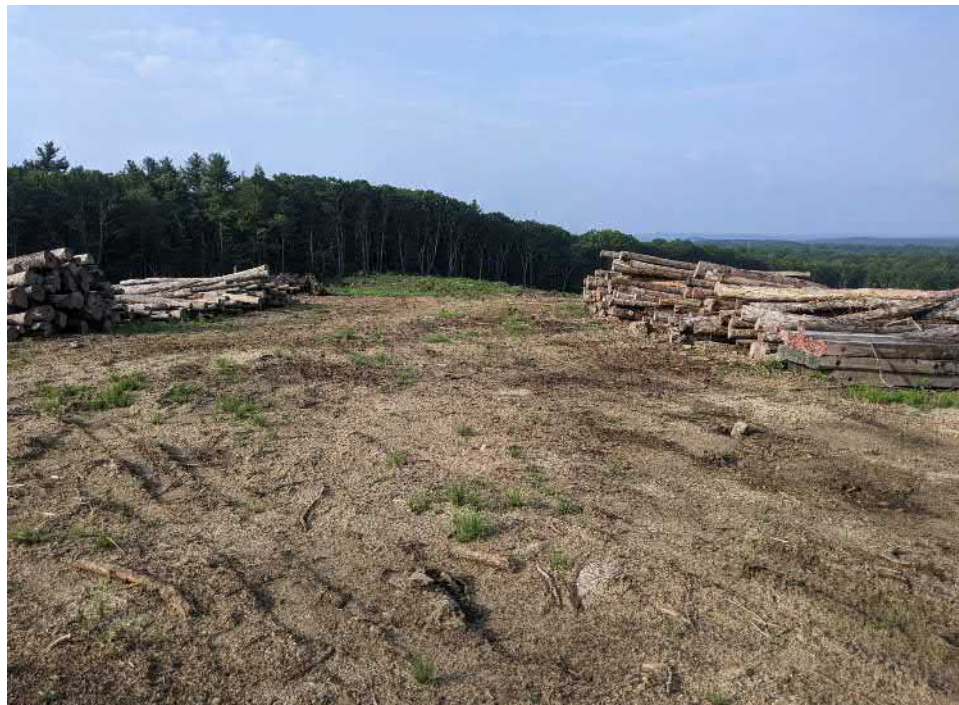
Photo 2

View of hydroseed within the stockpile area—facing southwest.

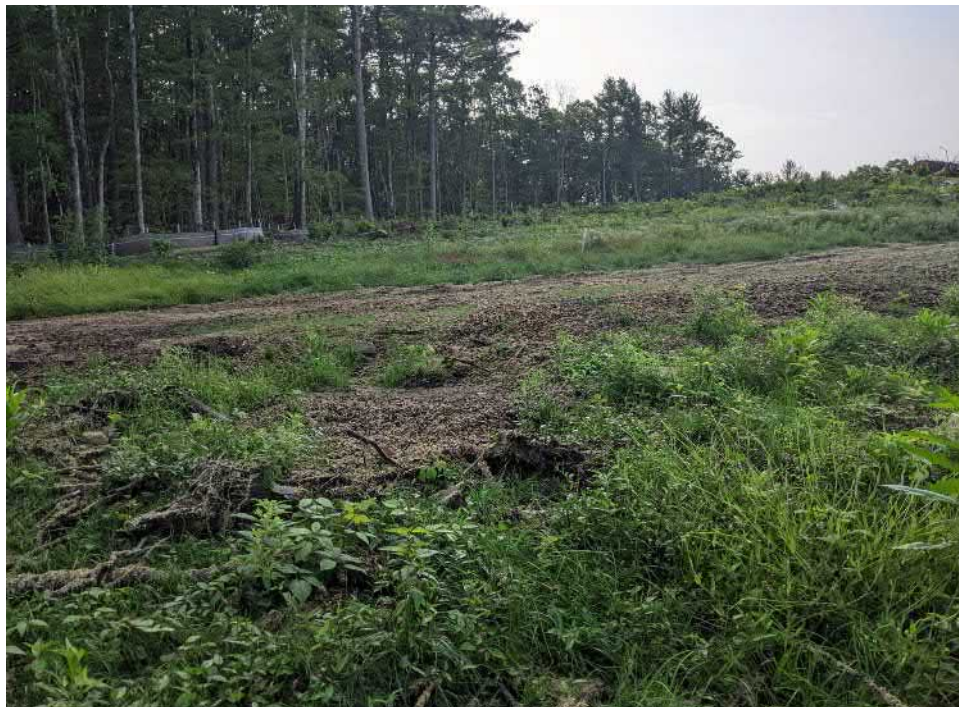
Photo 3

View of hydroseed within the access road—facing east.

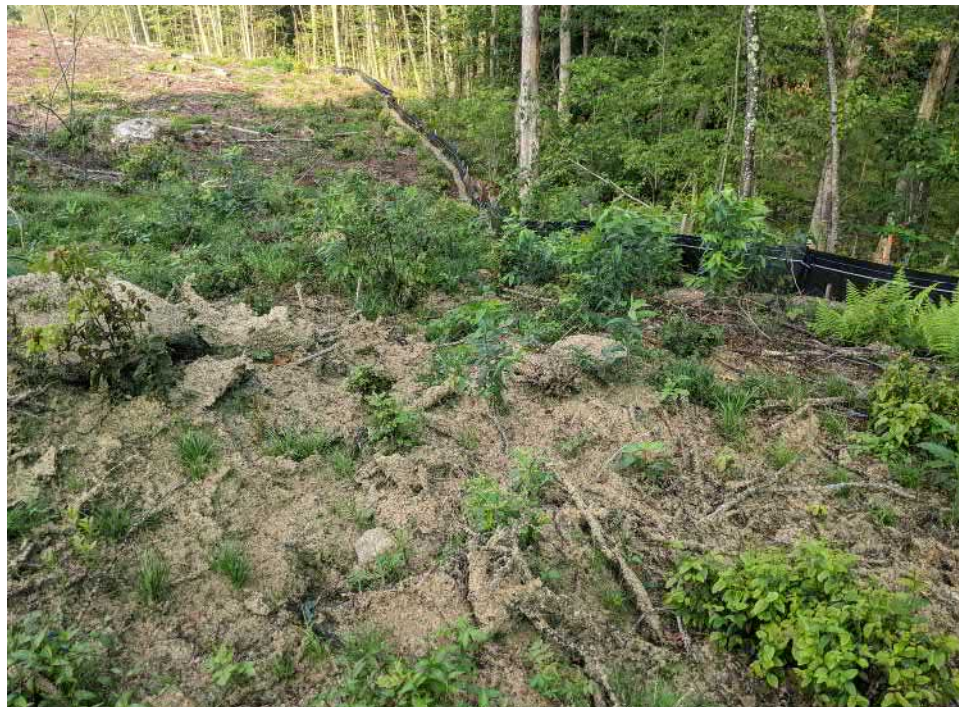
Photo 4

View of hydroseed applied to exposed soils to the southwest of the timber mats—facing northwest.

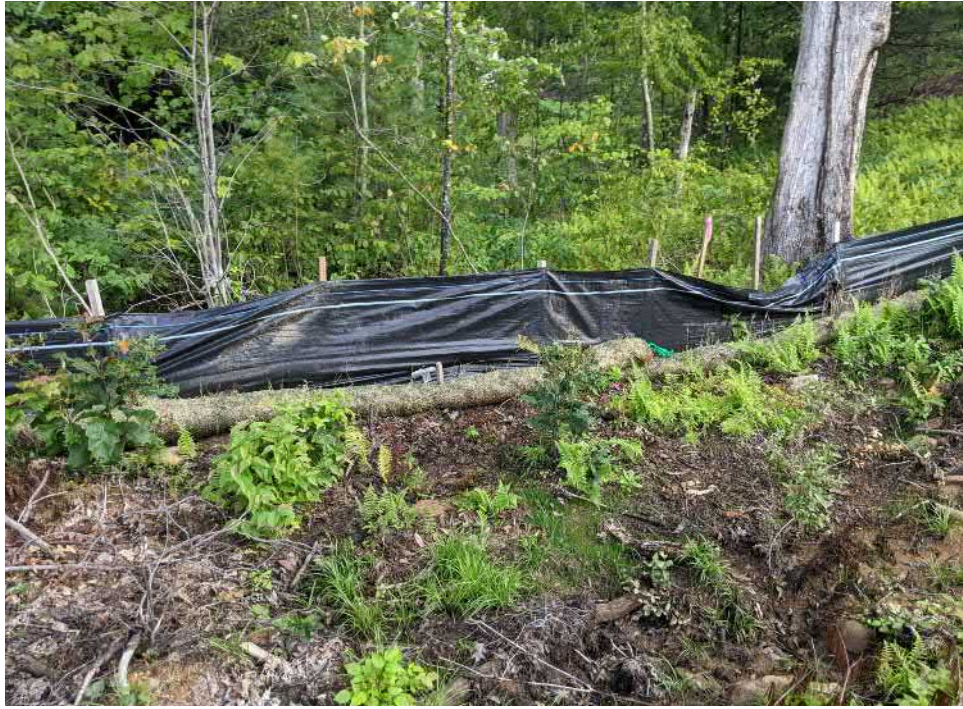
Photo 5

View of re-established straw wattles—facing north.

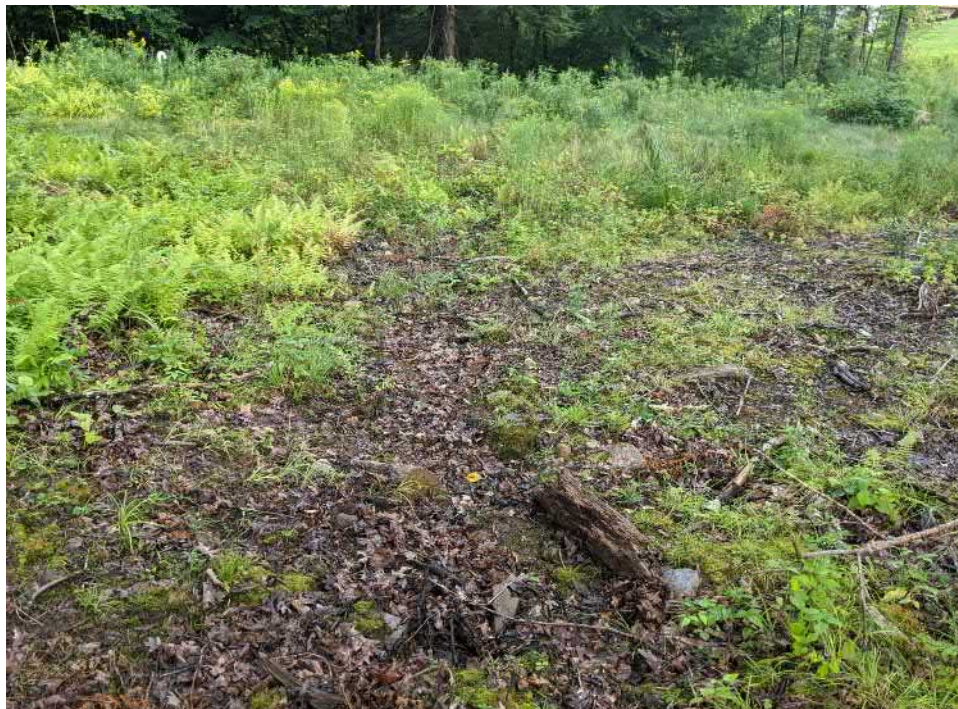
Photo 6

View of an area where sediment was removed from beyond the limits of work and seed was applied—facing north.

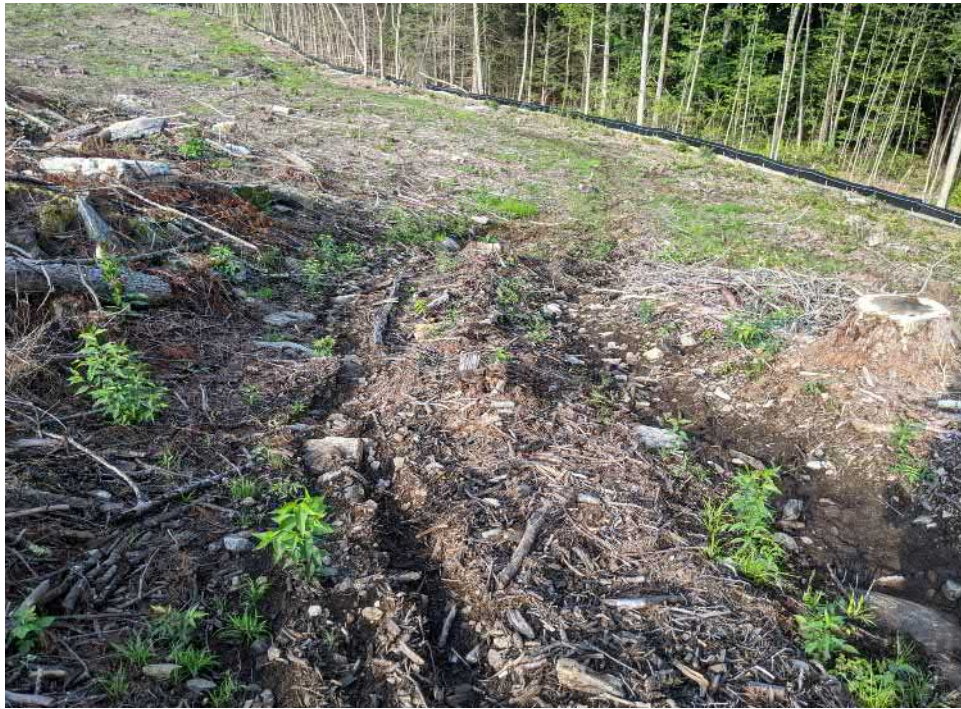
Photo 7

View of erosion channels and exposed soils within and along the equipment tracks present at the informal access road near the northern limits of work—facing northwest.
