PHOTOGRAPHIC DOCUMENTATION

North Sturbridge Road Solar Facility

Charlton, Massachusetts

Photographs Documented 08.11.2021

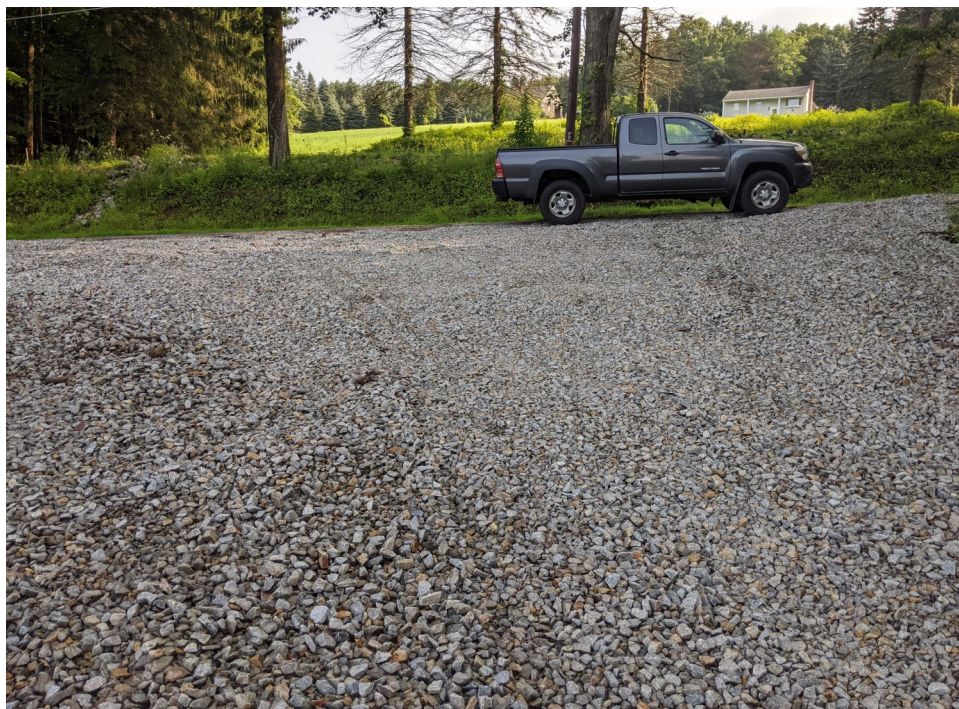
Photo 1

View of the recently maintained construction entrance—facing north.

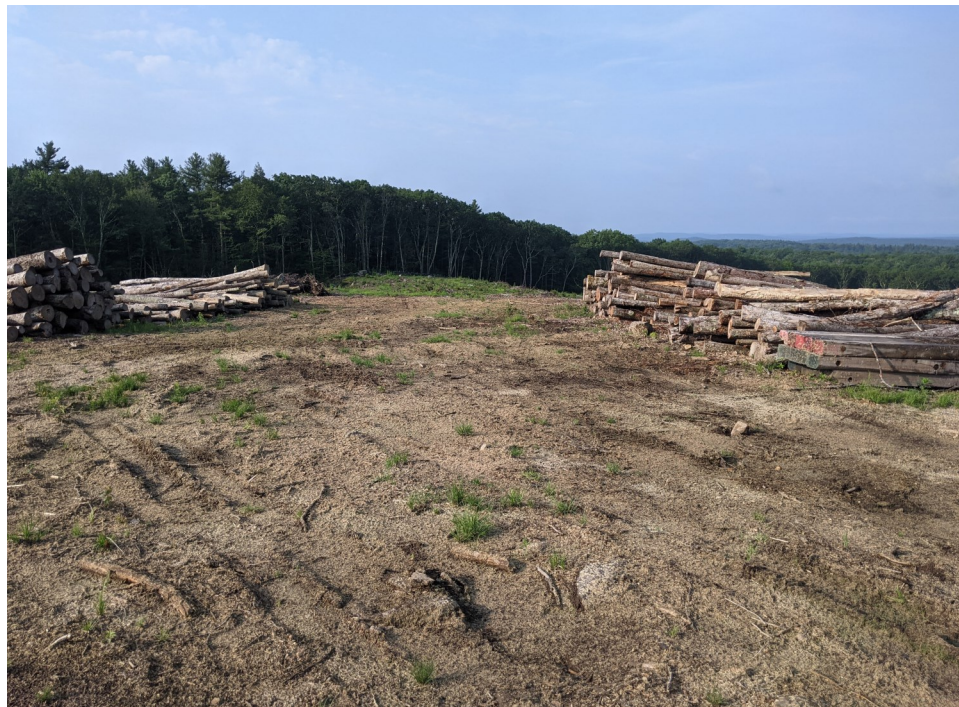
Photo 2

View of hydroseed within the stockpile area—facing southwest.

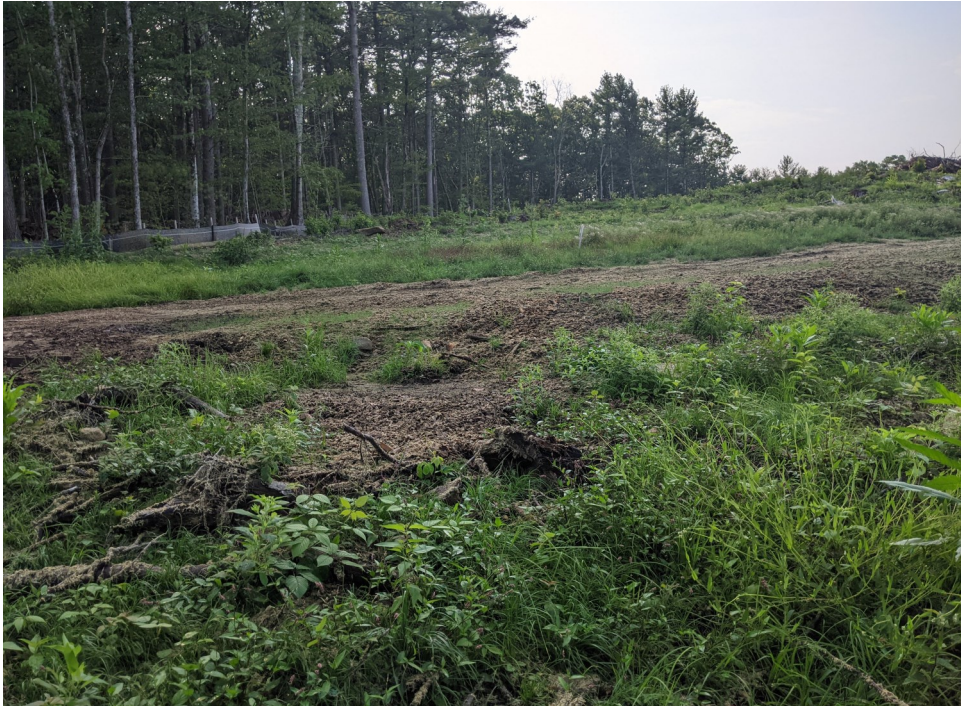
Photo 3

View of hydroseed within the access road—facing east.

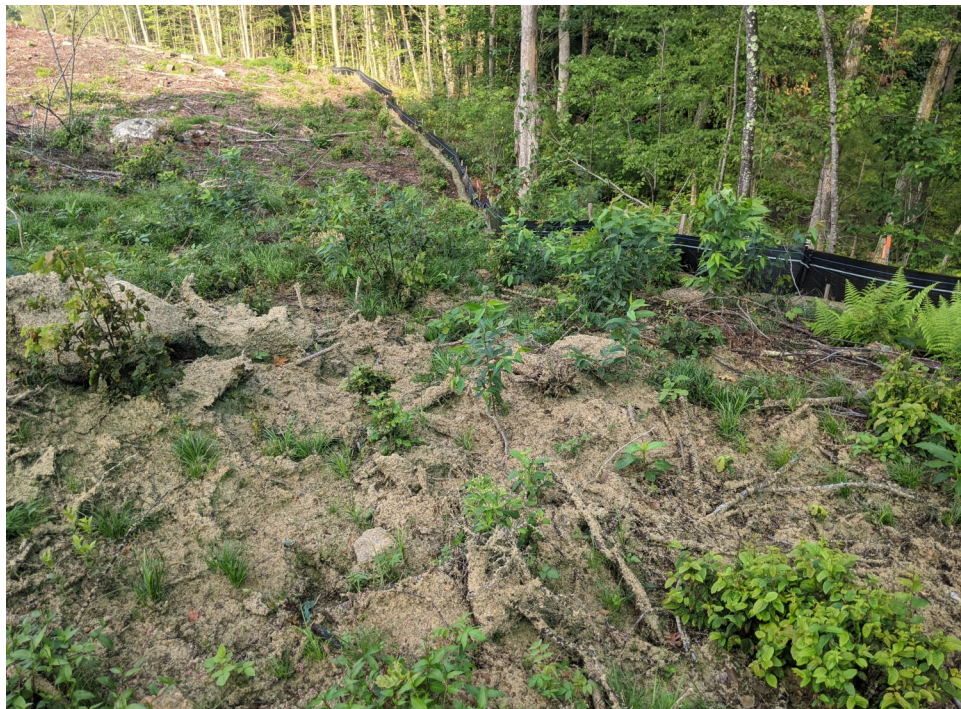
Photo 4

View of hydroseed applied to exposed soils to the southwest of the timber mats—facing northwest.

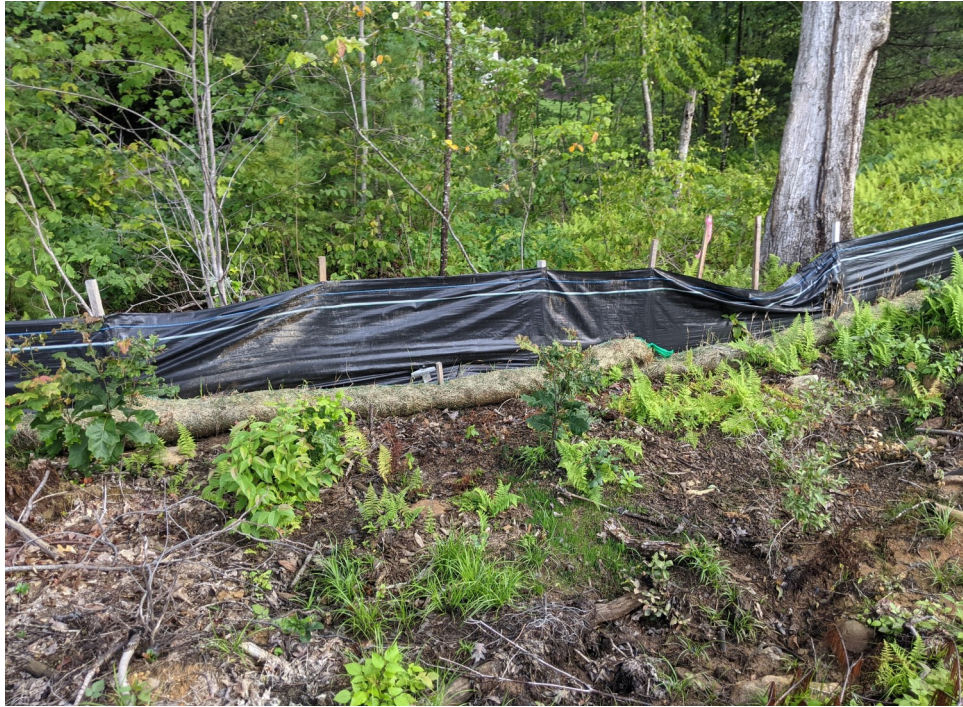
Photo 5

View of re-established straw wattles, rather than installation of a compost filter tube—facing north.

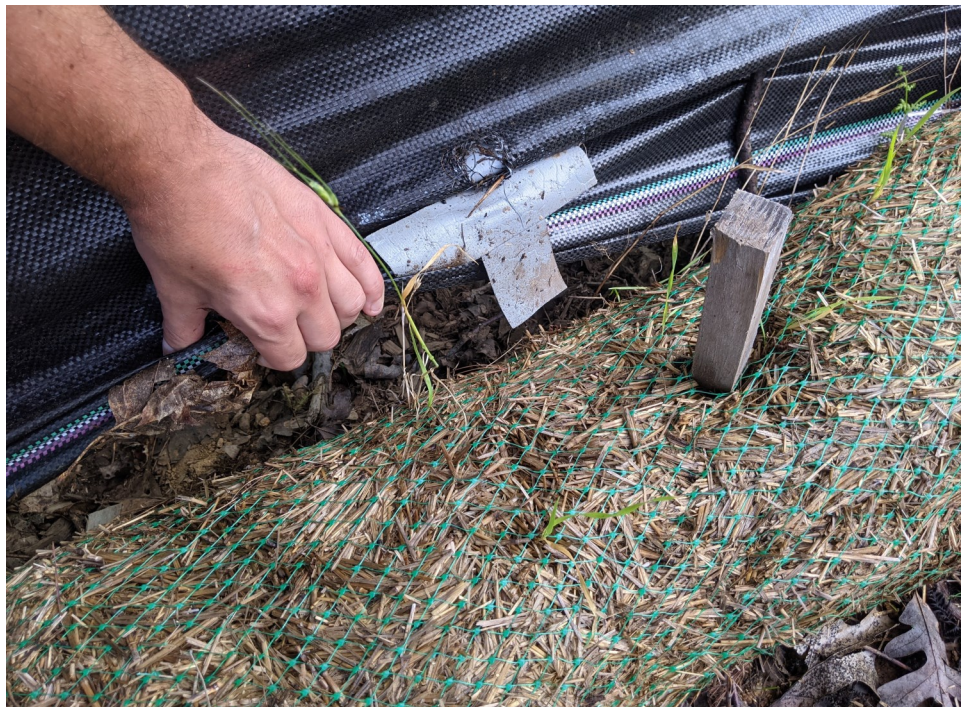
Photo 6

View of the siltation fencing incorrectly re-installed.

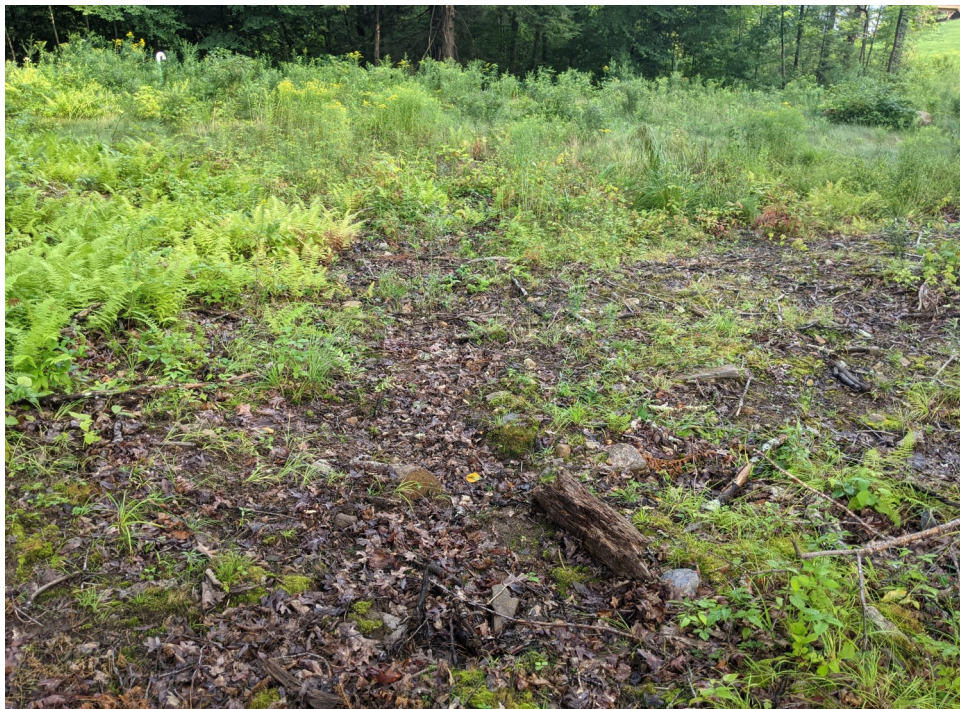
Photo 7

View of sediment removed from beyond the limits of work, and seed applied—facing north.

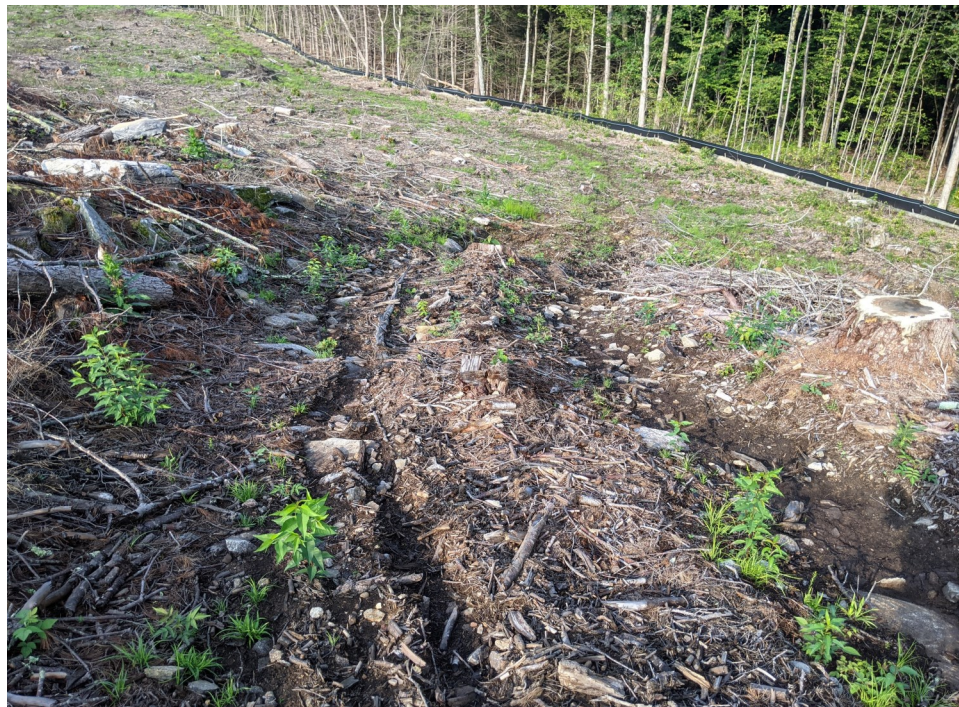
Photo 8

View of erosion gullies and exposed soils resulting from the informal access road along the northern limits of work—facing northwest.
