**Inspection Report for** North Sturbridge Road Solar Facility

**NPDES ID No.:** MAR10031G

**Inspection Date:** 08/20/2021

**PHOTOGRAPHIC DOCUMENTATION**

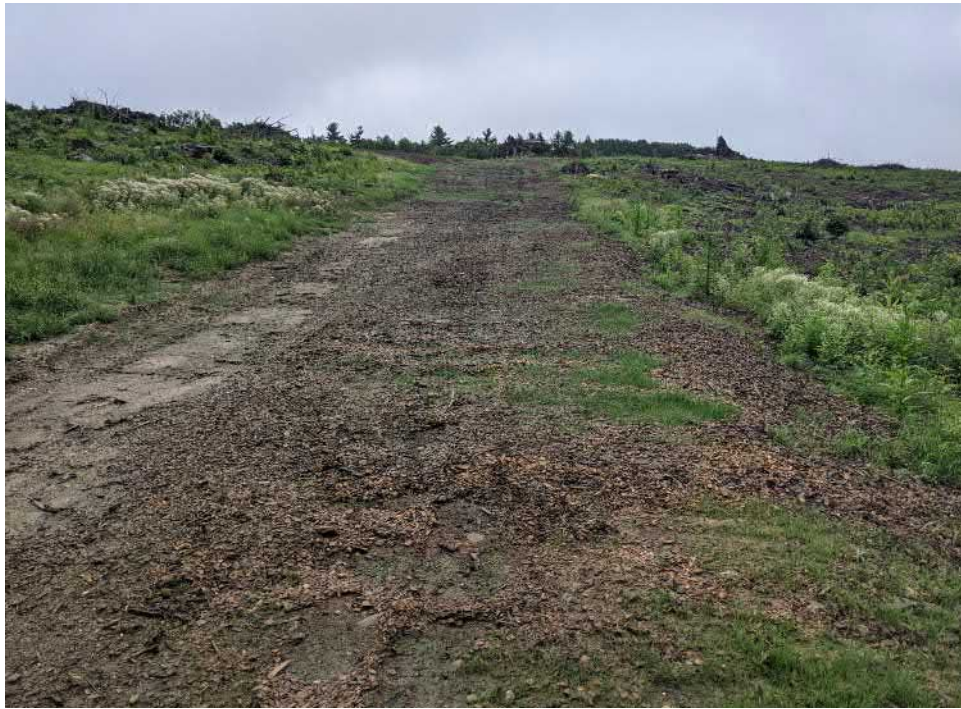
**Photo 1**

Stabilization Area [insert additional rows if applicable]	Stabilization Method	Have You Initiated Stabilization?	Notes
1. Earthen access road leading to stockpile area	Straw mulch or hydroseed	<input checked="" type="checkbox"/> Yes 7/30/2021 <input type="checkbox"/> No	The stockpile area and associated access road have been hydroseeded. Germination has begun and the area will be monitored for successful establishment.

View of conditions within the access road leading to the stockpile area—facing south.

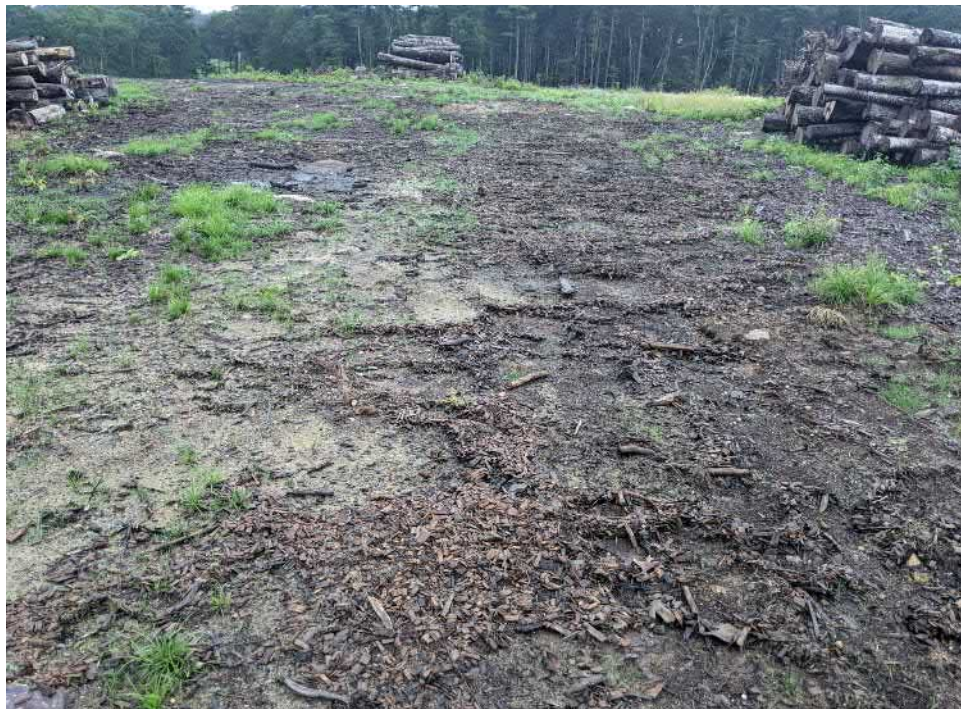
**Photo 2**

2. Stabilized Construction Entrance (Site Entrance – Access Road)	No	No		
3. Stump and Soil Stockpile Area	No	No		Hydroseed was applied to exposed soil in this area and continues to germinate.

View of germination within the stockpile area—facing northeast.

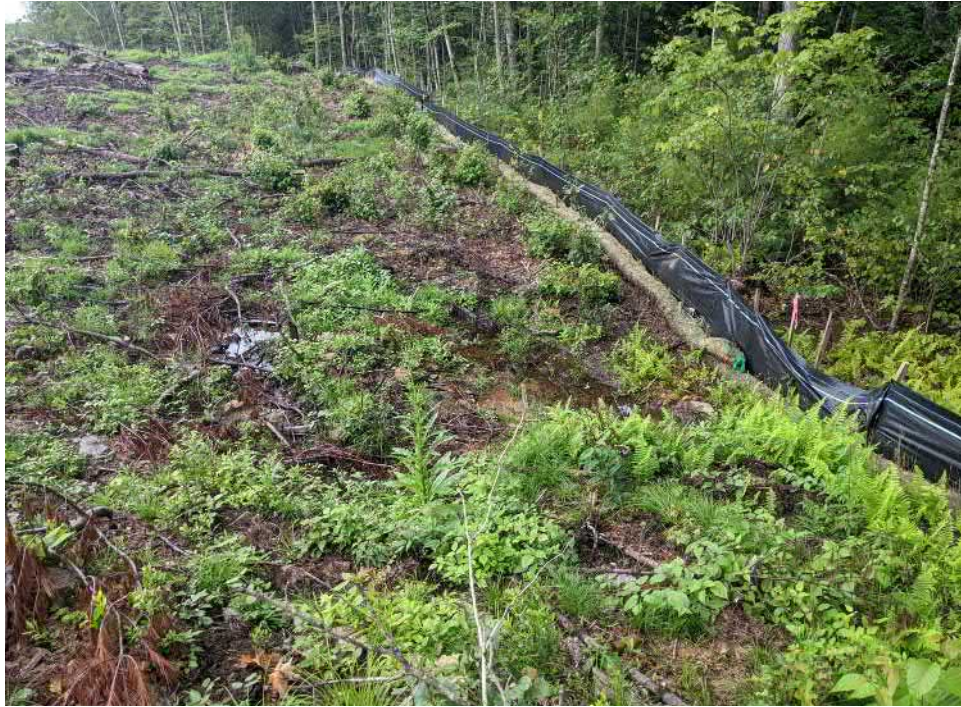
**Photo 3**

View of ponding water within the area of the former erosion control breach—facing north-west.

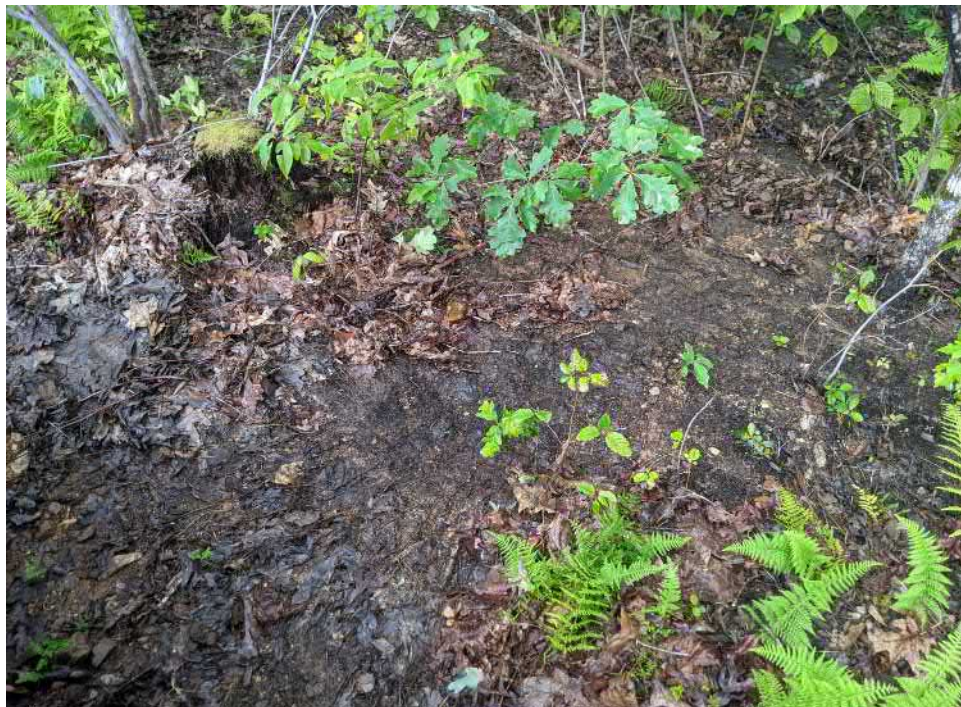
**Photo 4**

Type/Location of E&S Control	Maintenance Needed?*	Corrective Action Required?*	Date on Which Maintenance or Corrective Action First Identified?	Notes
1. Silt Fence and Straw Wattles	Yes	No	7/22/2021	<p>During the 7/22/2021 inspection, an erosion control breach was observed along the northern erosion control line, at the western corner of Phase 1. No sediment was discharged to a Water of the U.S. BETA recommended the maintenance of the siltation fencing as well as the installation of a supplemental 18" compost filter tube. A straw wattle was reinstalled, and the siltation fencing was not properly entrenched for a stretch of approximately 10'.</p> <p><b>The siltation fence remains improperly installed and requires maintenance to ensure efficacy of the erosion control measure.</b></p> <p>Evidence of concentrated stormwater runoff leaving the Site under this siltation fencing (i.e. channelization) was observed during this Site inspection.</p>

Discharge Location [insert additional discharge locations if applicable]	Observations
1. Southwest of the timber mat entrance road, at the location of the former erosion control breach.	Describe the discharge:  <b>Evidence of stormwater discharge leaving the Site (i.e. channelization) was observed downgradient of the limits of work due to the improper repair of siltation fencing. Although an erosion channel has begun to form, no sediment discharge was observed.</b>  At points of discharge and the channels and banks of surface waters in the immediate vicinity, are there any visible signs of erosion and/or sediment accumulation that can be attributed to your discharge? <input checked="" type="checkbox"/> Yes <input type="checkbox"/> No  If yes, describe what you see, specify the location(s) where these conditions were found, and indicate whether modification, maintenance, or corrective action is needed to resolve the issue:

View of evidence that stormwater had flowed under the siltation fencing and discharged downgradient of the limits of work.

Channelization due to concentrated stormwater runoff was observed downgradient of the limits of work at the location of the former erosion control breach. A modification of the proposed erosion controls measures is recommended to address both the proper repair of the siltation fencing and the implementation of BMPs upgradient of the area to attenuate stormwater flows that appear to concentrate with two (2) discrete flow paths (i.e. installation of mulch berms).

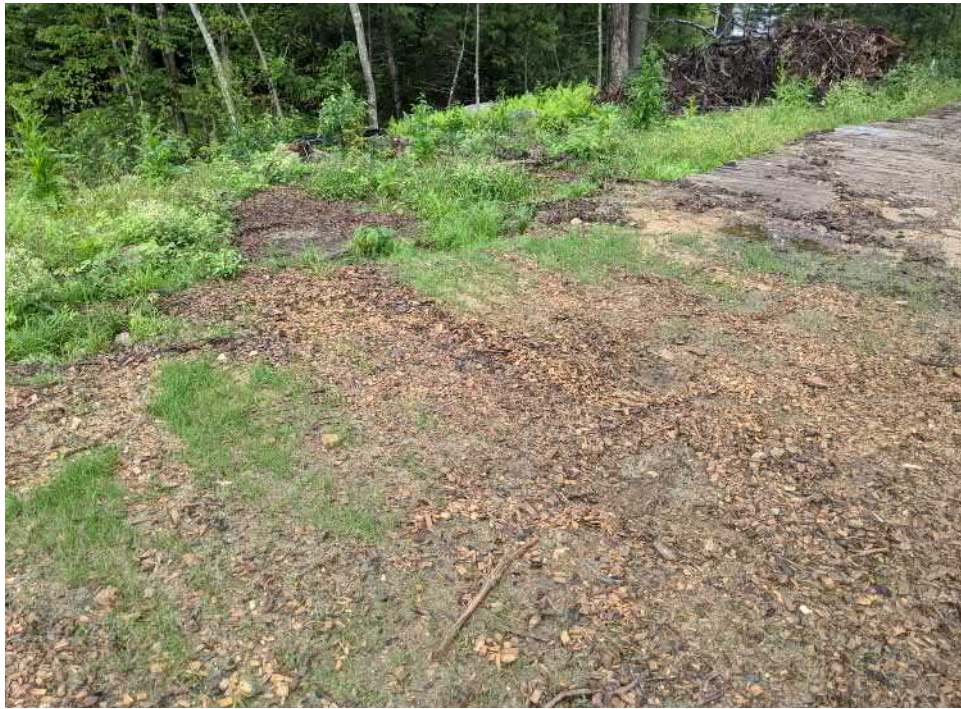
**Photo 5**

View of an area contributing runoff to the area of the former erosion control breach; note the channel forming to the left of the timber mats—facing northwest.

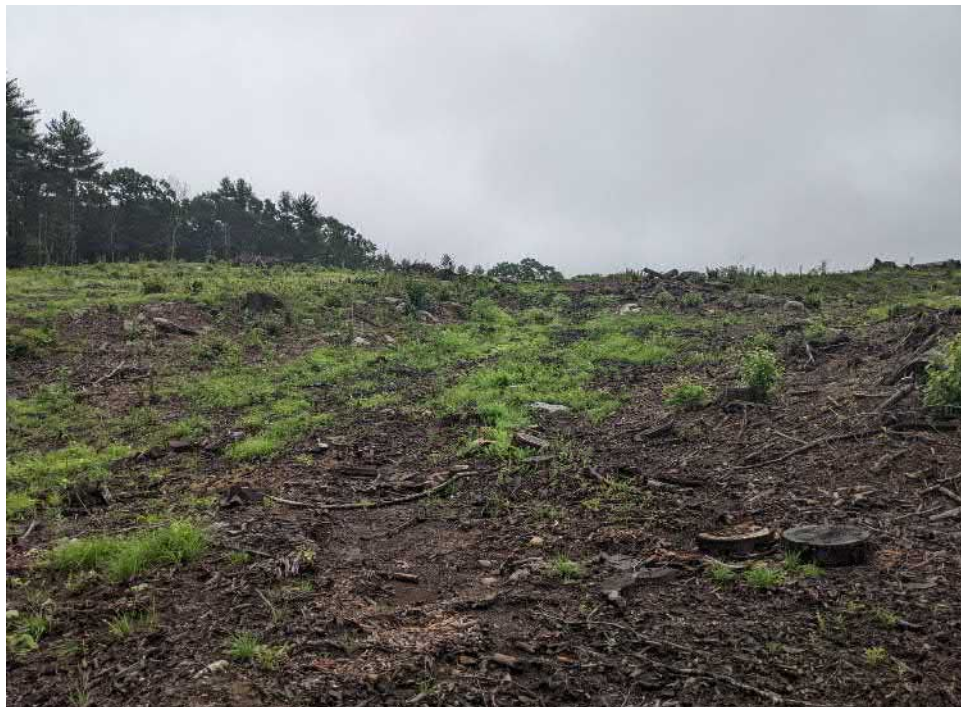
**Photo 6**

View of the area to the south of the former erosion control breach that appears to also contribute runoff to that segment of erosion controls—facing southeast.

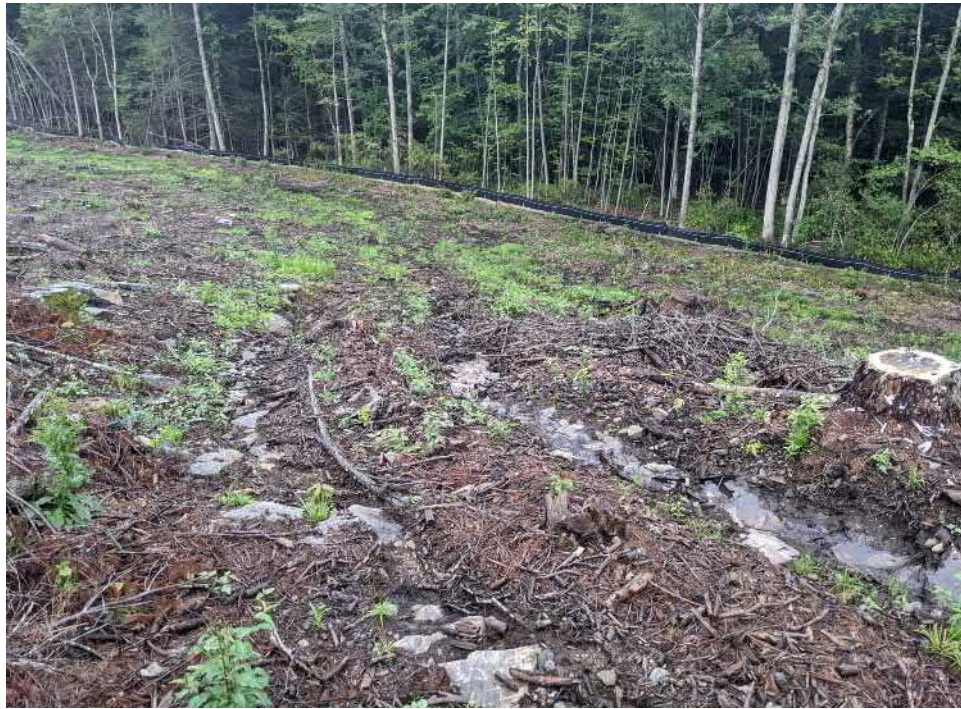
**Photo 7**

2. Informal access road along northern portion of the Site	Straw mulch or hydroseed	<input type="checkbox"/> Yes [Enter date] <input checked="" type="checkbox"/> No	<b>The informal access road along the northern portion of the Site requires stabilization if there is a cessation of work at the Site.</b> Erosion channels are beginning to form within upgradient portions of this access road. Erosion is currently confined to the limits of work. The contractor indicated that stabilization by smoothing out soils and seeding or spreading mulch would occur on 7/30/2021, however, stabilization of this area has not yet been initiated.

View of erosion channels and exposed soils within and along the equipment tracks present at the informal access road near the northern limits of work—facing northwest.
