PHOTOGRAPHIC DOCUMENTATION

North Sturbridge Road Solar Facility

Charlton, Massachusetts

Photographs Documented 08.20.2021

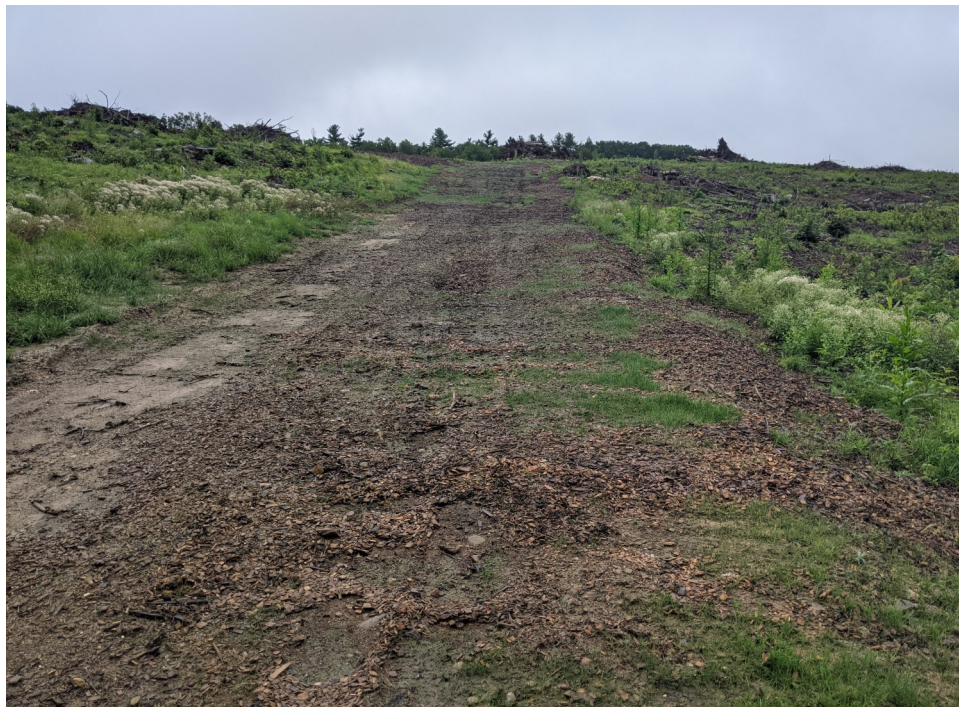
Photo 1

View of conditions within the access road leading to the stockpile area—facing south.

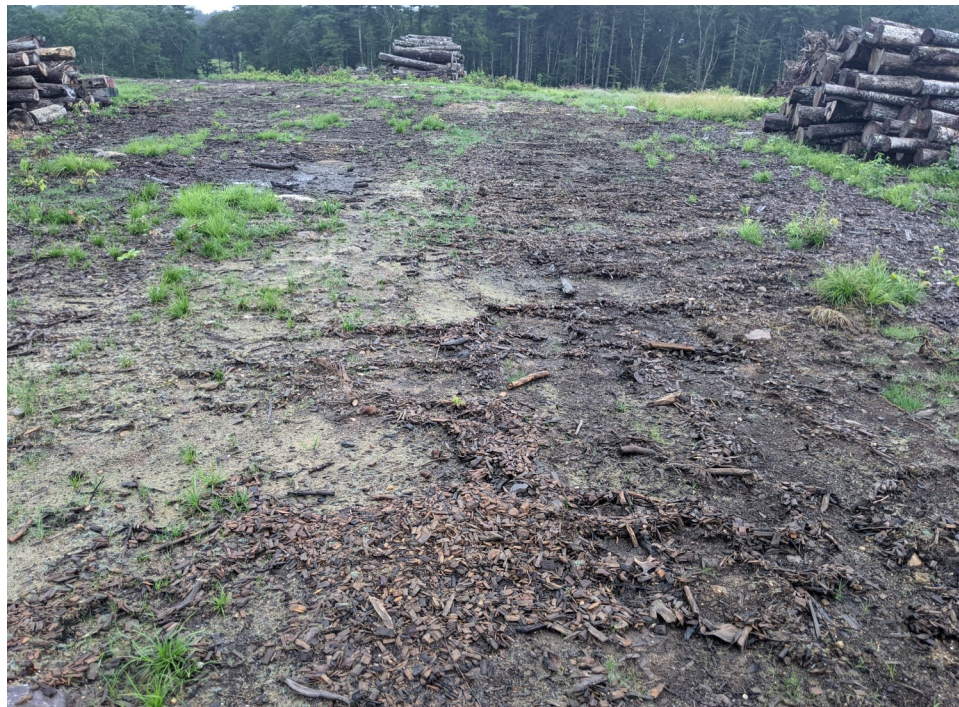
Photo 2

View of germination within the stockpile area—facing northeast.

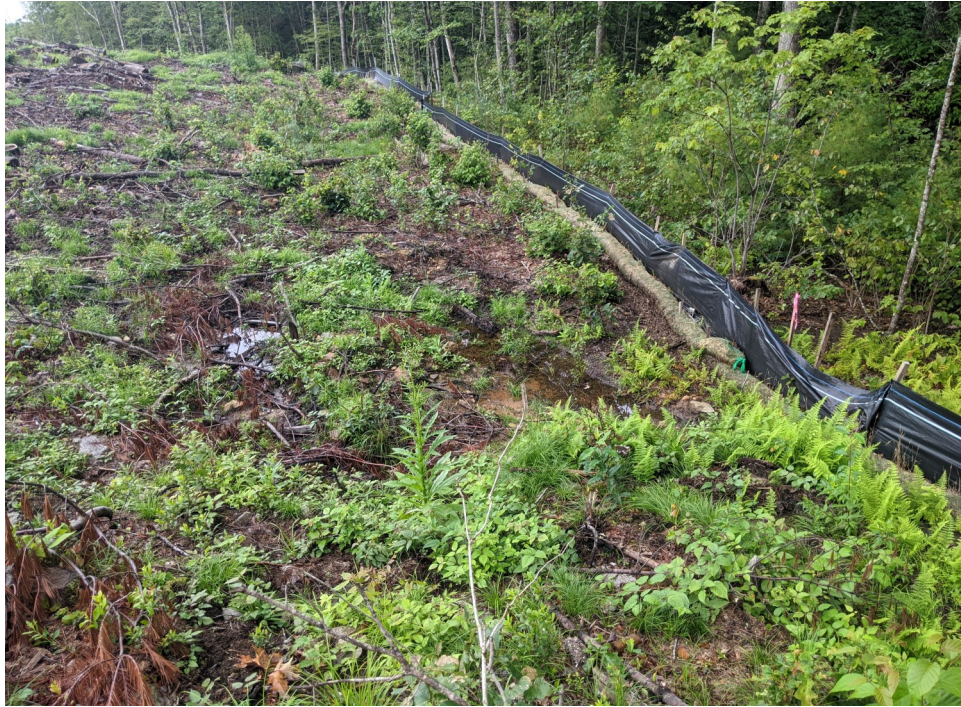
Photo 3

View of ponding water within the area of the former erosion control breach—facing north-west.

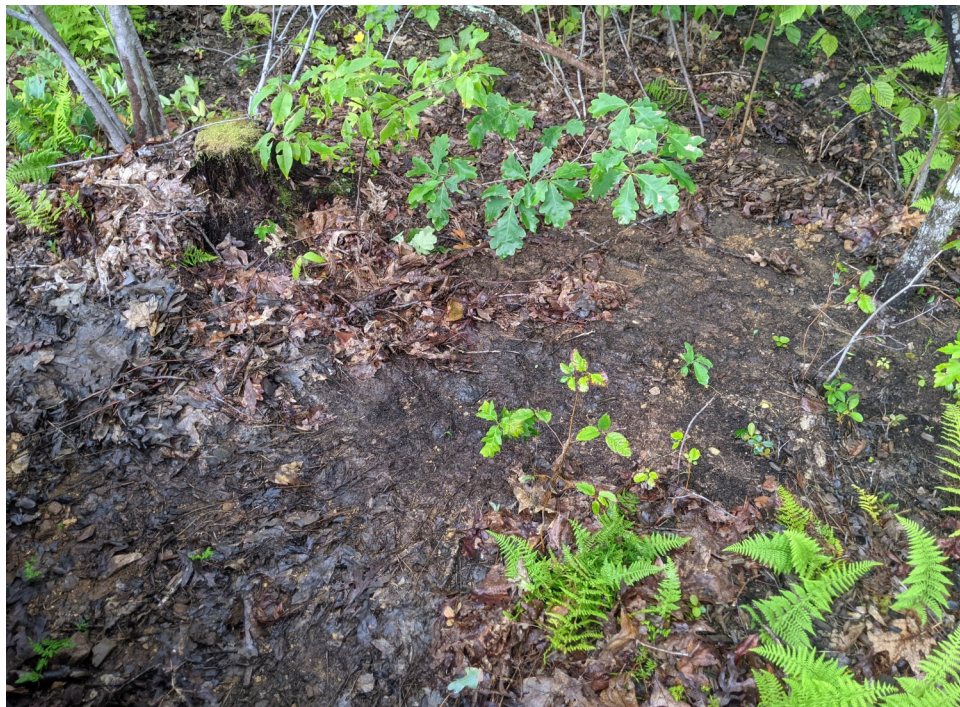
Photo 4

View of evidence that stormwater had flowed under the siltation fencing and discharged downgradient of the limits of work.

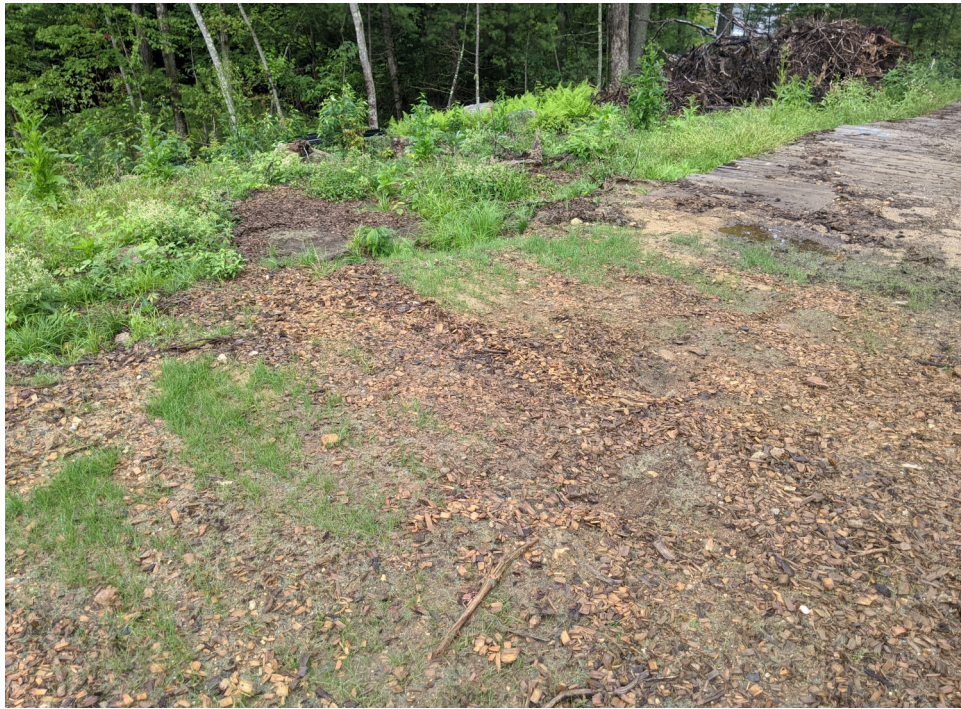
Photo 5

View of an area contributing runoff to the area of the former erosion control breach; note the channel forming to the left of the timber mats—facing northwest.

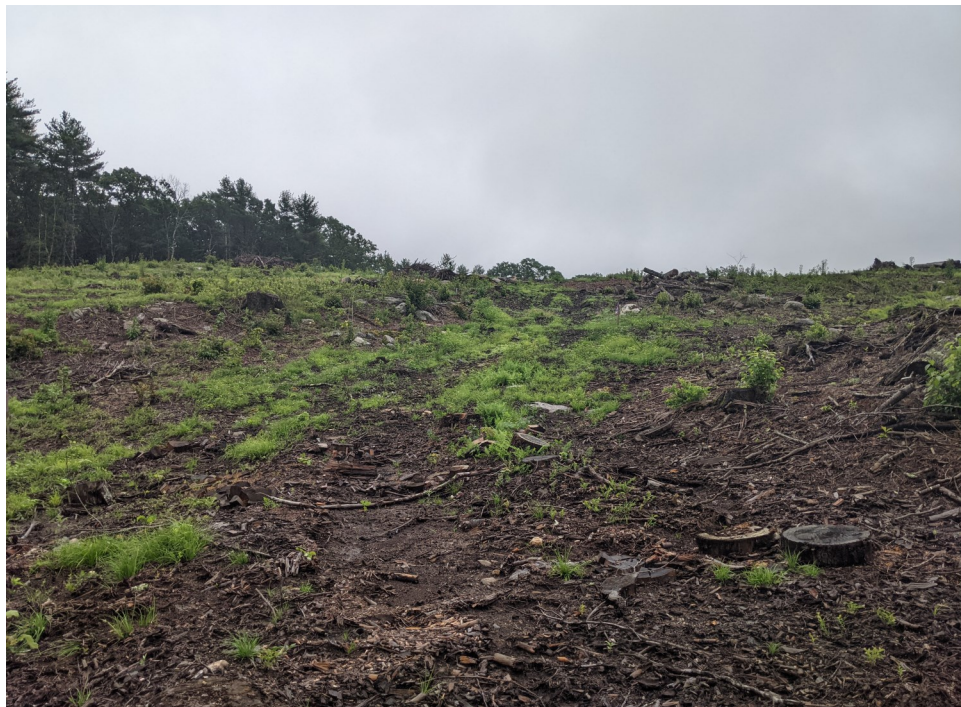
Photo 6

View of the area to the south of the former erosion control breach that appears to also contribute runoff to that segment of erosion controls—facing southeast.

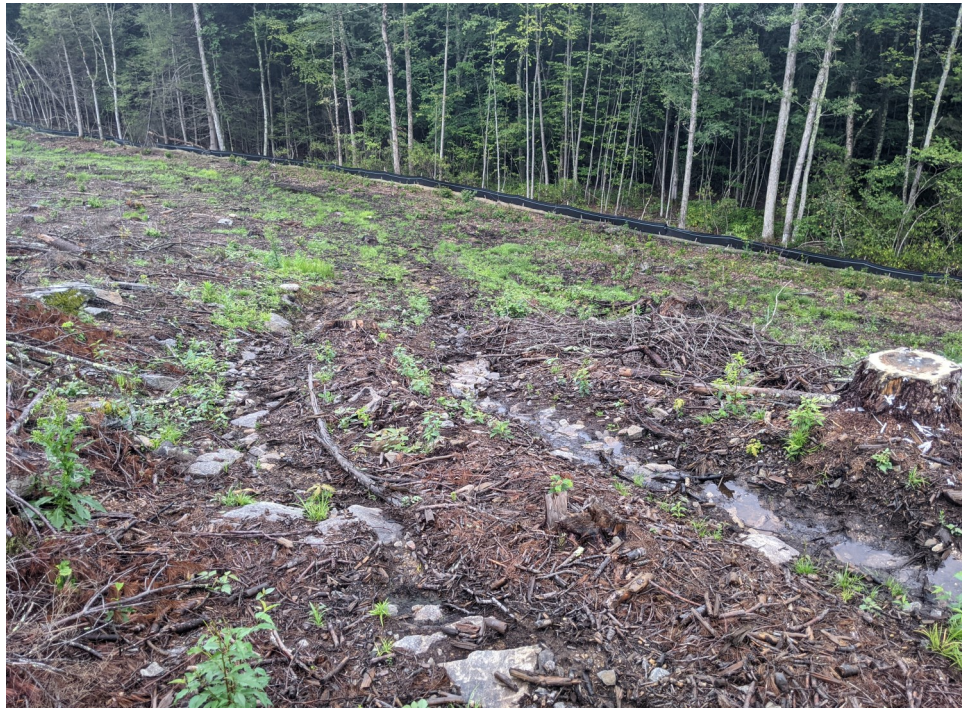
Photo 7

View of erosion channels and exposed soils within and along the equipment tracks present at the informal access road near the northern limits of work—facing northwest.
