PHOTOGRAPHIC DOCUMENTATION

North Sturbridge Road Solar Facility

Charlton, Massachusetts

Photographs Documented 08.20.2021

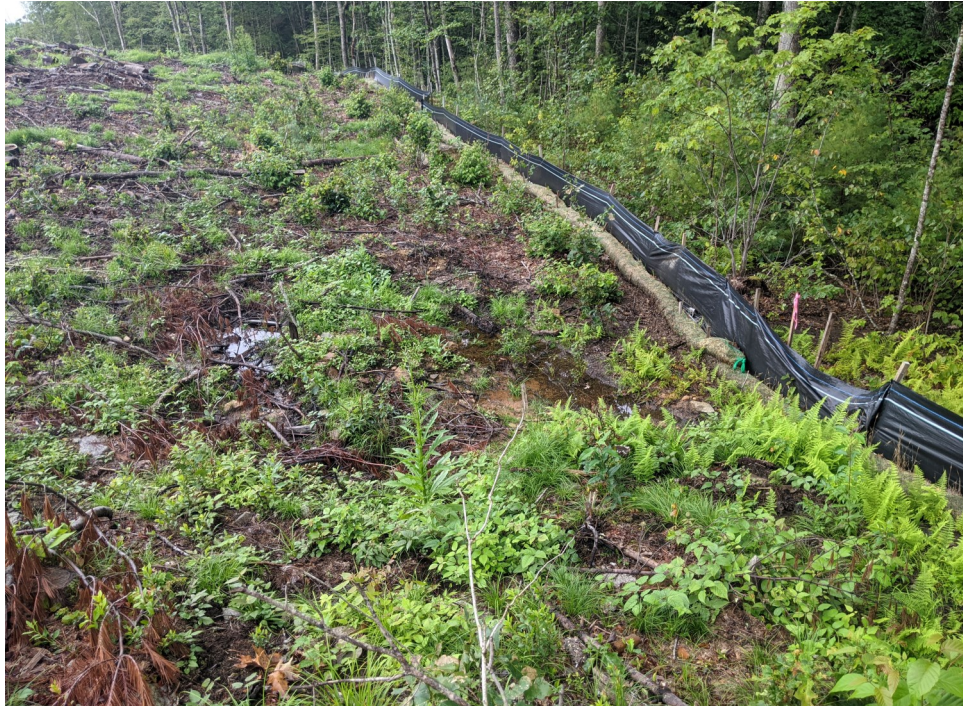
Photo 3

View of ponding water within the area of the former erosion control breach—facing north-west.

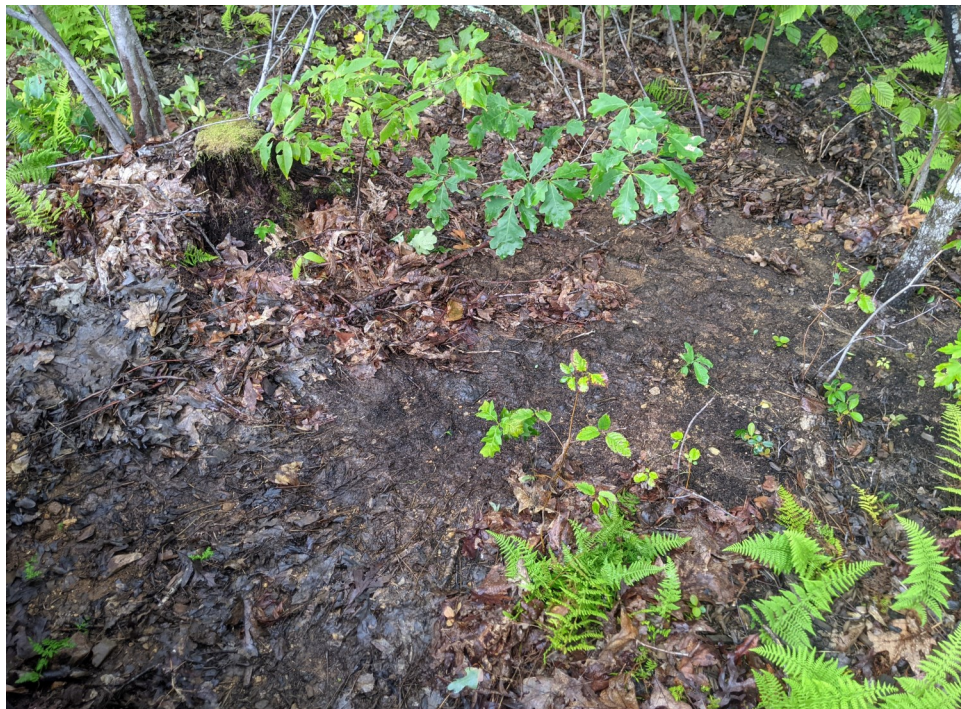
Photo 4

View of evidence of stormwater flowing under the siltation fencing and discharging downgradient of the limits of work.
