Inspection Report for North Sturbridge Road Solar Facility

NPDES ID No.: MAR10031G

Inspection Date: 08/23/2021

North Sturbridge Road Solar Facility

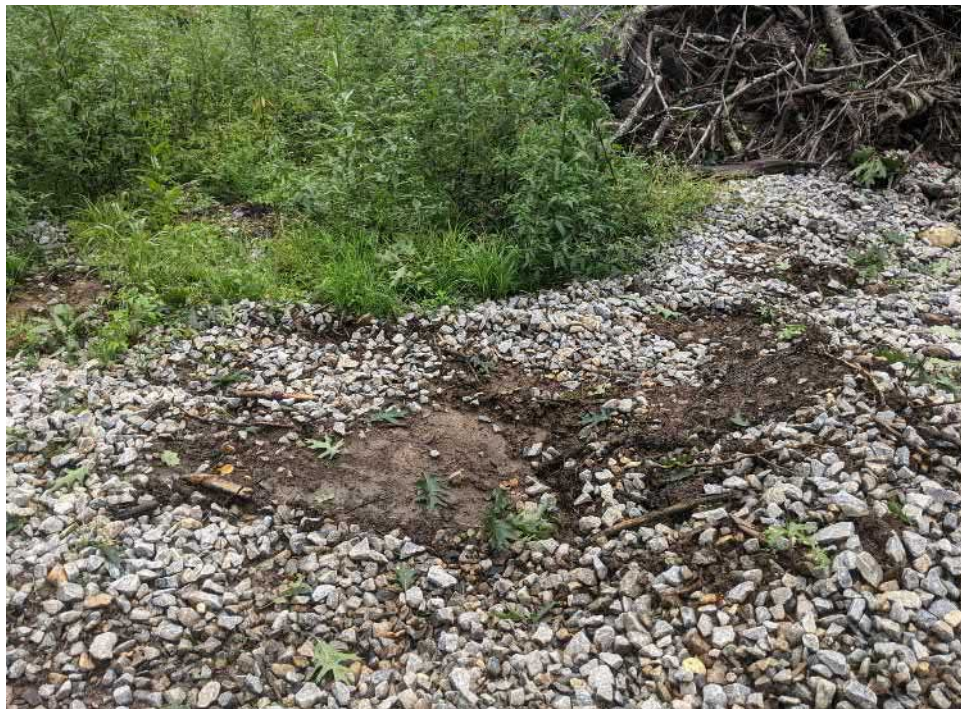
Photo 1

2. Stabilized Construction Entrance (Site Entrance – Access Road)	Yes	No	8/23/2021	<p>Exposed soils are present at the western side of the stabilized construction entrance and have begun to erode. Exposed soils around the construction entrance should be stabilized. This can be</p>

View of exposed soils along the west side of the stabilized construction entrance—facing west.

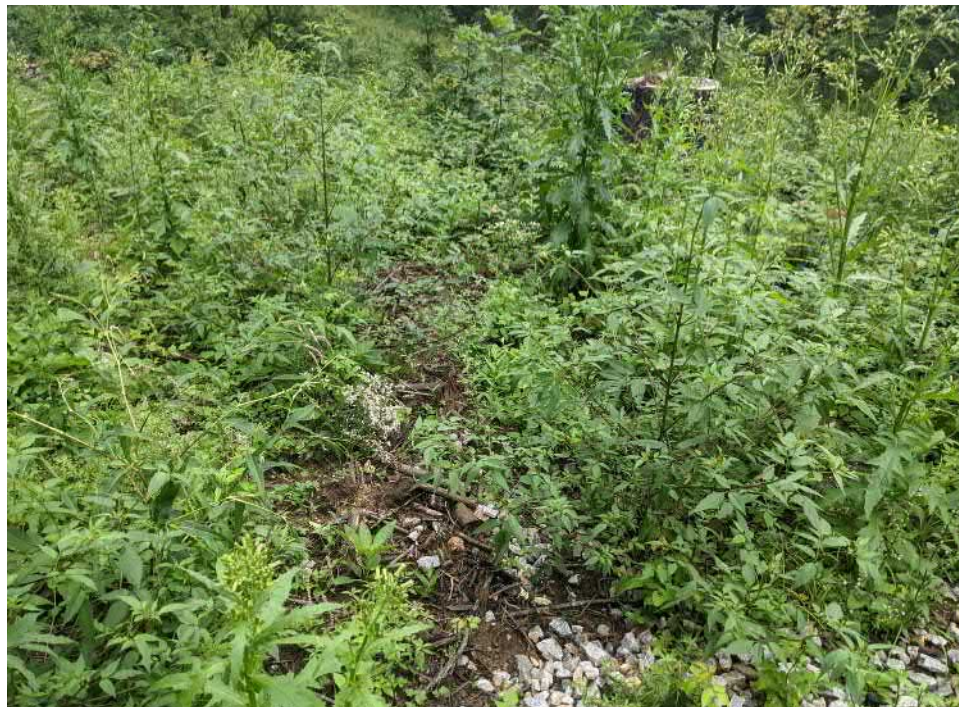
Photo 2

View of scour associated with the exposed soils at the construction entrance; this scour is confined to the limits of work—facing southwest.

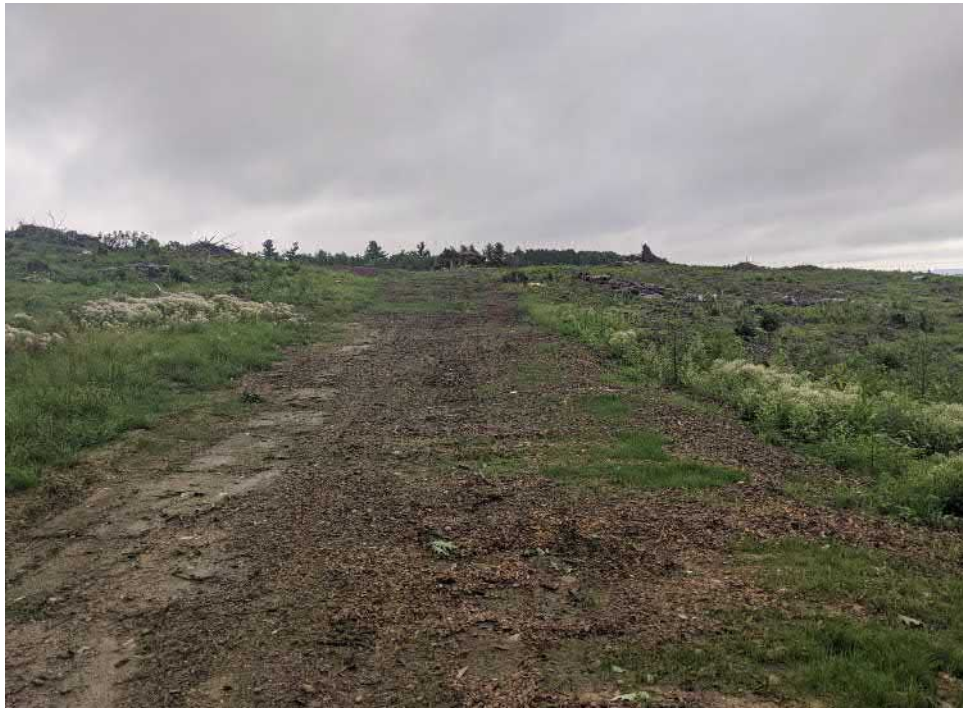
Photo 3

Stabilization Area [insert additional rows if applicable]	Stabilization Method	Have You Initiated Stabilization?	Notes
1. Earthen access road leading to stockpile area	Straw mulch or hydroseed	<input checked="" type="checkbox"/> Yes 7/30/2021 <input type="checkbox"/> No	The stockpile area and associated access road have been hydroseeded. Germination has begun and the area will be monitored for successful establishment.

View of the earthen access road—facing south.

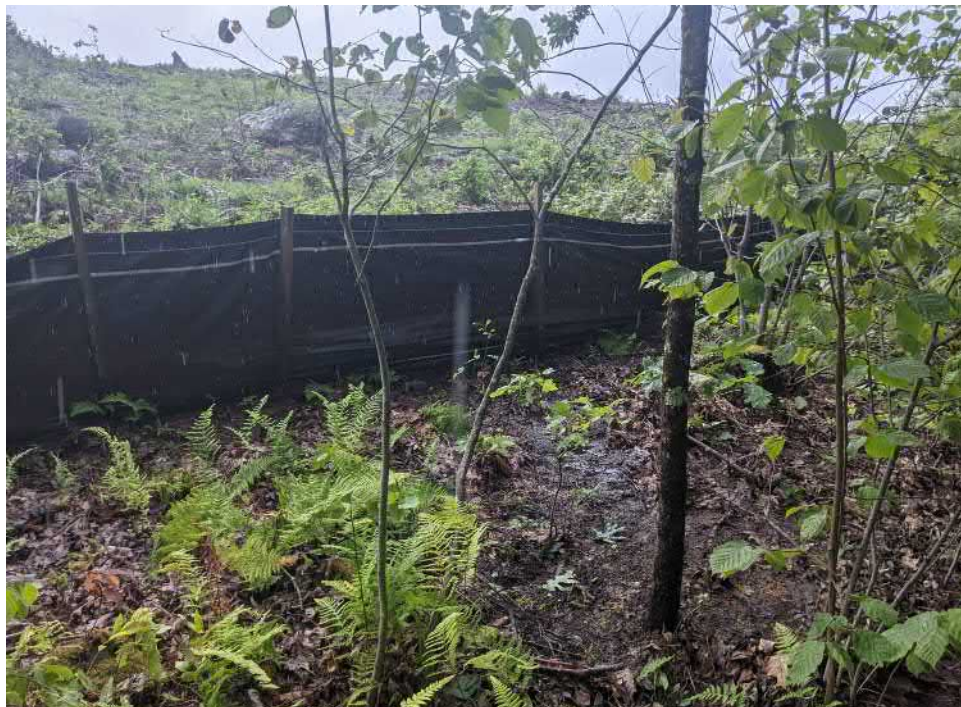
Photo 4

Type/Location of E&S Control	Maintenance Needed?*	Corrective Action Required?*	Date on Which Maintenance or Corrective Action First Identified?	Notes
1. Silt Fence and Straw Wattles	Yes	No	7/22/2021	<p>During the 7/22/2021 inspection, an erosion control breach was observed along the northern erosion control line, at the western corner of Phase 1 (Discharge 1). No sediment was discharged to a Water of the U.S. BETA recommended the maintenance of the siltation fencing as well as the installation of a supplemental 18" compost filter tube. A straw wattle was reinstalled, and the siltation fencing was not properly entrenched for a stretch of approximately 10'.</p> <p>The siltation fence remains improperly installed and requires maintenance to ensure efficacy of the erosion control measure. Evidence of concentrated stormwater runoff leaving the Site under this siltation fencing (i.e. channelization) was observed during this Site inspection. Evidence of leaf litter scour likely associated with this discharge was observed along the boundary of the downgradient Vegetated Wetland.</p>

View of runoff undercutting the siltation fencing at the area of erosion controls that required maintenance as identified on 7/22/2021 - facing southwest.

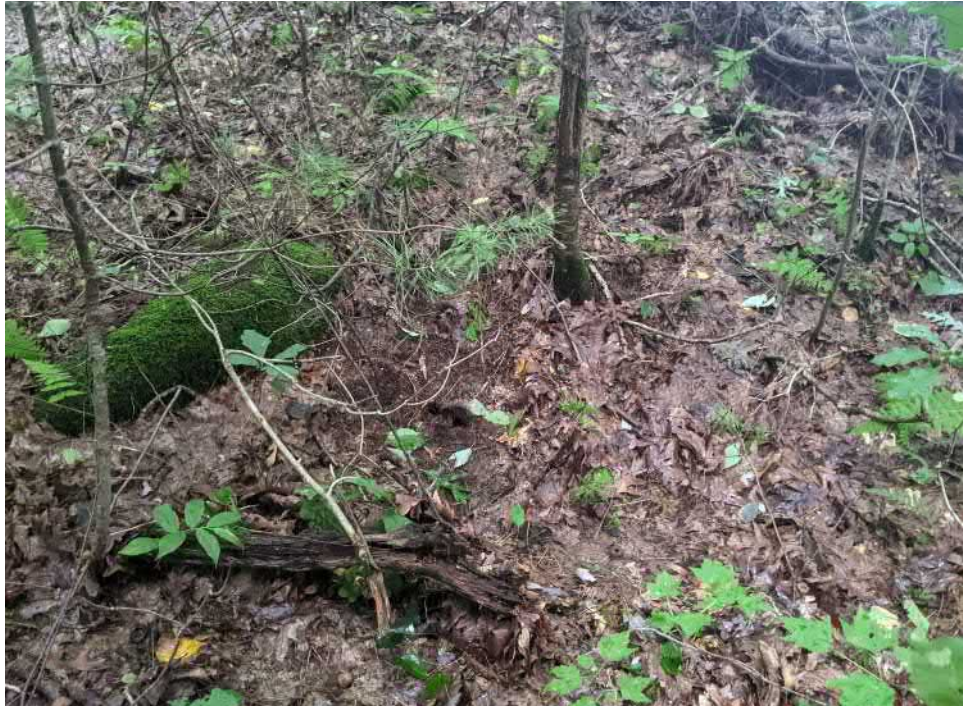
Photo 5

View of scour forming upgradient of the off-site Vegetated Wetland—facing east.

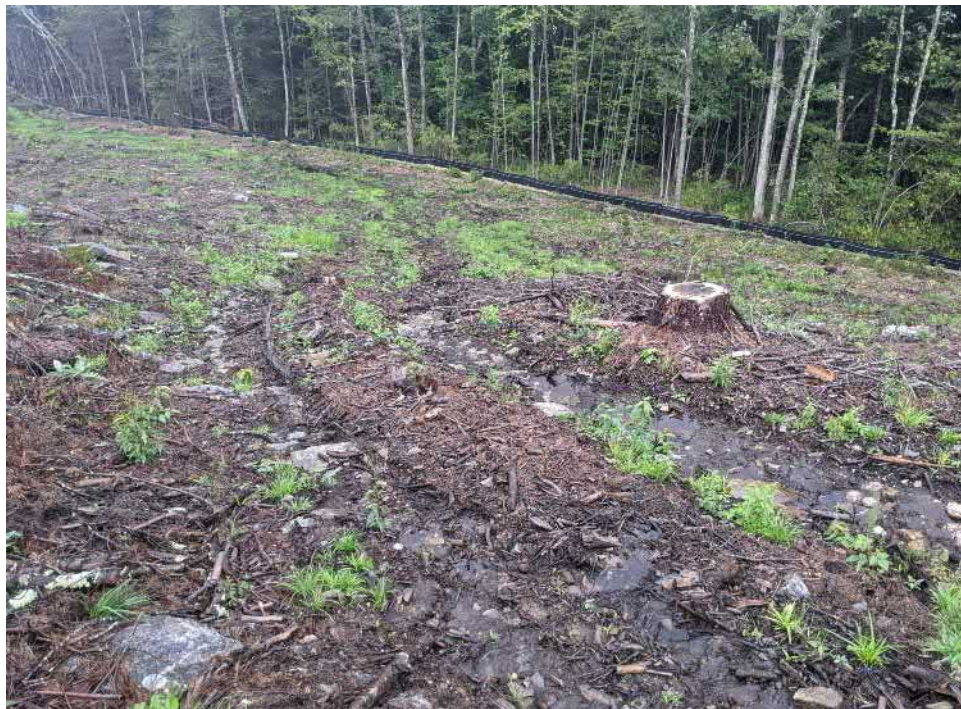
Photo 6

2. Informal access road along northern portion of the Site	Straw mulch or hydroseed	<input type="checkbox"/> Yes [Enter date] <input checked="" type="checkbox"/> No	The informal access road along the northern portion of the Site requires stabilization if there is a cessation of work at the Site. Erosion channels are beginning to form within upgradient portions of this access road. The contractor indicated that stabilization by smoothing out soils and seeding or spreading mulch would occur on 7/30/2021. Stabilization of this area has not been initiated. This channelization of runoff likely contributed to the additional erosion control breach observed during this Site inspection.

View of erosion channels at the location of the informal access path along the northern limits of work—facing northwest.

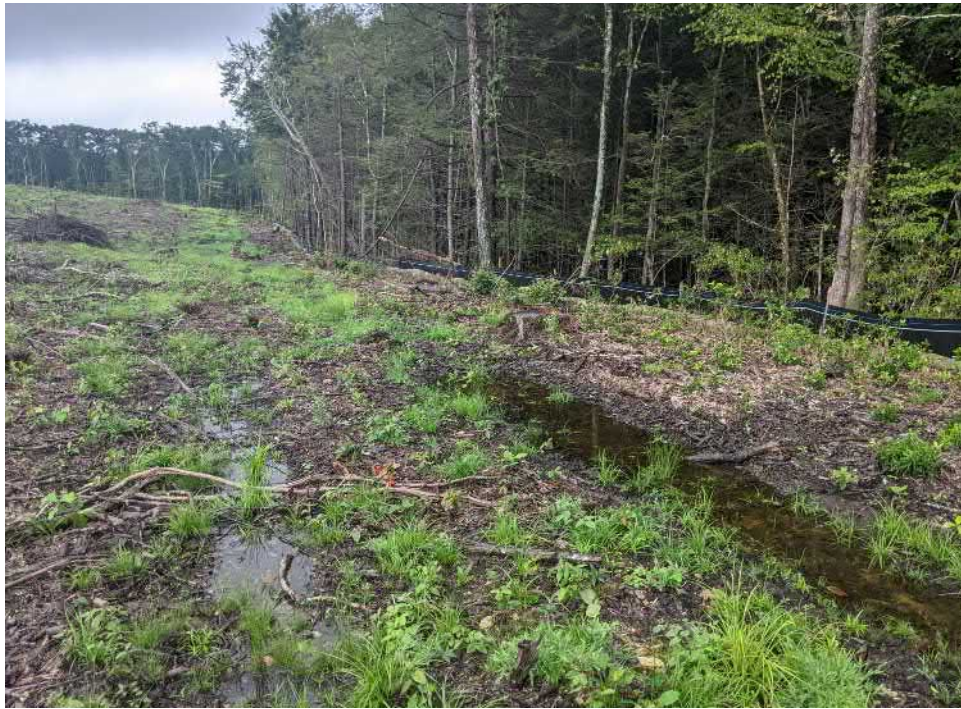
Photo 7

View of ponding associated with the runoff flowing down the access path depicted in Photo 6—facing northwest.

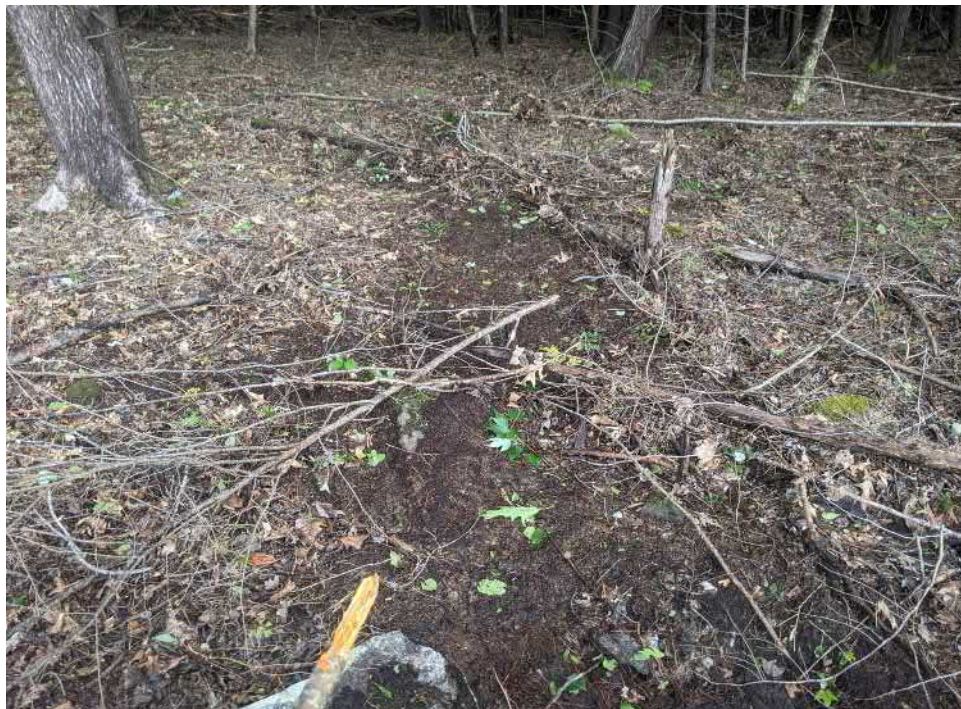
Photo 8

8/23/2021	<p>An additional breach was observed along the northerly limits of work during this Site inspection (Discharge 2). Stormwater runoff has undercut an approximately 10-foot-long stretch of siltation fencing. The siltation fencing should be entrenched. If underlying stones prevent this from occurring, then the limit of work at this location should be protected with supplemental erosion controls, which could include installing two (2) rows of compost filters tubes at least 12 inches in diameter.</p>

View of scour beyond the northern limits of work resulting from runoff undercutting the siltation fencing (Discharge 2)—facing north.

4. Area beyond limits of work at newly discovered erosion control breach	Hand application of seed	<input type="checkbox"/> Yes [Enter date] <input checked="" type="checkbox"/> No	Scour beyond the limits of work resulting from runoff undercutting siltation fencing should be raked out by hand and seeded.
