**PHOTOGRAPHIC DOCUMENTATION**

North Sturbridge Road Solar Facility

Charlton, Massachusetts

Photographs Documented 08.23.2021

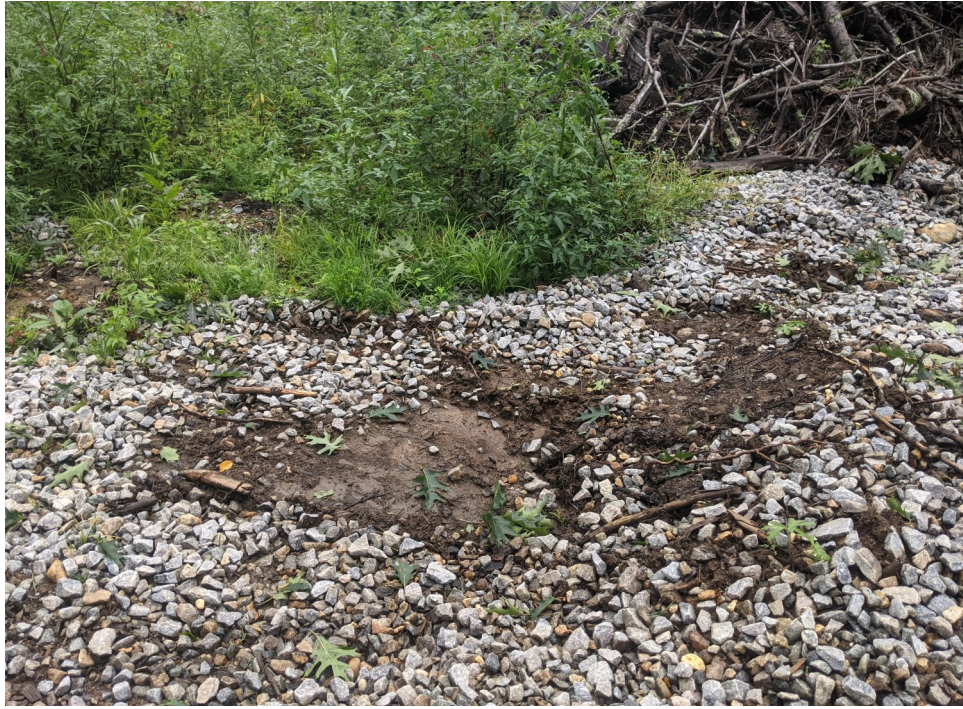
**Photo 1**

View of exposed soils along the west side of the stabilized construction entrance—facing west.

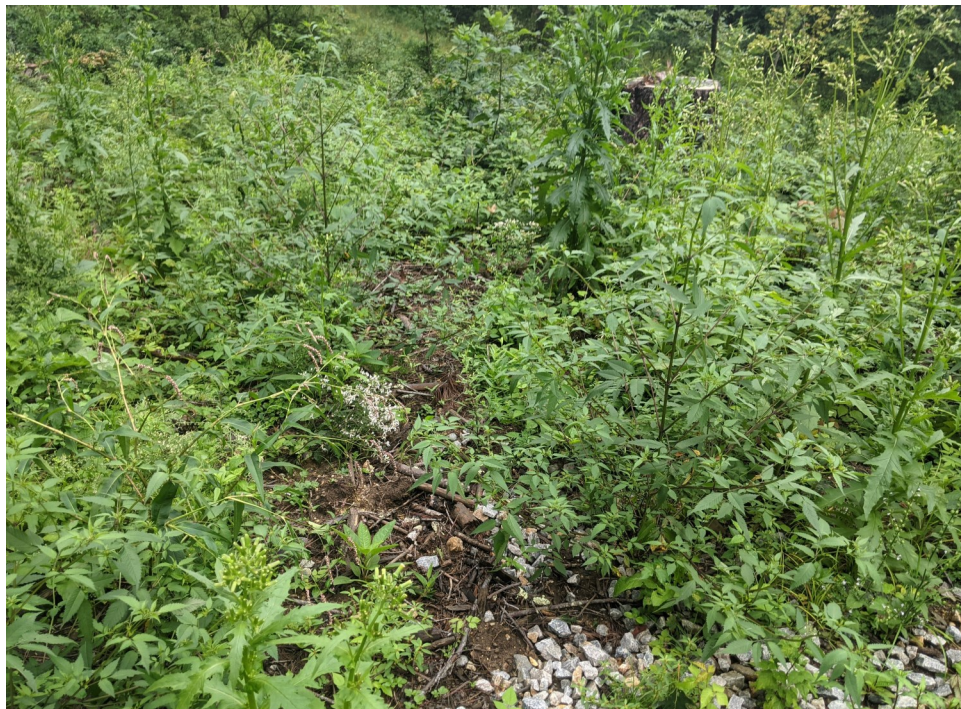
**Photo 2**

View of scour associated with the exposed soils at the construction entrance; this scour is confined to the limits of work—facing southwest.

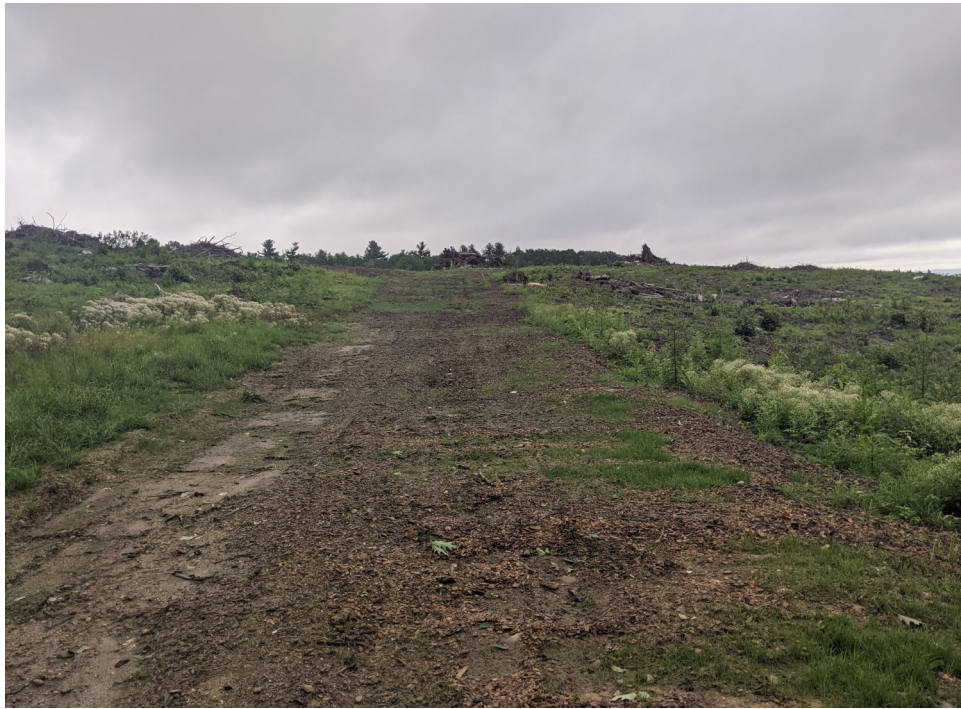
**Photo 3**

View of the earthen access road—facing south.

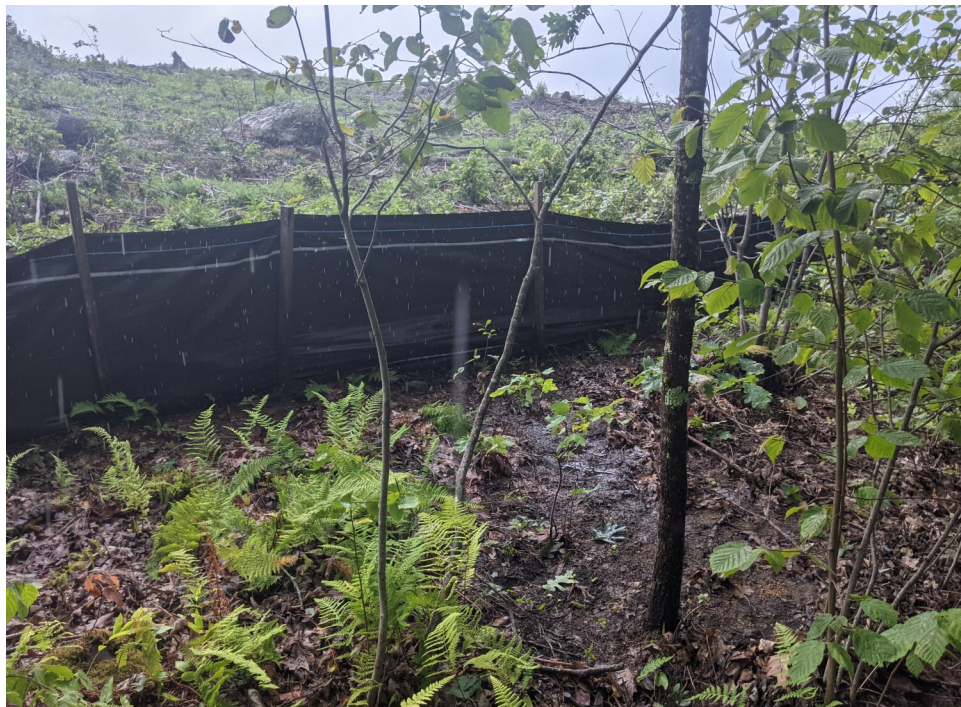
**Photo 4**

View of runoff undercutting the siltation fencing at the area of erosion controls that required maintenance as identified on 7/22/2021 - facing southwest.

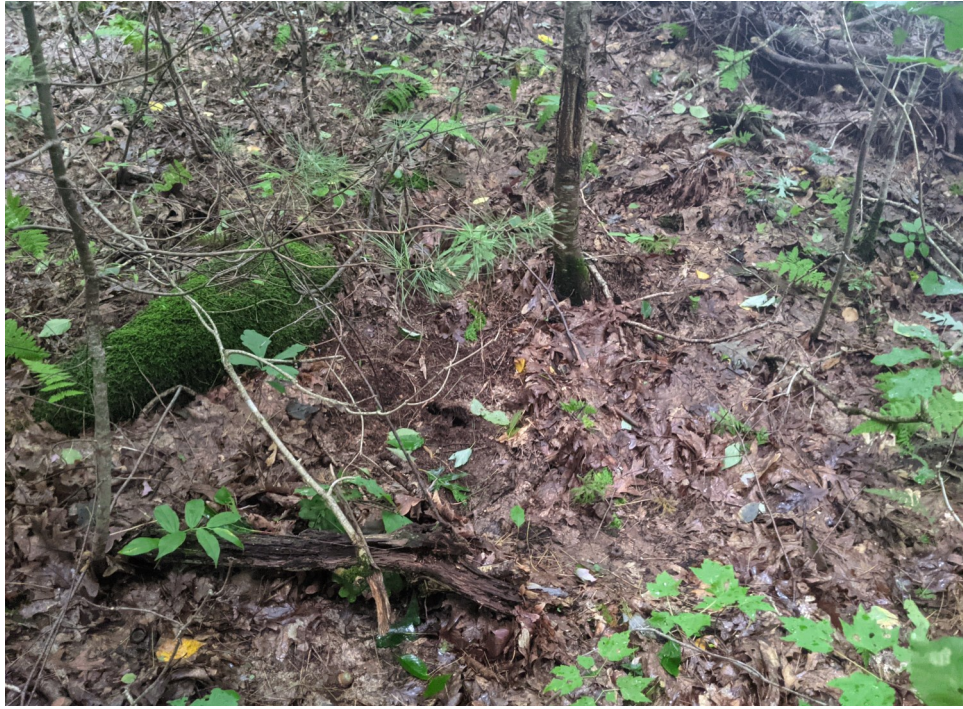
**Photo 5**

View of scour forming upgradient of the off-site Vegetated Wetland—facing east.

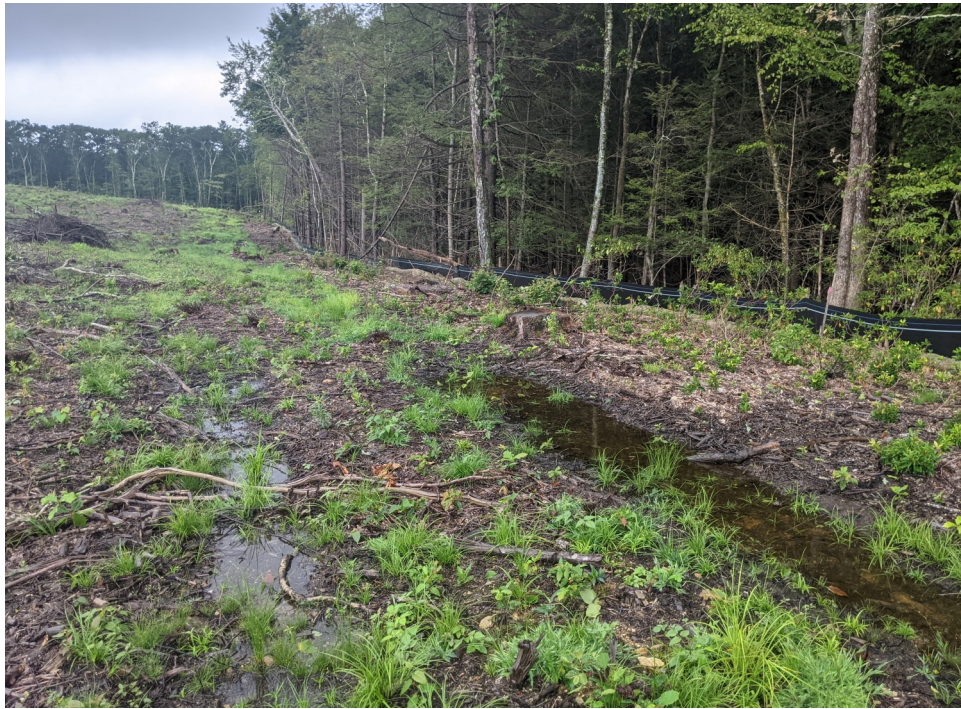
**Photo 7**

View of ponding associated with the runoff flowing down the access path depicted in Photo 6—facing northwest.
