**PHOTOGRAPHIC DOCUMENTATION**

North Sturbridge Road Solar Facility

Charlton, Massachusetts

Photographs Documented 08.23.2021

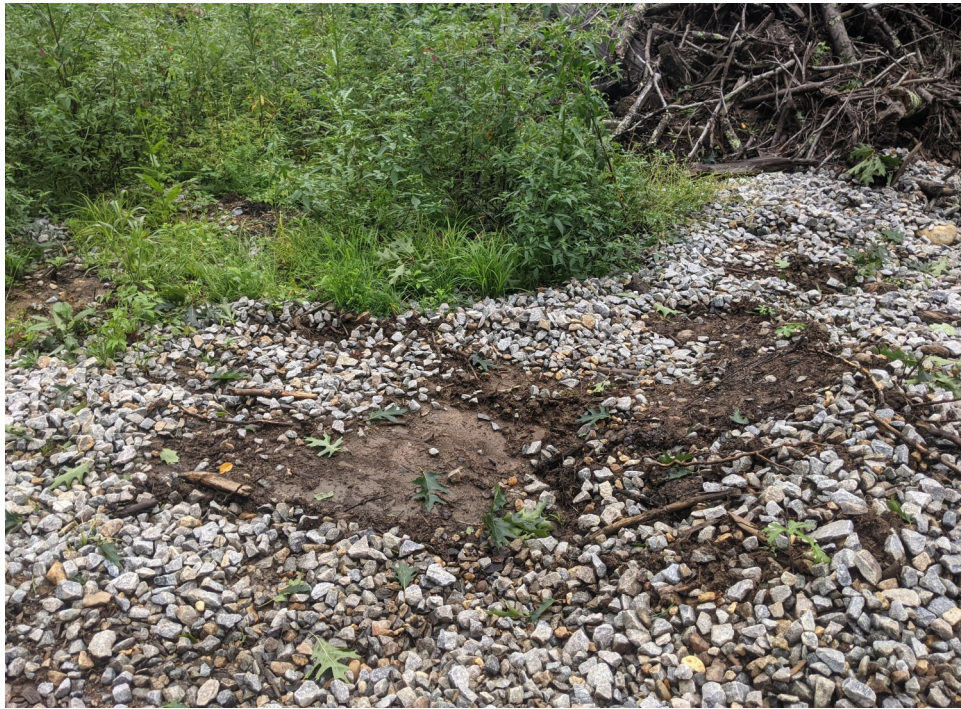
**Photo 1**

View of exposed soils along the west side of the stabilized construction entrance—facing west.

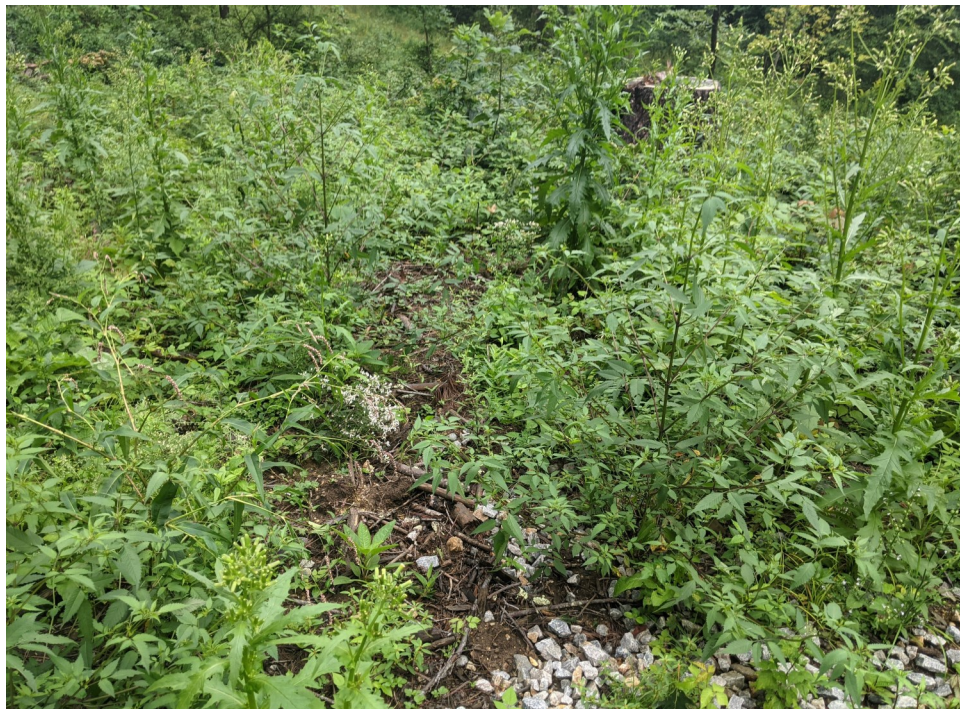
**Photo 2**

View of scour associated with the aforementioned exposed soils at the construction entrance; all scour is confined to the limits of work—facing southwest.

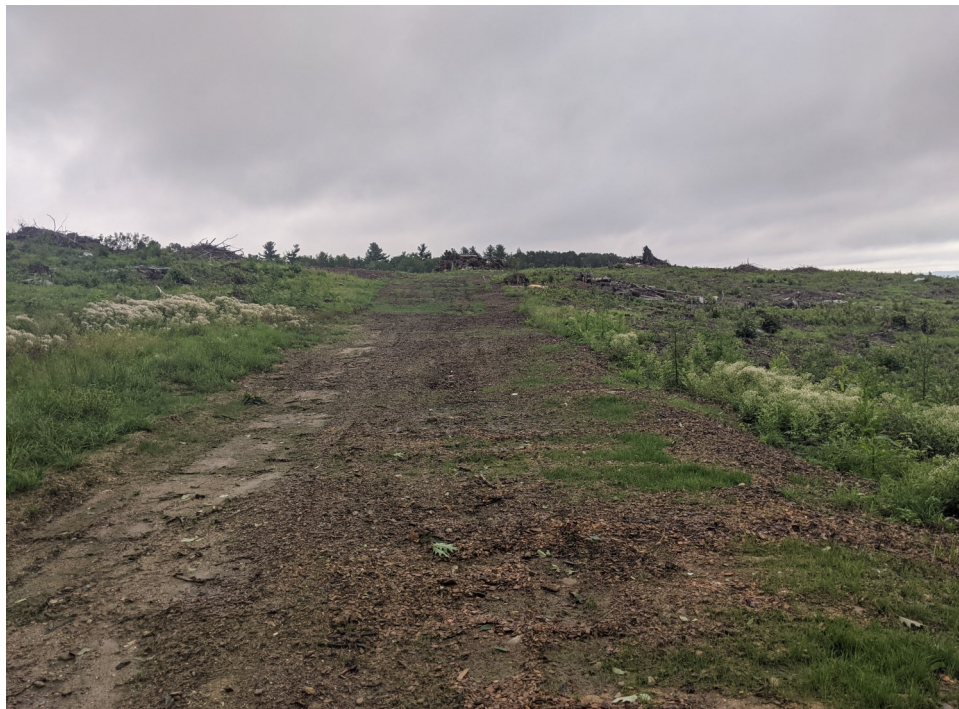
**Photo 3**

View of the earthen access road—facing south.

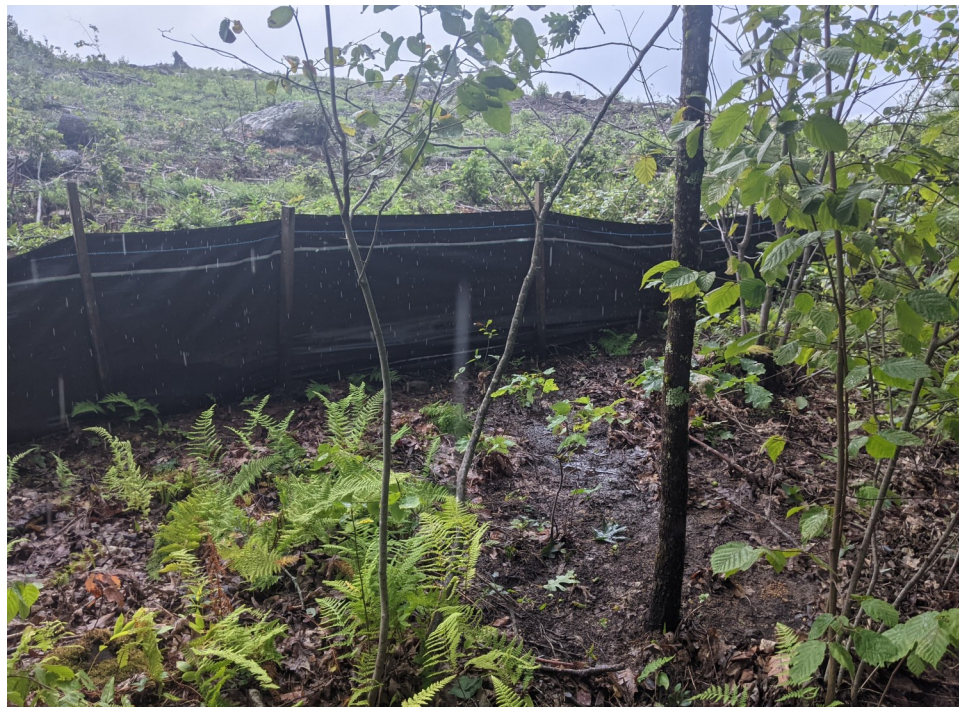
**Photo 4**

View of runoff undercutting the siltation fencing at the location of the former erosion control breach (Discharge 1) - facing southwest.

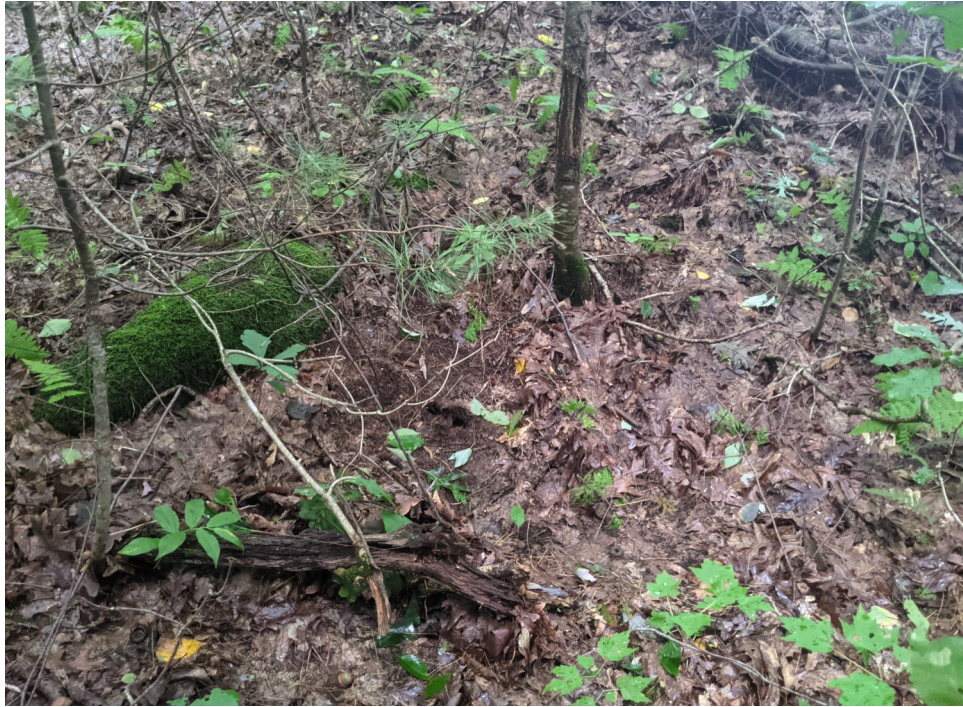
**Photo 5**

View of scour forming just upgradient of the off-site Vegetated Wetland—facing east.

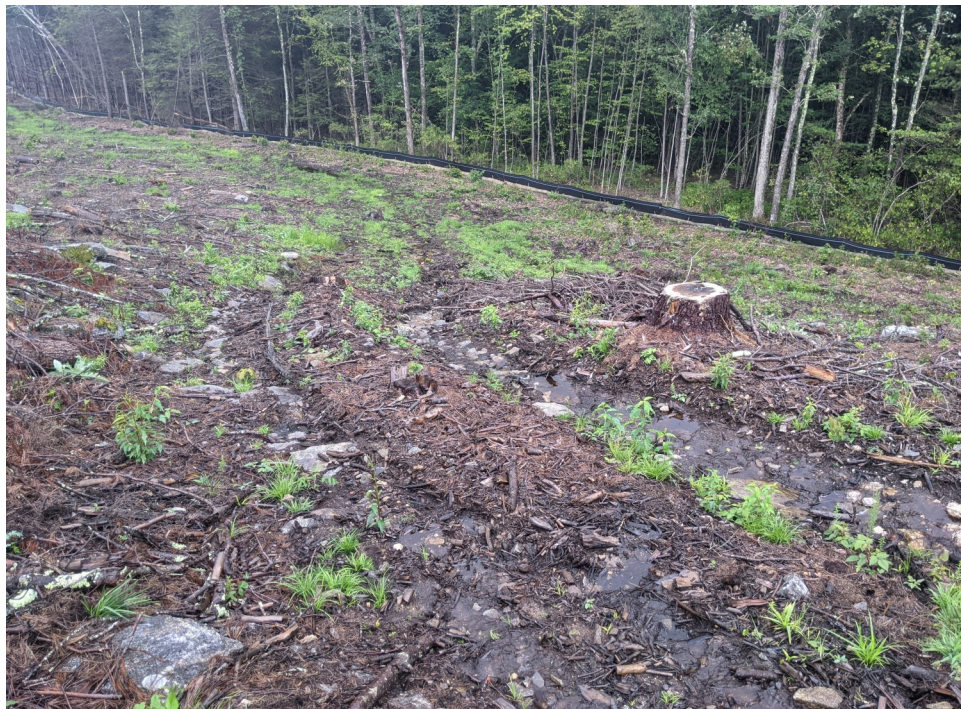
**Photo 6**

View of erosion channels at the location of the informal access path along the northern limits of work—facing northwest.

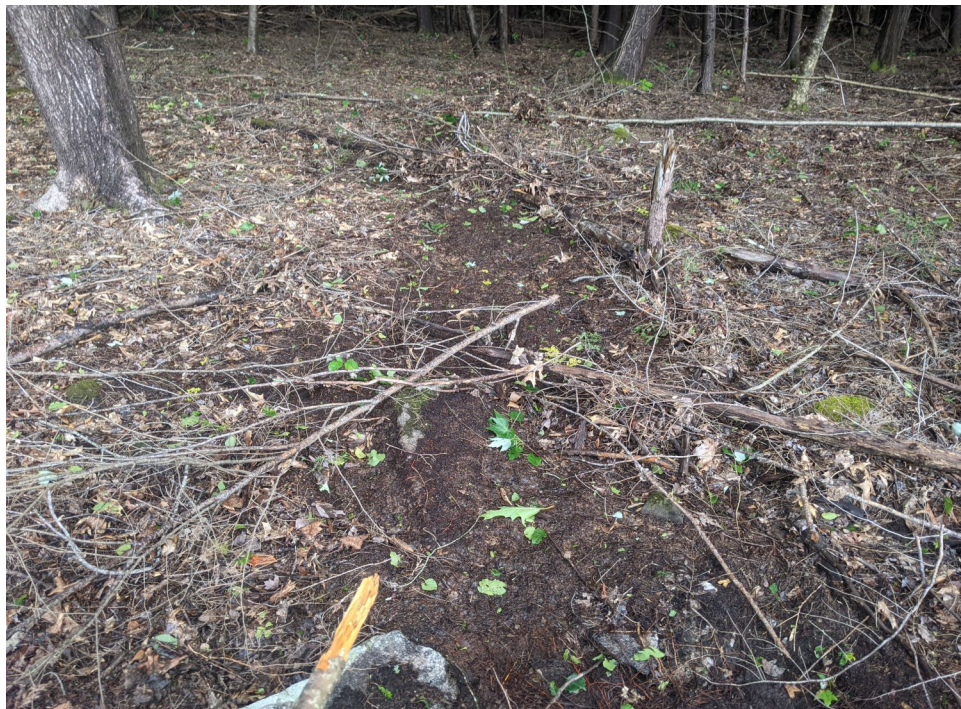
**Photo 8**

View of scour just beyond the northern limits of work due to runoff undercutting the siltation fencing (Discharge 2)—facing north.
