Inspection Report for North Sturbridge Road Solar Facility NPDES ID No.: MAR10031G Inspection Date: 08/24/2021

North Sturbridge Road Solar Facility Charlton, Massachusetts Photographs Documented 08.24.2021

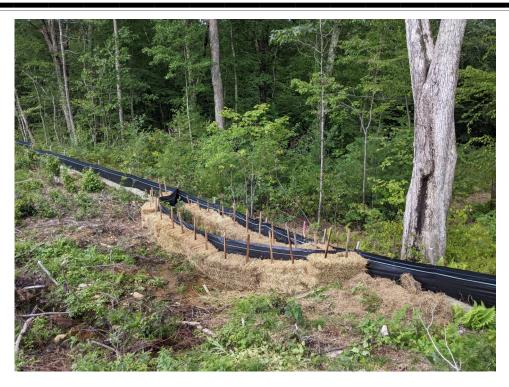
Photo 1

View of the repaired erosion control measures associated with Discharge 1—facing north-west.

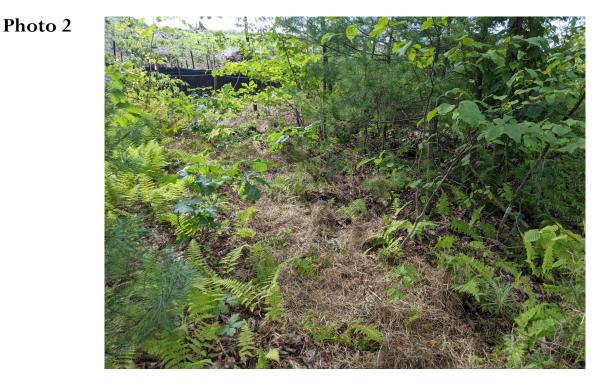
View of stabilization measures implemented beyond the limits of work at the location of Discharge 1—facing south.

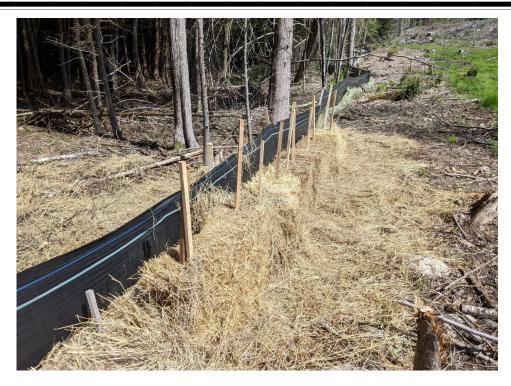
Photo 3

View of the repaired erosion control breach associated with Discharge 2; note the stabilization of exposed soils beyond the limits of work—facing northeast.

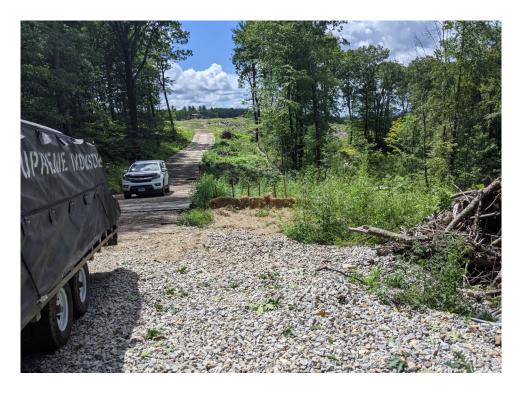
Photo 4

View of exposed soils stabilized at the construction entrance; note the implementation of straw bales—facing south.
