PHOTOGRAPHIC DOCUMENTATION

North Sturbridge Road Solar Facility

Charlton, Massachusetts

Photographs Documented 08.24.2021

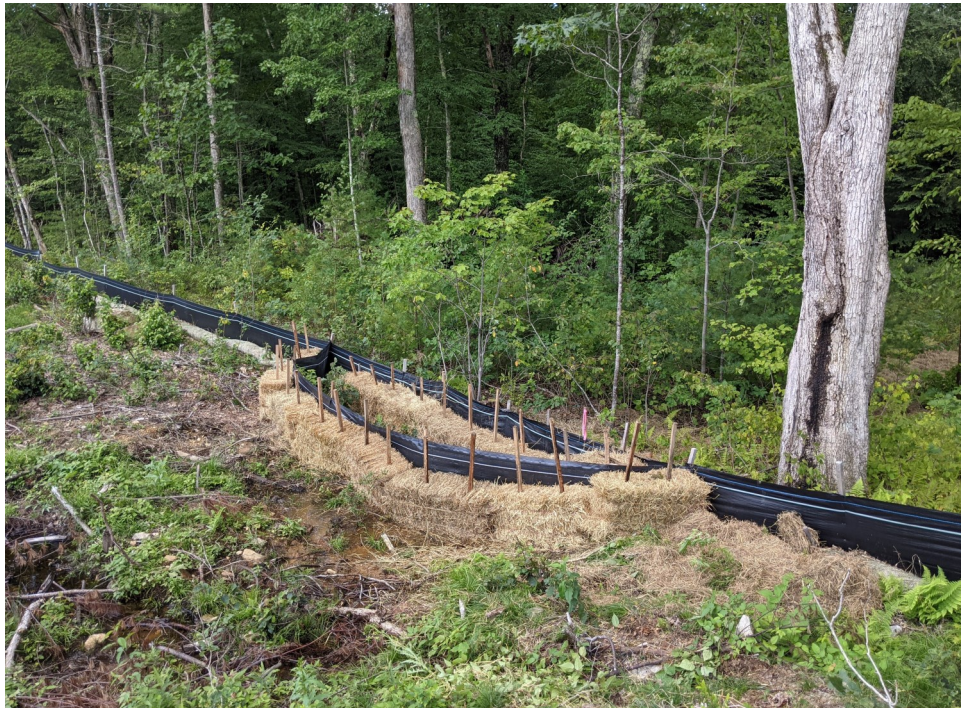
Photo 1

View of the repaired erosion control measures associated with Discharge 1—facing north-west.

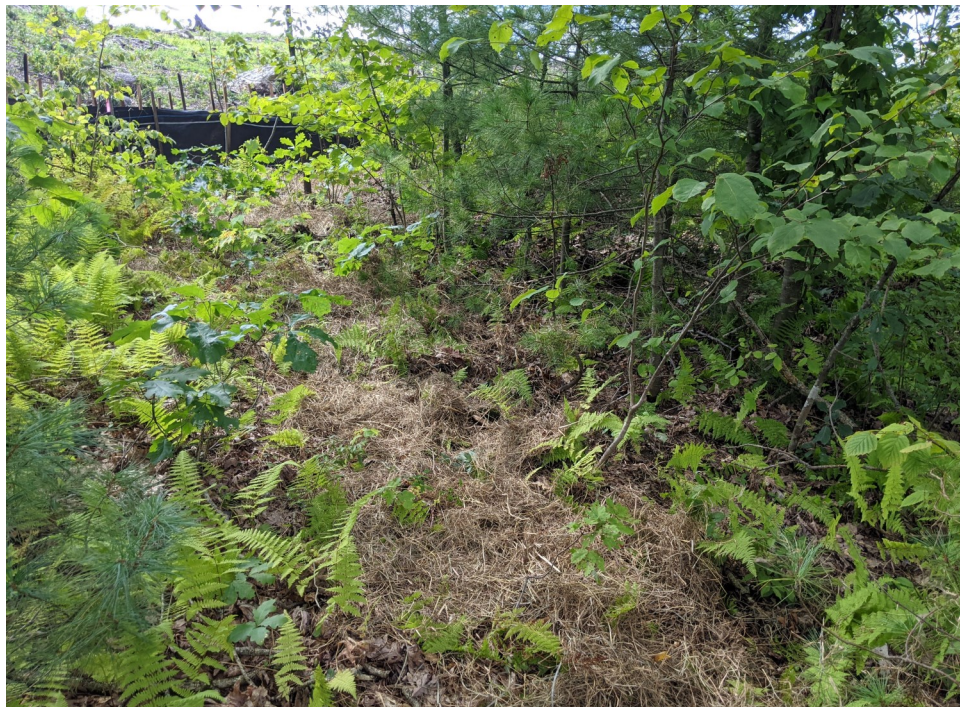
Photo 2

View of stabilization measures implemented beyond the limits of work at the location of Discharge 1—facing south.

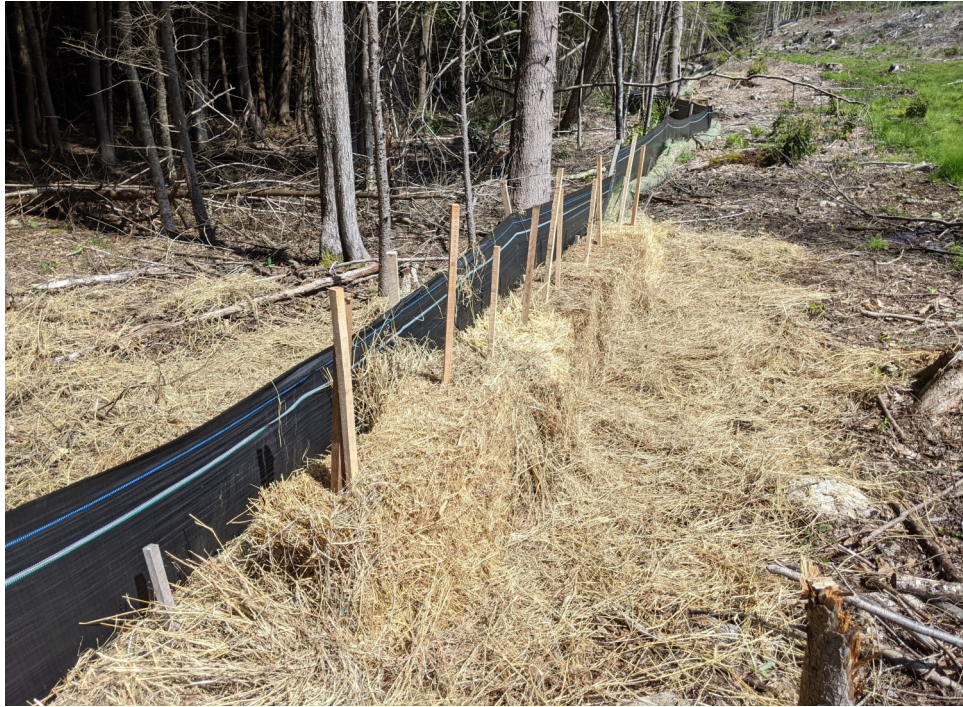
Photo 3

View of the repaired erosion control breach associated with Discharge 2; note the stabilization of exposed soils beyond the limits of work—facing northeast.

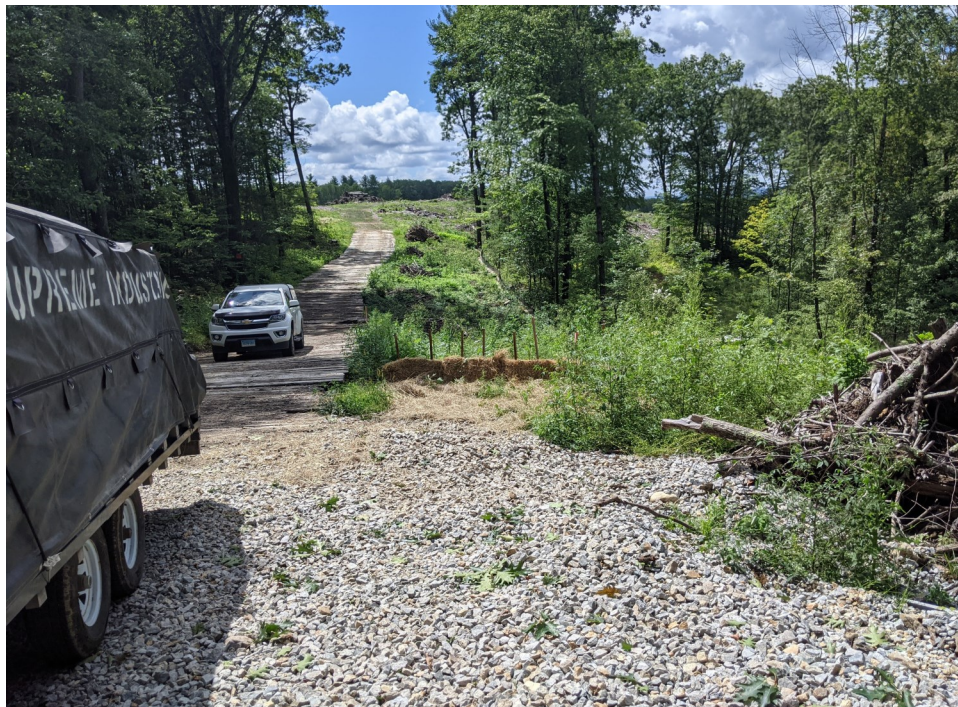
Photo 4

View of exposed soils stabilized at the construction entrance; note the implementation of straw bales—facing south.
