#### Inspection Report for North Sturbridge Road Solar Facility NPDES ID No.: MAR10031G Inspection Date: 09/02/2021

PHOTOGRAPHIC DOCUMENTATION North Sturbridge Road Solar Facility Charlton, Massachusetts Photographs Documented 09.02.2021

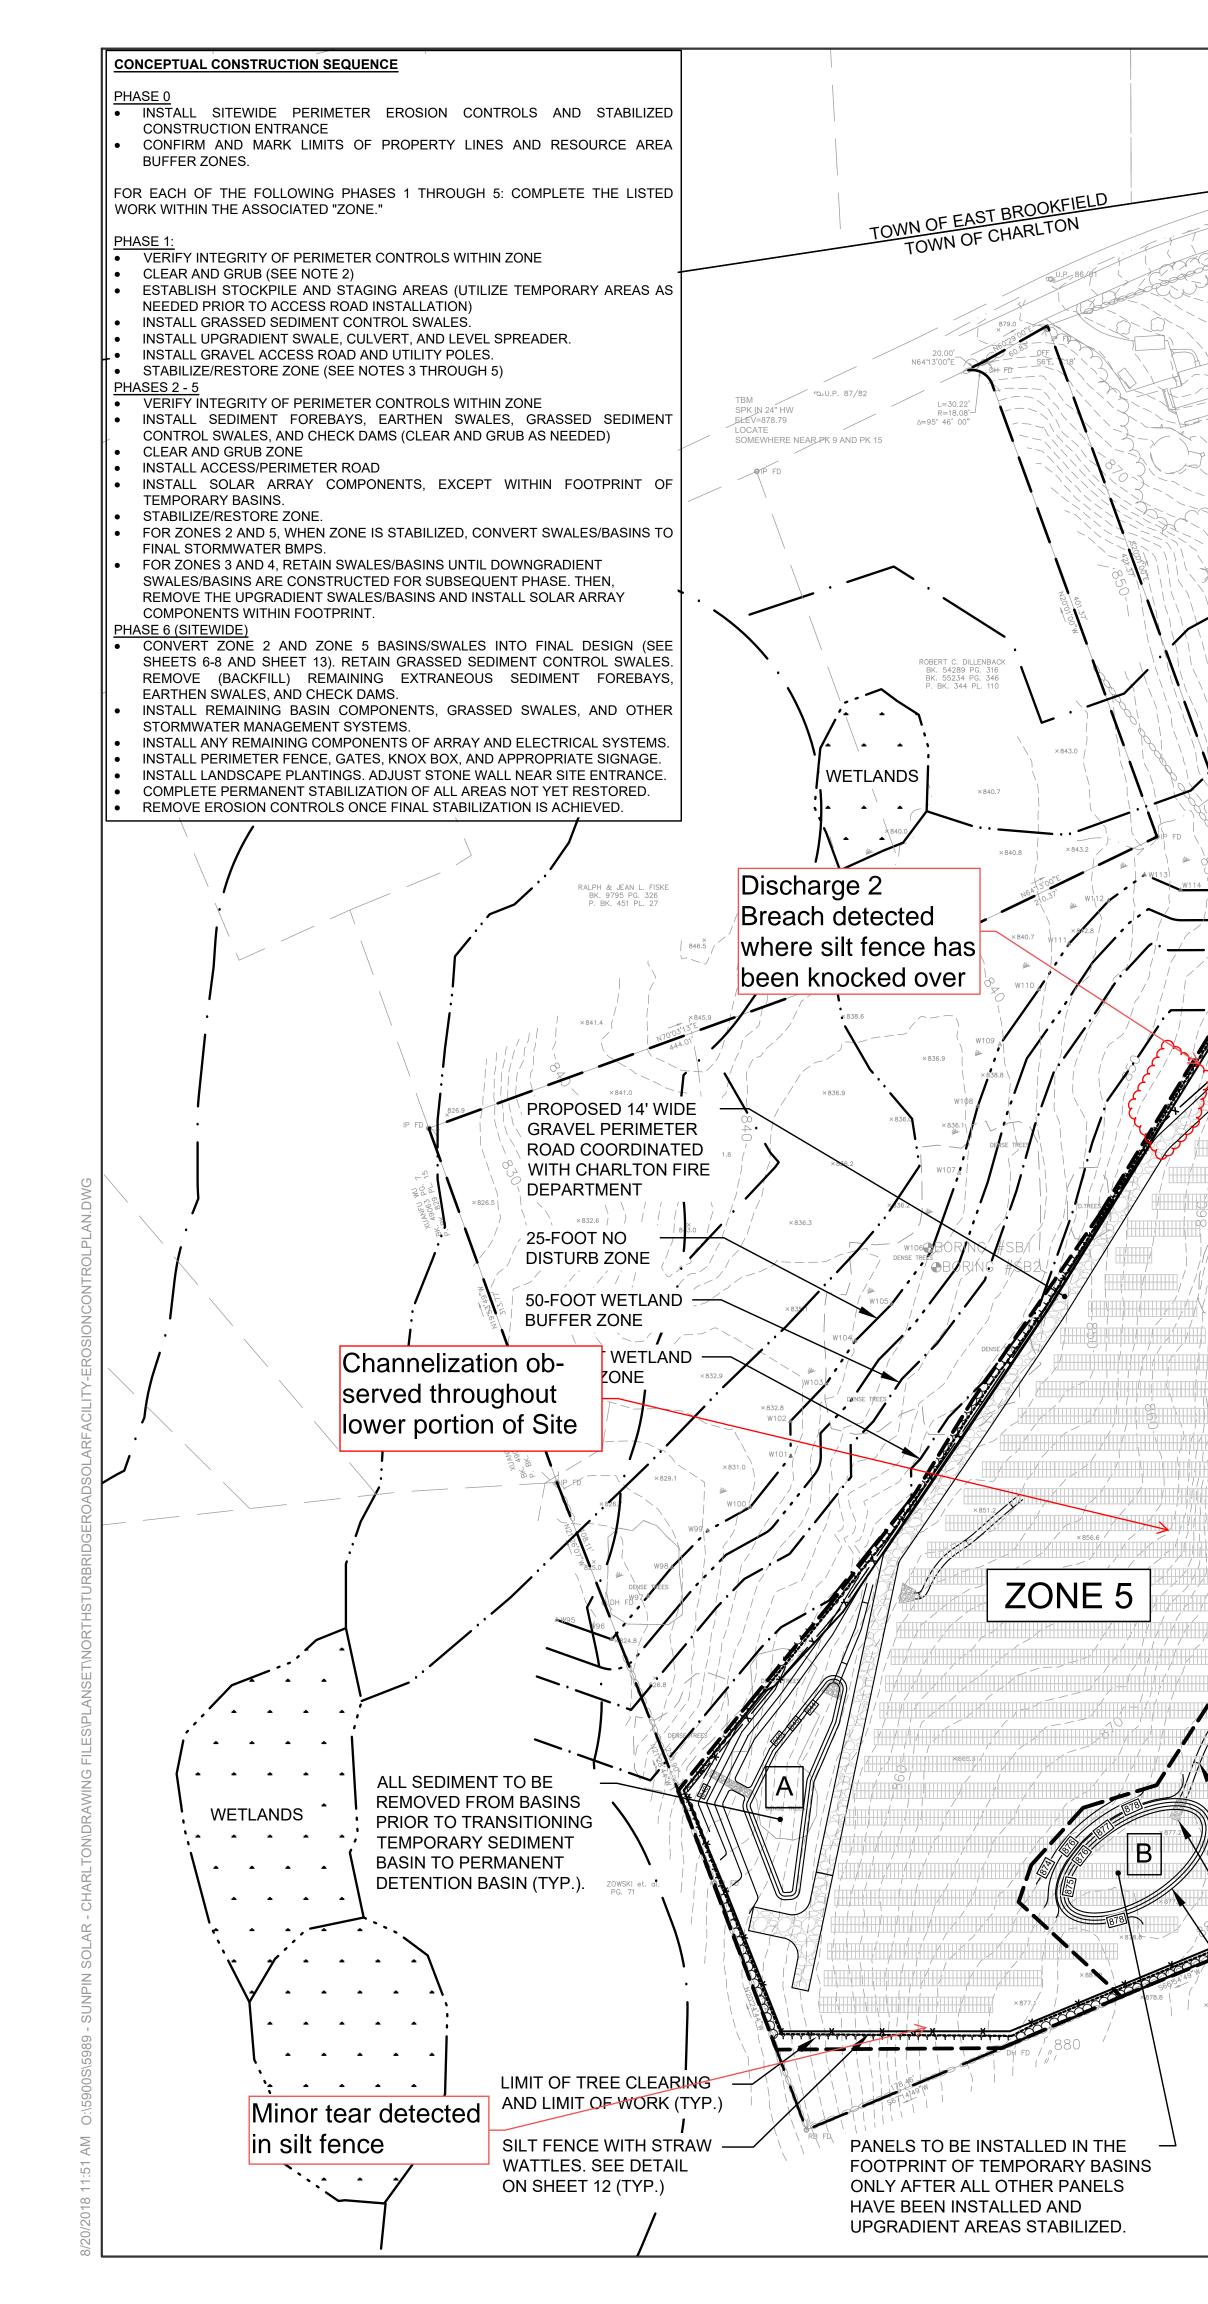
# Discharge 1 (ADDRESSED) ZONE Location of channelization within machinery tracks ZONE 2 F ZONE 3 ZONE 4

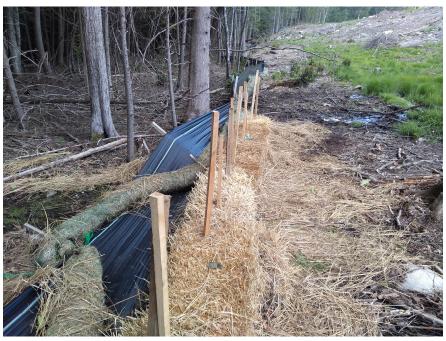
### Photo 1

1. Silt Fence and Straw Wattles	Yes (As of 9/2/2021)	No	9/2/2021	A breach was observed at Discharge 2. Although the double row of straw bales is intact, silt fence was observed to be knocked over and signs of stormwater flow were detected in the area beyond the fence. A minor tear was identified in a section of silt fence on the southern side of the Site with no erosion observed. Minor degradation of a straw wattle was observed on the southeastern side of the Site; no erosion was observed but pools of water were found to be forming behind the straw wattle

View of the damage erosion control measures associated with Discharge 2—facing north.

Description of Discharges (CGP Part 4.6.6)				
Was a stormwater discharge or other discharge occurring from any part of your site at the time of the inspection? $\Box$ Yes $\boxtimes$ No If "yes", provide the following information for each point of discharge:				
Discharge Location	Observations			
Discharge 2	Describe the discharge: Breach in silt fence allowed runoff to bypass erosion controls.         At points of discharge and the channels and banks of surface waters in the immediate vicinity, are there any visible signs of erosion and/or sediment accumulation that can be attributed to your discharge?         If yes, describe what you see, specify the location(s) where these conditions were found, and indicate whether modification, maintenance, or corrective action is needed to resolve the issue: Small areas of bare soil observed in area immediately beyond perimeter controls. Repairs to erosion controls and re-seeding of damaged areas is required.

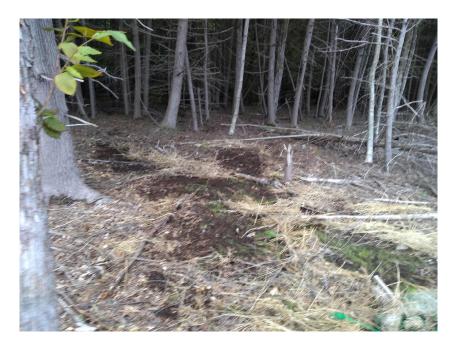
## Photo 2

View of area downgradient of Discharge 2-facing west.

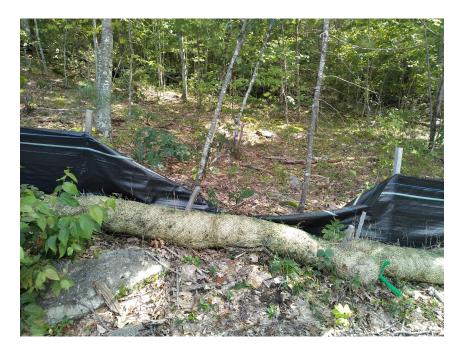
## Photo 3

View of the damaged silt fence in southern perimeter of Site —facing south.

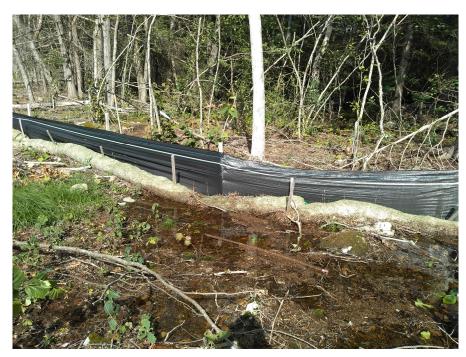
# Photo 4

View of degraded straw wattle at southeast perimeter of Site —facing east.
