Inspection Report for North Sturbridge Road Solar Facility

NPDES ID No.: MAR10031G

Inspection Date: 09/02/2021

**FIGURE 1:
SWPPP
INSPECTION
SKETCH
9/02/2021**

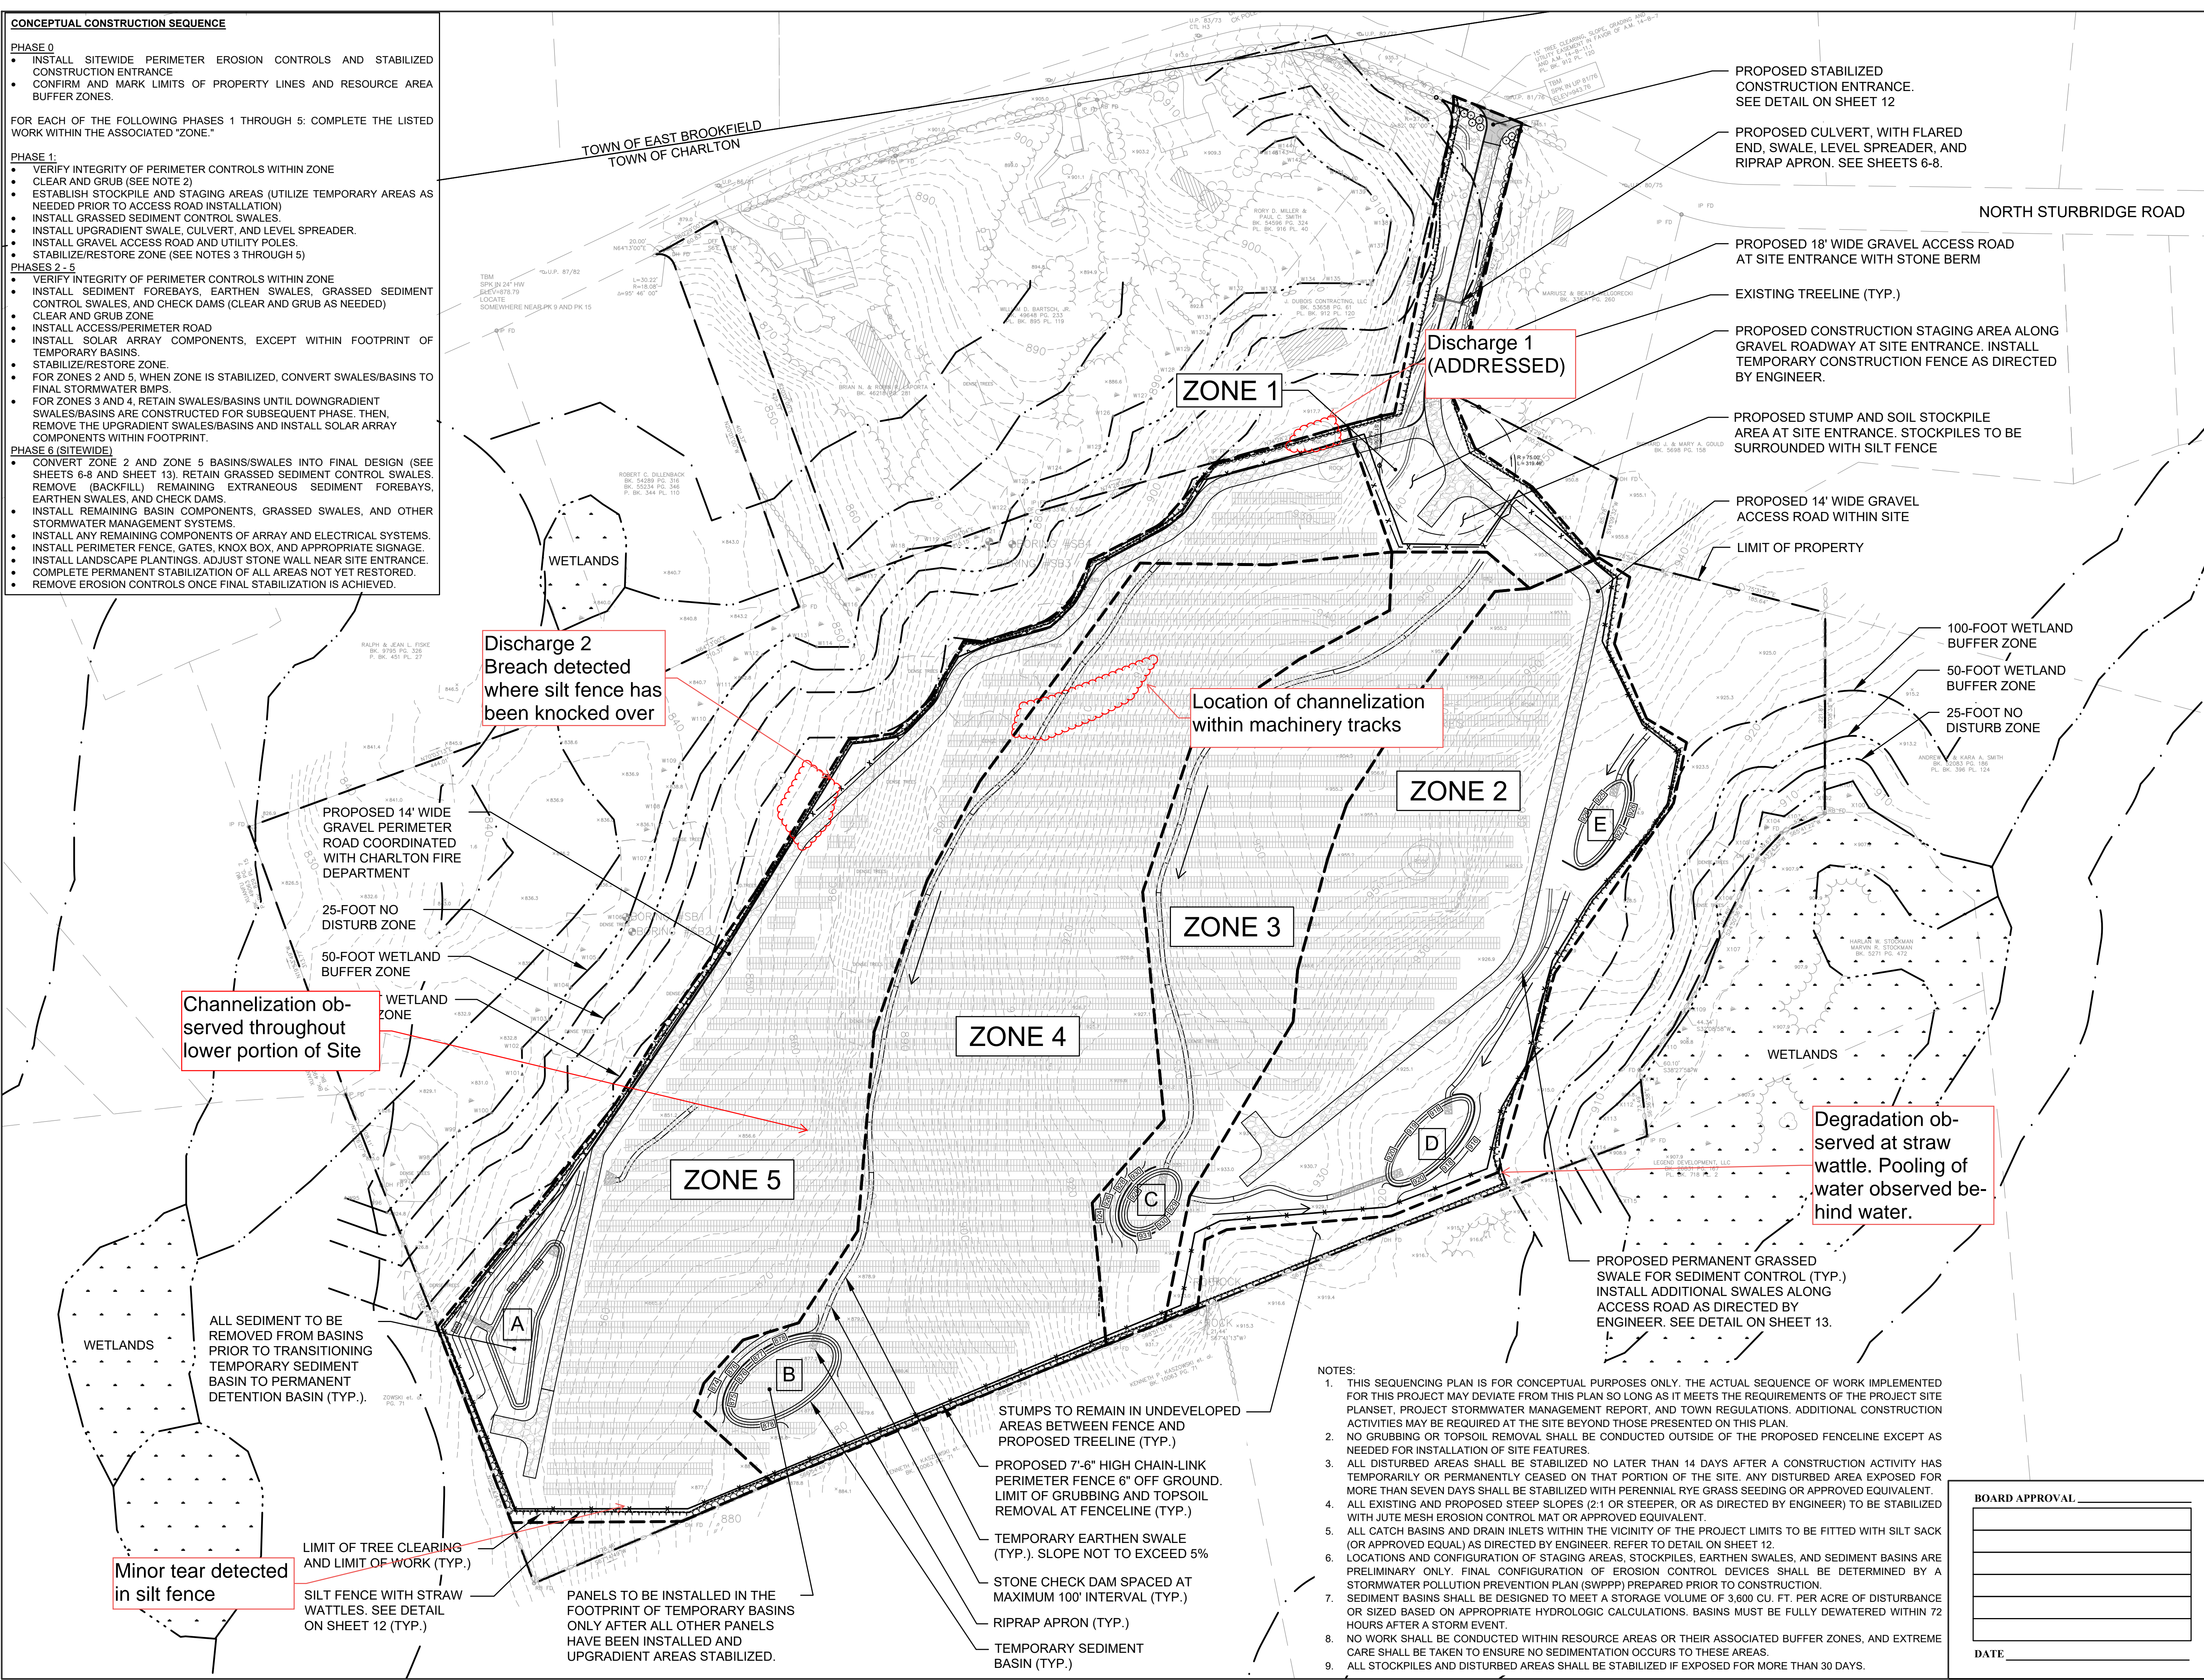
2. Informal access road along northern portion of the Site	Straw mulch or hydroseed	<input type="checkbox"/> Yes [Enter date] <input checked="" type="checkbox"/> No	Erosion channels are beginning to form within upgradient portions of the informal access road (Figure 1). The contractor indicated that stabilization by smoothing out soils and seeding or spreading mulch would occur on 7/30/2021. Stabilization of this area has not been initiated. After inspection of the area on 8/24/2021, it was determined that

Degradation observed at straw wattle. Pooling of water observed behind water.

Minor tear detected in silt fence

Discharge 2 Breach detected where silt fence has been knocked over

Location of channelization within machinery tracks

Channelization observed throughout lower portion of Site

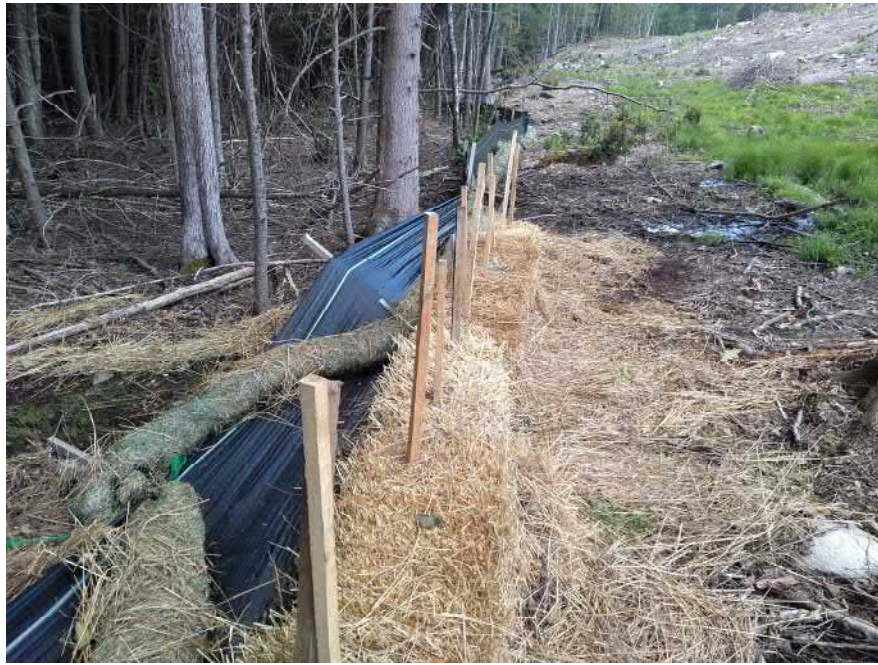
Photo 1

Type/Location of E&S Control	Maintenance Needed?*	Corrective Action Required?*	Date on Which Maintenance or Corrective Action First Identified?	Notes
1. Silt Fence and Straw Wattles	Yes (As of 9/2/2021)	No	9/2/2021	<p>A breach was observed at Discharge 2. Although the double row of straw bales is intact, silt fence was observed to be knocked over and signs of stormwater flow were detected in the area beyond the fence.</p> <p>A minor tear was identified in a section of silt fence on the southern side of the Site with no erosion observed.</p> <p>Minor degradation of a straw wattle was observed on the southeastern side of the Site; no erosion was observed but pools of water were found to be forming behind the straw wattle</p>

View of the damage erosion control measures associated with Discharge 2—facing north.

Description of Discharges (CGP Part 4.6.6)	
<p>Was a stormwater discharge or other discharge occurring from any part of your site at the time of the inspection? <input type="checkbox"/> Yes <input checked="" type="checkbox"/> No</p> <p>If "yes", provide the following information for each point of discharge:</p>	
Discharge Location	Observations
<p>Discharge 2</p>	<p>Describe the discharge: Breach in silt fence allowed runoff to bypass erosion controls.</p> <p>At points of discharge and the channels and banks of surface waters in the immediate vicinity, are there any visible signs of erosion and/or sediment accumulation that can be attributed to your discharge? <input checked="" type="checkbox"/> Yes <input type="checkbox"/> No</p> <p>If yes, describe what you see, specify the location(s) where these conditions were found, and indicate whether modification, maintenance, or corrective action is needed to resolve the issue: Small areas of bare soil observed in area immediately beyond perimeter controls. Repairs to erosion controls and re-seeding of damaged areas is required.</p>

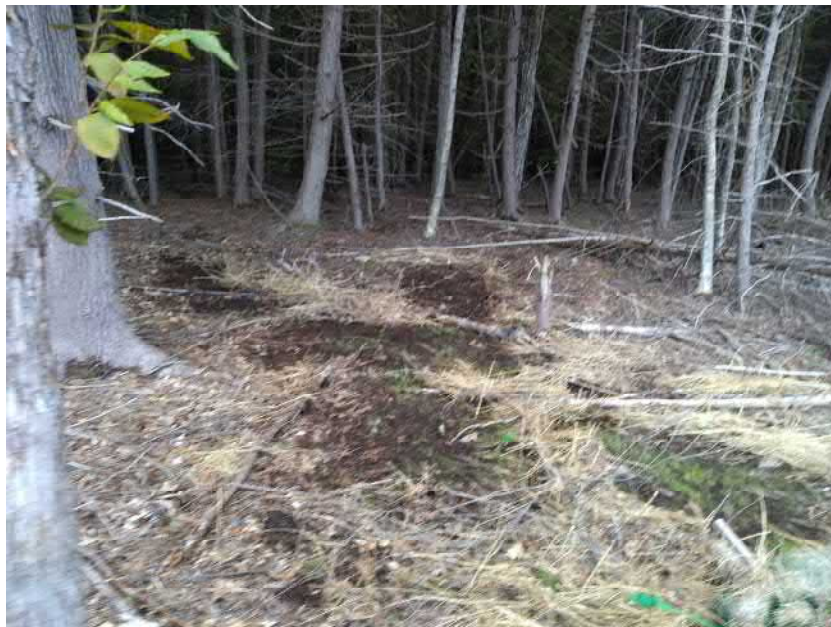
Photo 2

8/24/2021	observed within areas of disturbed soils within the limits of work; however, little to no germination was observed within the disturbed area downgradient of the limit of work. Additional seed should be hand-applied in this area. The areas downgradient of Discharges 1 and 2 have been stabilized with straw and seed. These areas will be monitored for germination and stabilization.
7. Topsoil Re-Use	N/A	N/A		
8. Storm Drain Inlets (North Brookfield Road)	N/A	N/A		
9. Temporary Drainage Swales (Throughout Site)	N/A	N/A		
10. Temporary Sediment Basins (Throughout Site)	N/A	N/A

View of area downgradient of Discharge 2—facing west.

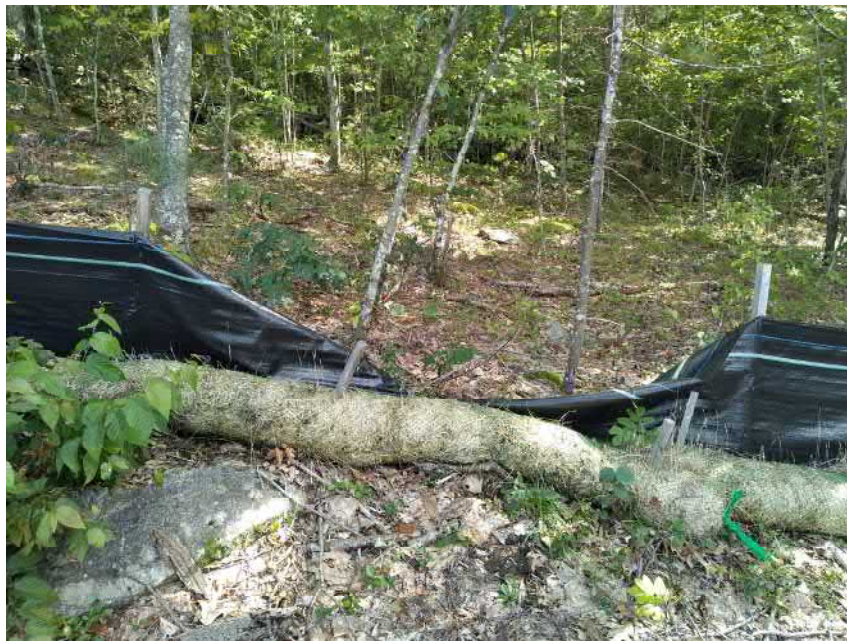
Photo 3

View of the damaged silt fence in southern perimeter of Site —facing south.

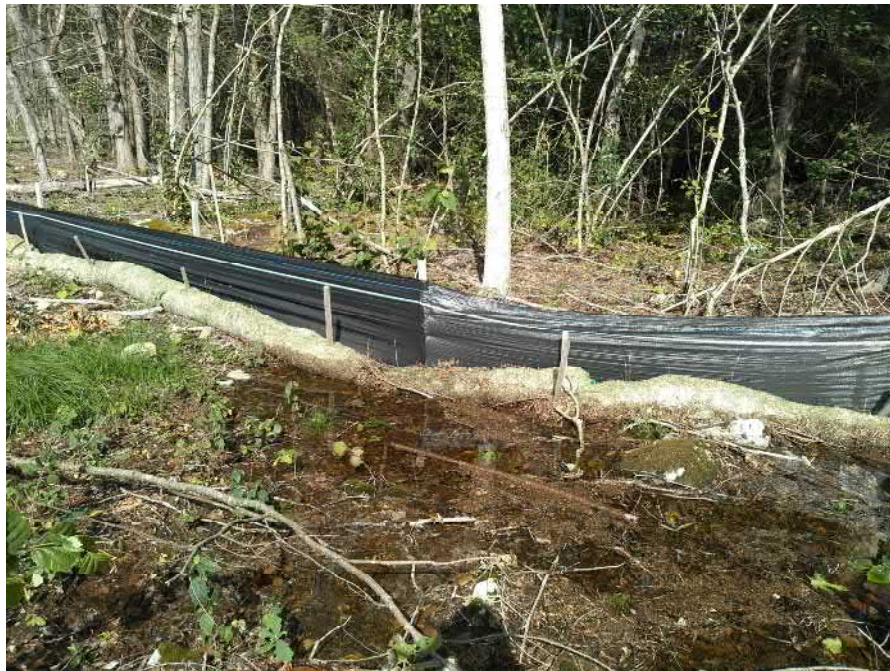
Photo 4

View of degraded straw wattle at southeast perimeter of Site —facing east.
