PHOTOGRAPHIC DOCUMENTATION  
North Sturbridge Road Solar Facility  
Charlton, Massachusetts  
Photographs Documented 09.02.2021

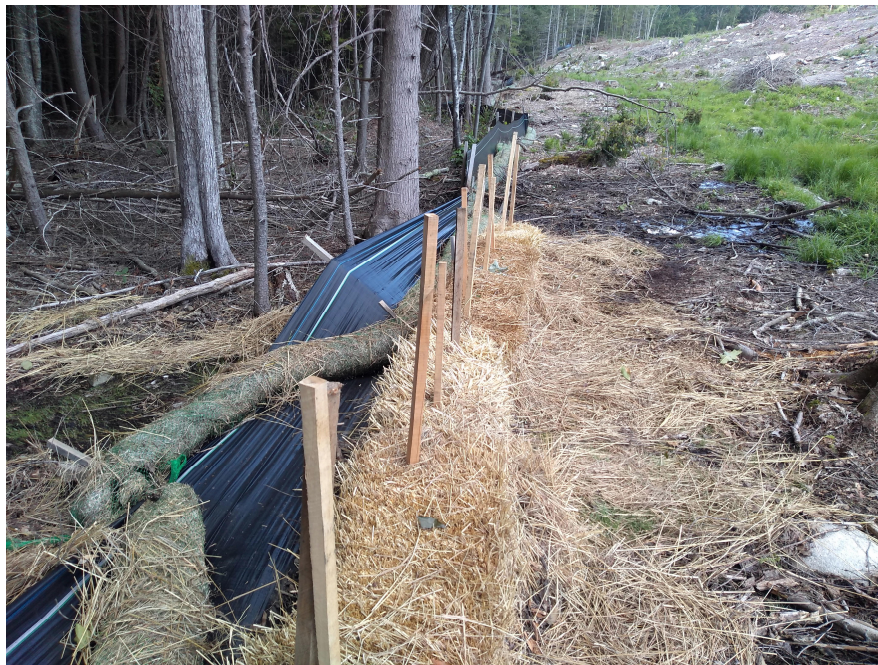
Photo 1

View of the damage erosion control measures associated with Discharge 2—facing north.

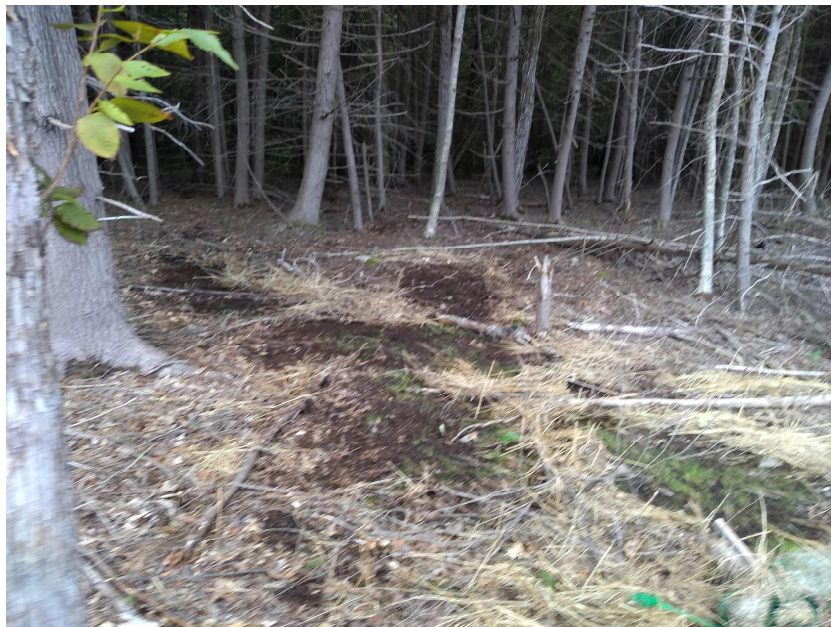
Photo 2

View of area downgradient of Discharge 2—facing west.

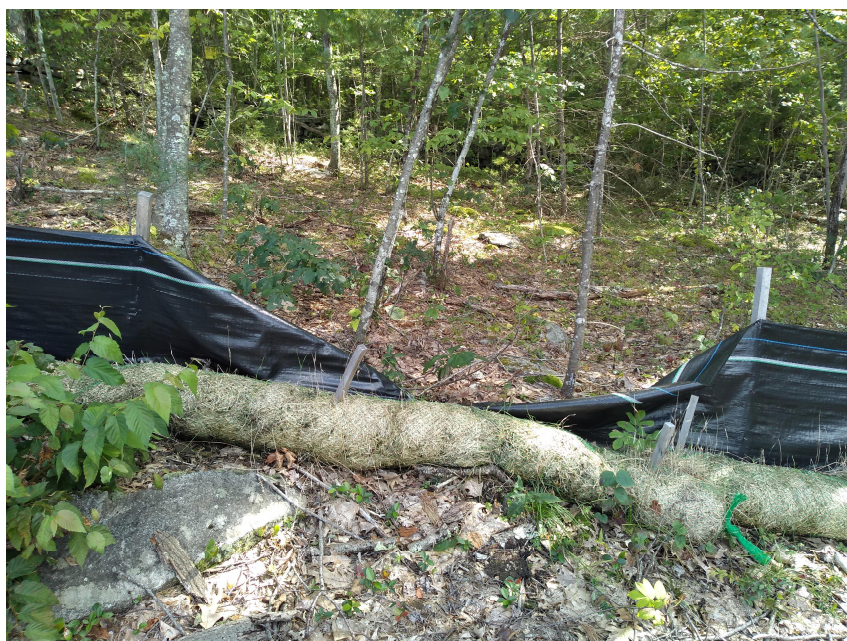
Photo 3

View of the damaged silt fence in southern perimeter of Site —facing south.

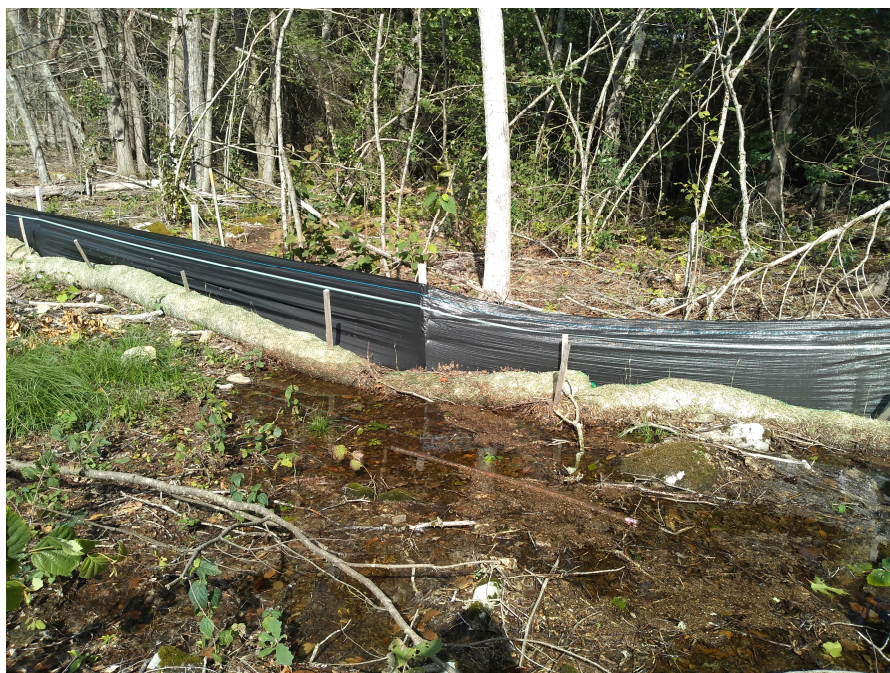
Photo 4

View of degraded straw wattle at southeast perimeter of Site —facing east.
