Inspection Report for North Sturbridge Road Solar Facility

NPDES ID No.: MAR10031G

Inspection Date: 09/02/2021

PHOTOGRAPHIC DOCUMENTATION
North Sturbridge Road Solar Facility
Charlton, Massachusetts
Photographs Documented 09.10.2021

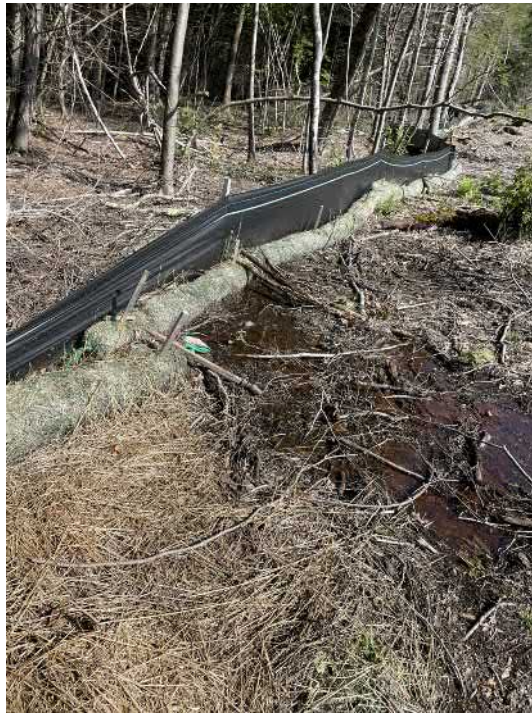
Photo 1

Type/Location of E&S Control	Maintenance Needed?*	Corrective Action Required?*	Date on Which Maintenance or Corrective Action First Identified?	Notes
1. Silt Fence and Straw Wattles	Yes (As of 9/2/2021)	No	9/2/2021	<p>A breach was observed at Discharge 2. Although the double row of straw bales is intact, silt fence was observed to be knocked over and signs of stormwater flow were detected in the area beyond the fence.</p> <p>A minor tear was identified in a section of silt fence on the southern side of the Site with no erosion observed.</p> <p>Minor degradation of a straw wattle was observed on the southeastern side of the Site; no erosion was observed but pools of water were found to be forming behind the straw wattle</p>

View of the damage erosion control measures associated with Discharge 2—facing north.

Description of Discharges (CGP Part 4.6.6)	
<p>Was a stormwater discharge or other discharge occurring from any part of your site at the time of the inspection? <input type="checkbox"/> Yes <input checked="" type="checkbox"/> No</p> <p>If "yes", provide the following information for each point of discharge:</p>	
Discharge Location	Observations
<p>Discharge 1</p>	<p>Describe the discharge: Breach in silt fence allowed runoff to bypass erosion controls.</p> <p>At points of discharge and the channels and banks of surface waters in the immediate vicinity, are there any visible signs of erosion and/or sediment accumulation that can be attributed to your discharge? <input checked="" type="checkbox"/> Yes <input type="checkbox"/> No</p> <p>If yes, describe what you see, specify the location(s) where these conditions were found, and indicate whether modification, maintenance, or corrective action is needed to resolve the issue: Small areas of bare soil observed in area immediately beyond perimeter controls. Repairs to erosion controls and re-seeding of damaged areas is required.</p>

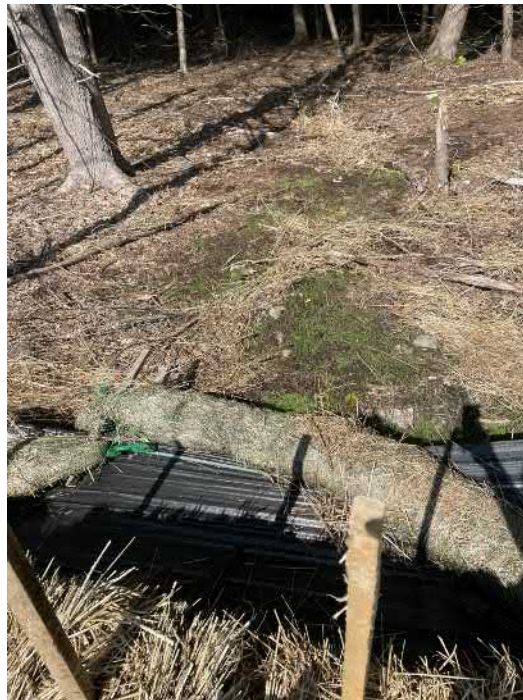
Photo 2

View of area downgradient of Discharge 2—facing west.

8/24/2021	observed within areas of disturbed soils within the limits of work; however, little to no germination was observed within the disturbed area downgradient of the limit of work. Additional seed should be hand-applied in this area. The areas downgradient of Discharges 1 and 2 have been stabilized with straw and seed. These areas will be monitored for germination and stabilization.
7. Topsoil Re-Use	N/A	N/A		
8. Storm Drain Inlets (North Brookfield Road)	N/A	N/A		
9. Temporary Drainage Swales (Throughout Site)	N/A	N/A		
10. Temporary Sediment Basins (Throughout Site)	N/A	N/A

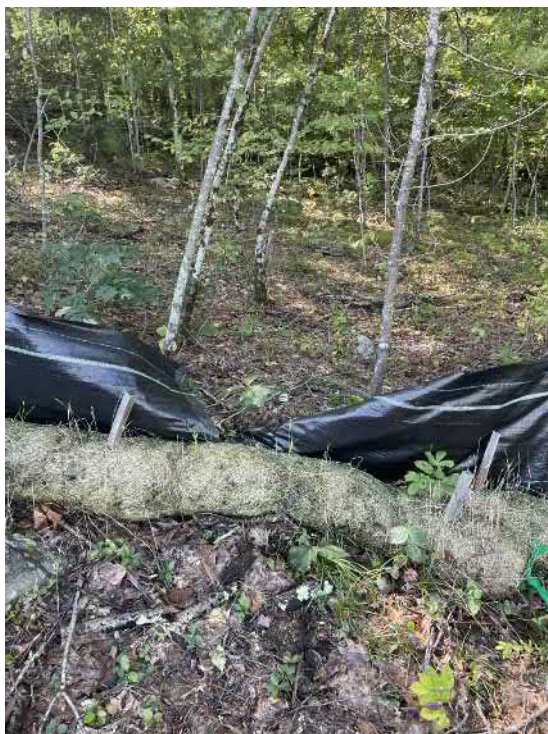
Photo 3

View of the damaged silt fence in southern perimeter of Site —facing south.

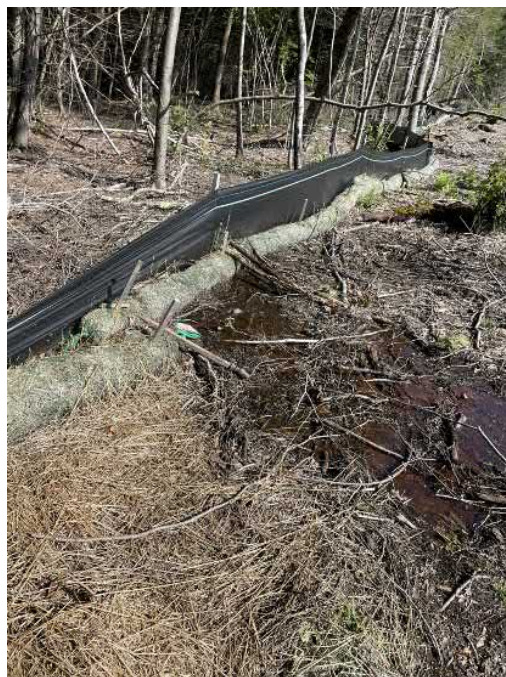
Photo 4

View of degraded straw wattle at southeast perimeter of Site —facing east.
