Inspection Report for North Sturbridge Road Solar Facility

NPDES ID No.: MAR10031G

Inspection Date: 09/17/2021

**FIGURE 1:  
SWPPP  
INSPECTION  
SKETCH  
9/02/2021**

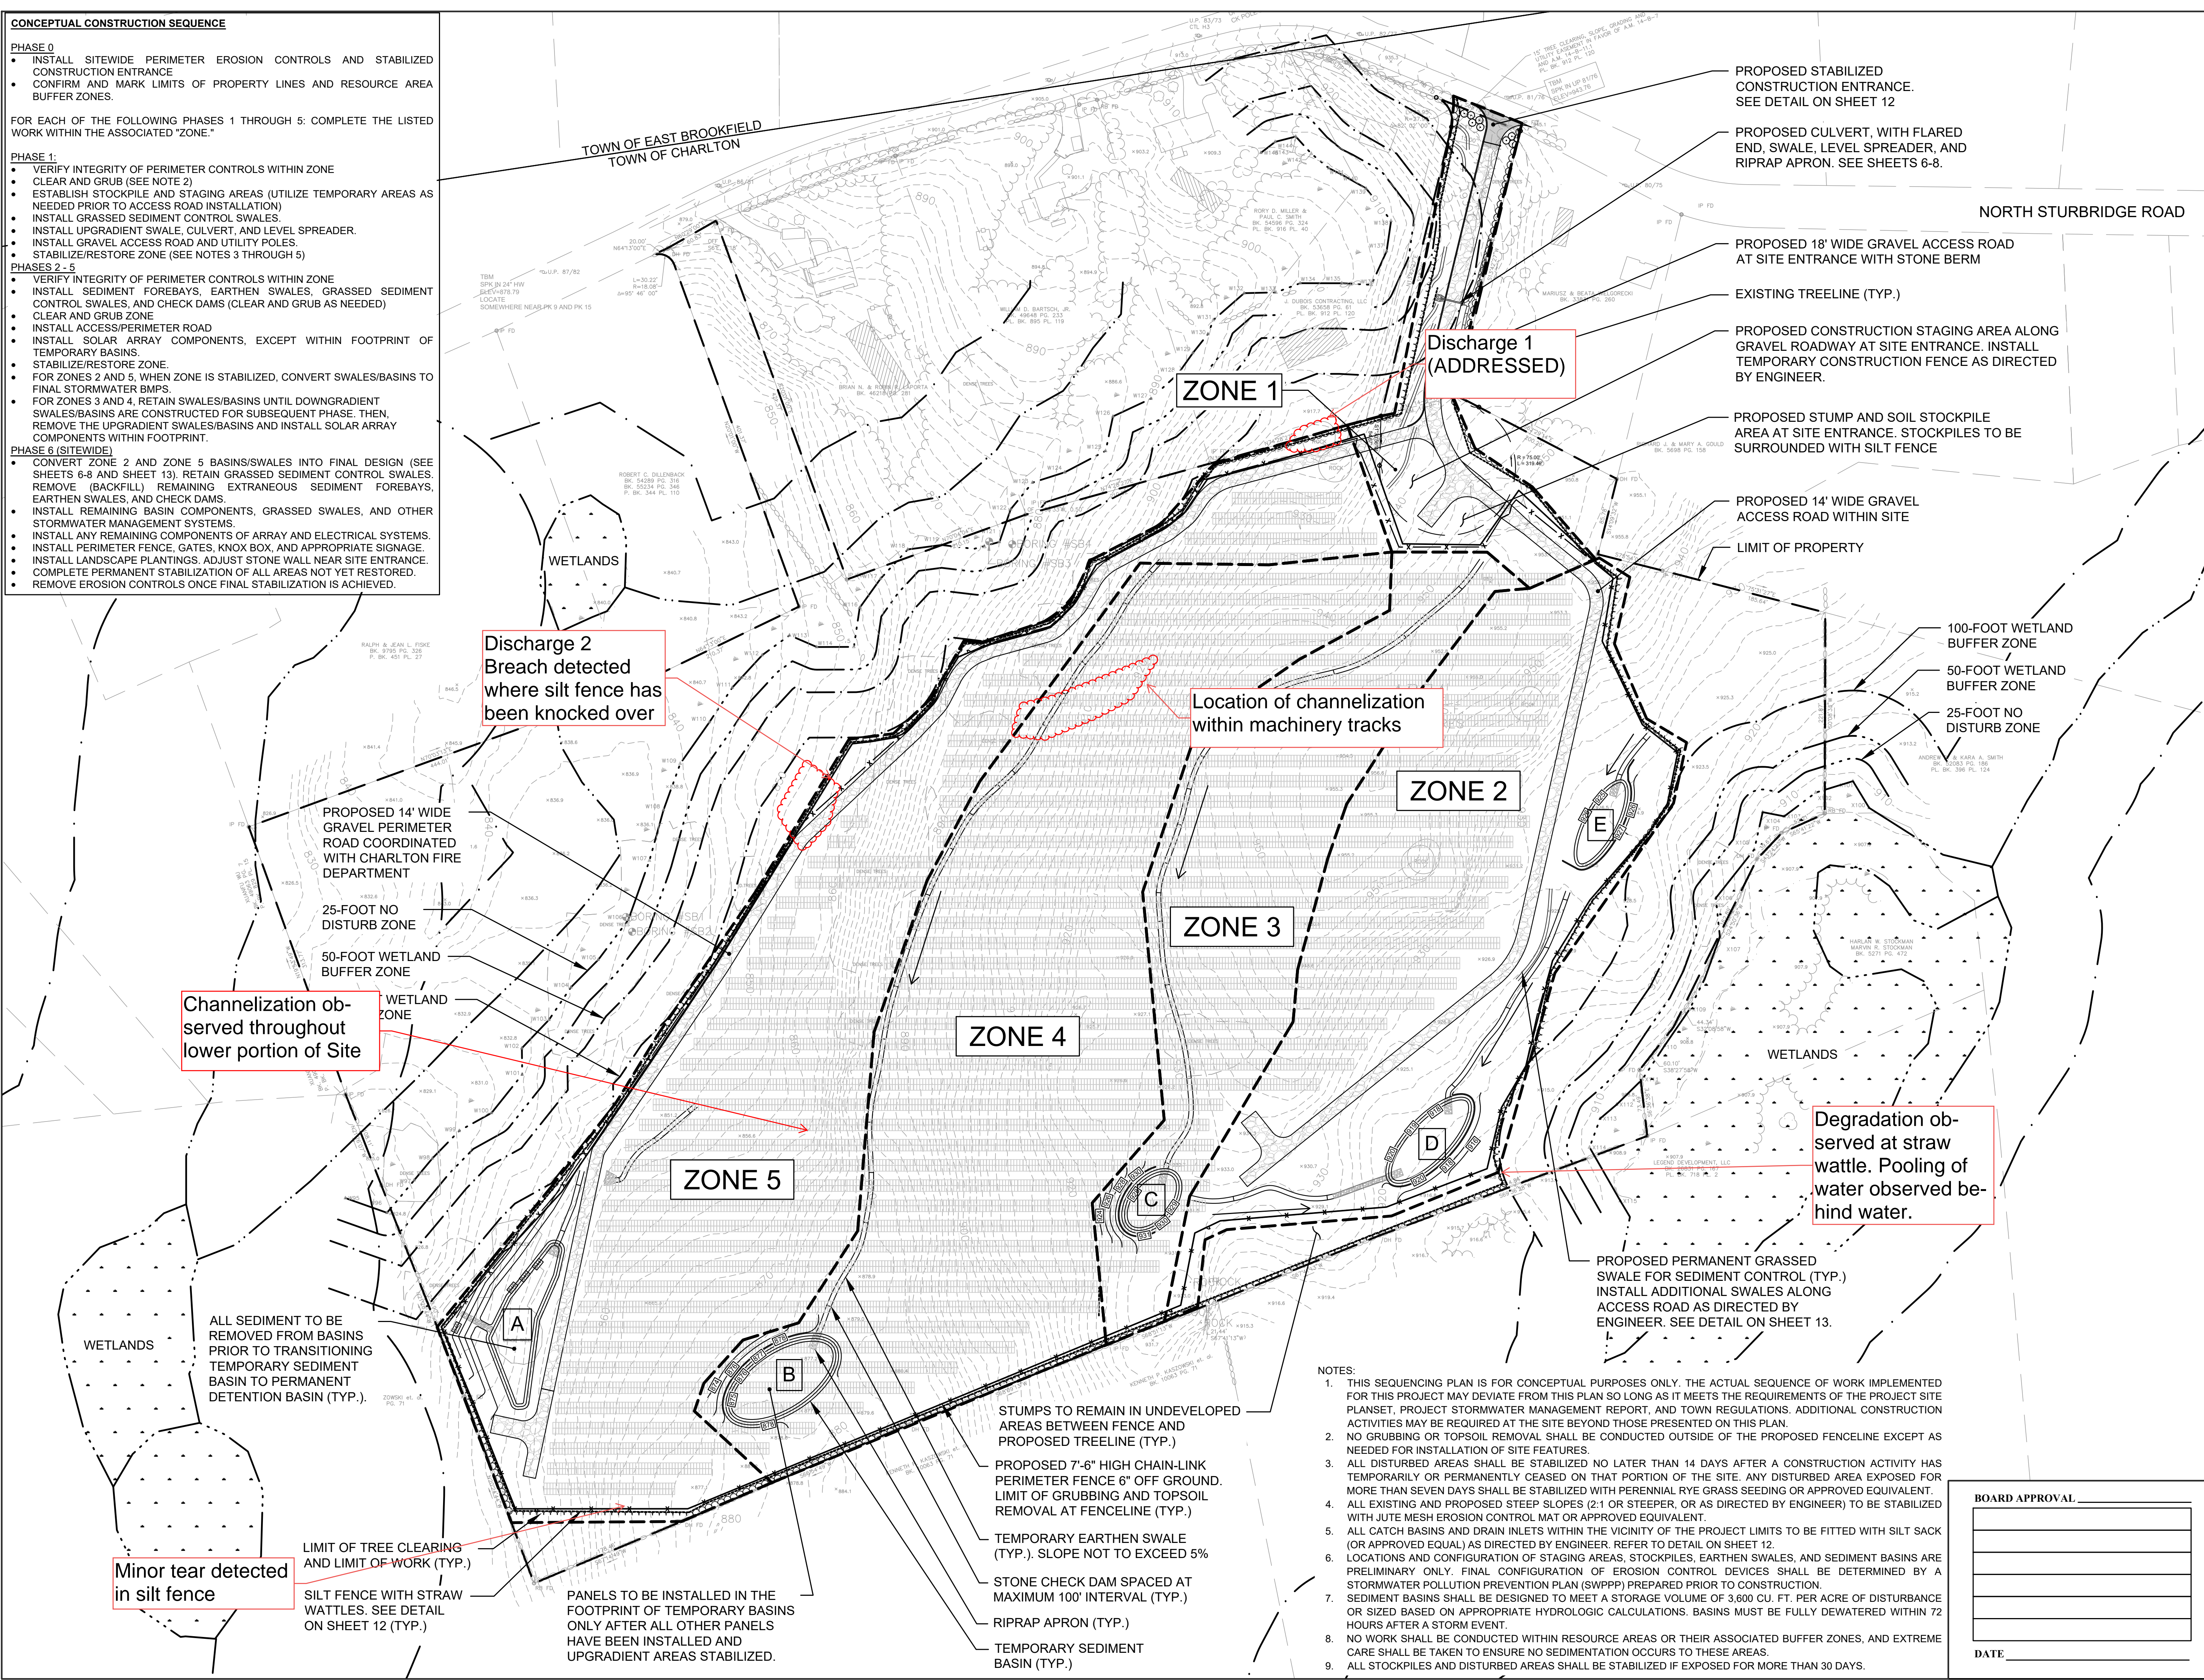
2. Informal access road along northern portion of the Site	Straw mulch or hydroseed	<input type="checkbox"/> Yes [Enter date] <input checked="" type="checkbox"/> No	Erosion channels are beginning to form within upgradient portions of the informal access road (Figure 1). The contractor indicated that stabilization by smoothing out soils and seeding or spreading mulch would occur on 7/30/2021. Stabilization of this area has not been initiated. After inspection of the area on 8/24/2021, it was determined that

Degradation observed at straw wattle. Pooling of water observed behind water.

Minor tear detected in silt fence

Discharge 2 Breach detected where silt fence has been knocked over

Location of channelization within machinery tracks

Channelization observed throughout lower portion of Site

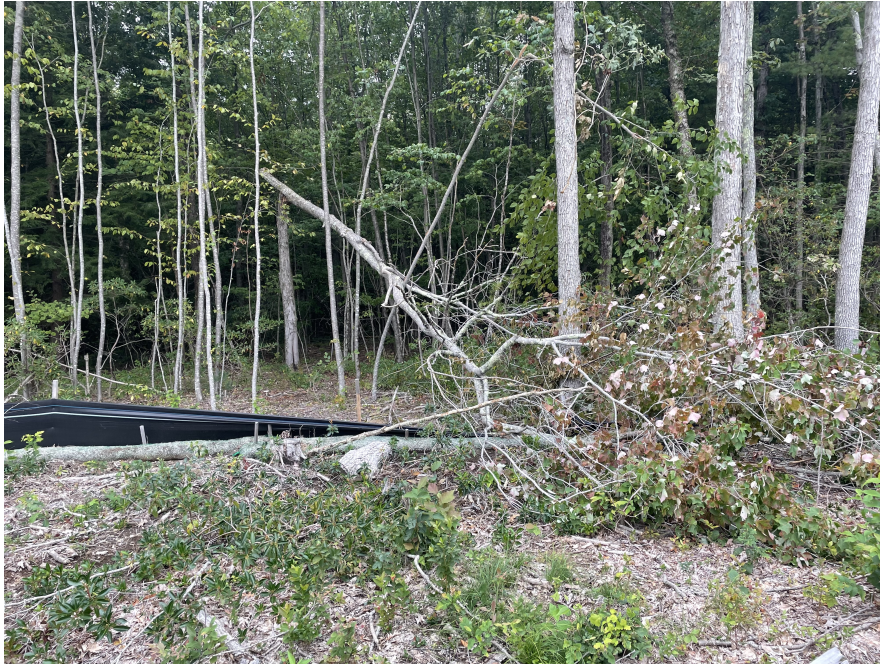
Photo 1

2. Stabilized Construction Entrance (Site Entrance – Access Road)	No (As of 9/2/2021)	No		<p>A tree was knocked over and laying on the silt fence on the on the northwestern portion of the site in Zone 5.</p> <p>Hydroseed was applied to exposed soil in this area and continues to germinate.</p>

View of tree fallen on northwestern portion of Zone 5.

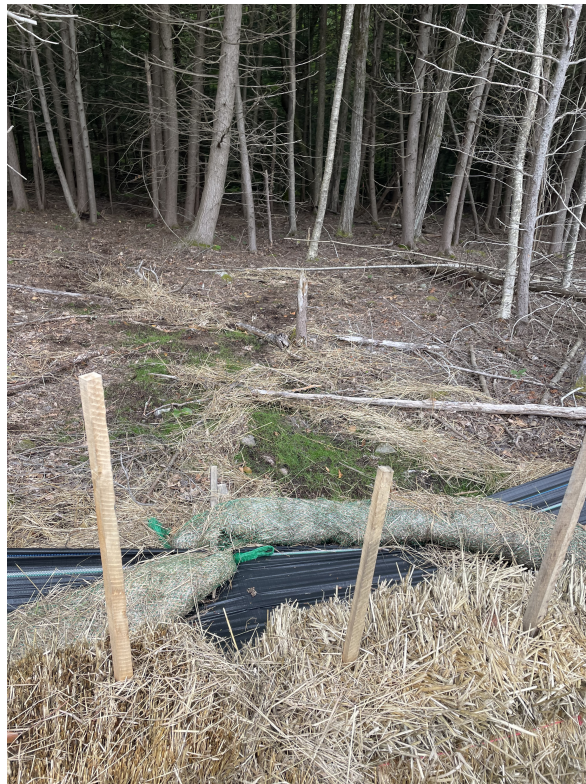
Photo 2

8/24/2021	<p>observed within areas of disturbed soils within the limits of work; however, little to no germination was observed within the disturbed area downgradient of the limit of work. Additional seed should be hand-applied in this area.</p> <p>The areas downgradient of Discharges 1 and 2 have been stabilized with straw and seed. These areas will be monitored for germination and stabilization.</p>
7. Topsoil Re-Use	N/A	N/A		
8. Storm Drain Inlets (North Brookfield Road)	N/A	N/A		
9. Temporary Drainage Swales (Throughout Site)	N/A	N/A		
10. Temporary Sediment Basins (Throughout Site)	N/A	N/A

View of area downgradient of Discharge 2—facing west.

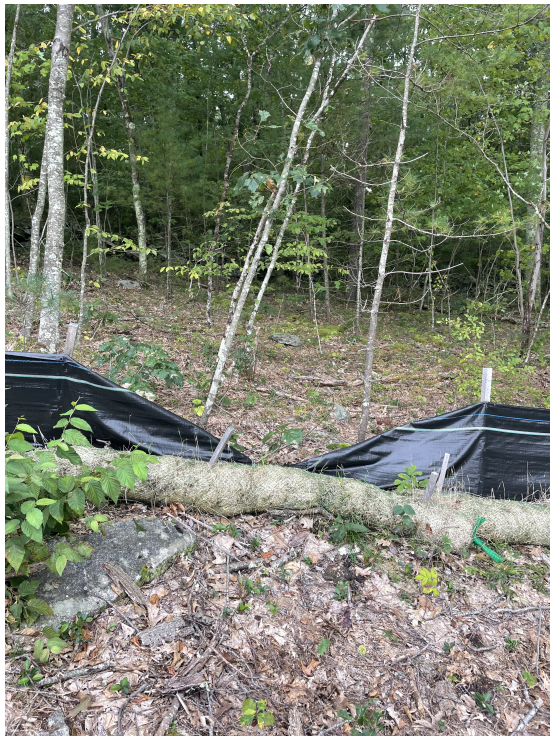
Photo 3

Type/Location of E&S Control	Maintenance Needed?*	Corrective Action Required?*	Date on Which Maintenance or Corrective Action First Identified?	Notes
1. Silt Fence and Straw Wattles	Yes (As of 9/2/2021)	No	9/2/2021	<p>A breach was observed at Discharge 2. Although the double row of straw bales is intact, silt fence was observed to be knocked over and signs of stormwater flow were detected in the area beyond the fence.</p> <p>A minor tear was identified in a section of silt fence on the southern side of the Site with no erosion observed.</p> <p>Minor degradation of a straw wattle was observed on the southeastern side of the Site; no erosion was observed but pools of water were found to be forming behind the straw wattle.</p>

View of the damaged silt fence in southern perimeter of Site —facing south.

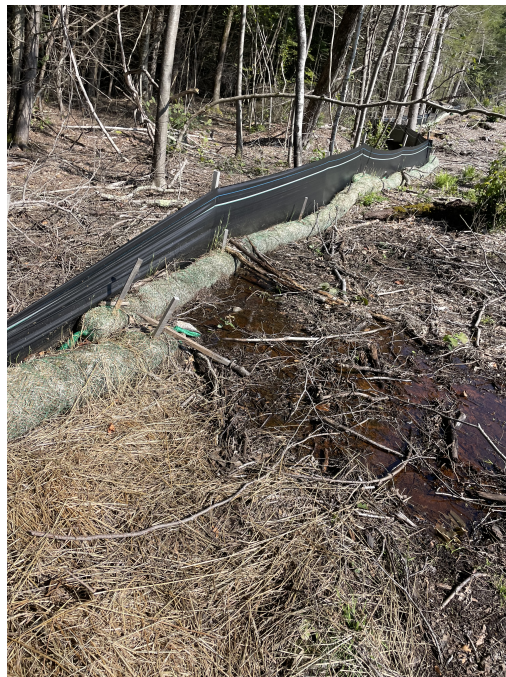
Photo 4

View of degraded straw wattle at southeast perimeter of Site —facing east.
