Inspection Report for North Sturbridge Road Solar Facility NPDES ID No.: MAR10031G Inspection Date: 09/17/2021

PHOTOGRAPHIC DOCUMENTATION North Sturbridge Road Solar Facility Charlton, Massachusetts Photographs Documented 09.17.2021

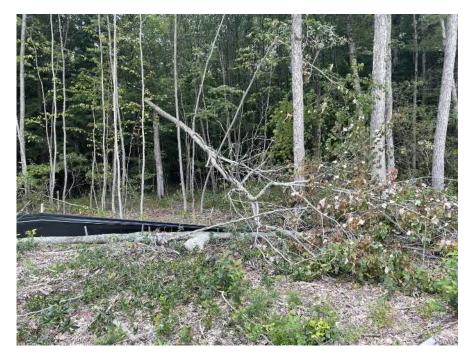
Photo 1

View of tree fallen on northwestern portion of Zone 5.

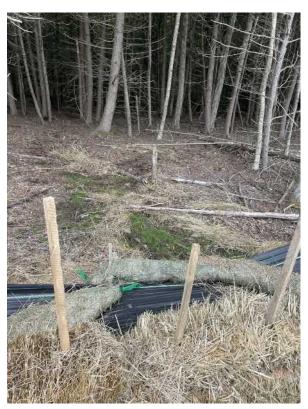
Photo 2

View of area downgradient of Discharge 2—facing west.

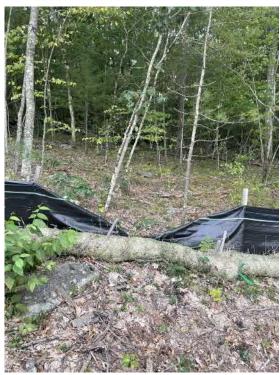
Photo 3

1. Silt Fence and Straw Wattles	Yes (As of 9/2/2021)	No	9/2/ 2021	A breach was observed at Discharge 2. Although the double row of straw bales is intact, silt fence was observed to be knocked over and signs of stormwater flow were detected in the area beyond the fence. A minor tear was identified in a section of silt fence on the southern side of the Site with no erosion observed. Minor degradation of a straw wattle was observed on the southeastern side of the Site; no erosion was observed but pools of water were found to be forming behind the straw wattle.
Stabilized Construction Entrance (Site Entrance – Access Road)	No (As of 9/2/2021)	No		A tree was knocked over and laying on the silt fence on the on the northwestern portion of the site in Zone 5. Hydroseed was applied to exposed soil in this area and continues to

View of the damaged silt fence in southern perimeter of Site —facing south.

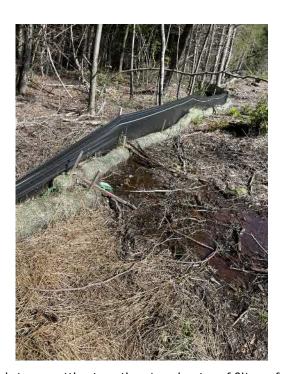
Photo 4

View of degraded straw wattle at southeast perimeter of Site —facing east.
