Inspection Report for North Sturbridge Road Solar Facility

NPDES ID No.: MAR10031G

Inspection Date: 09/24/2021

PHOTOGRAPHIC DOCUMENTATION

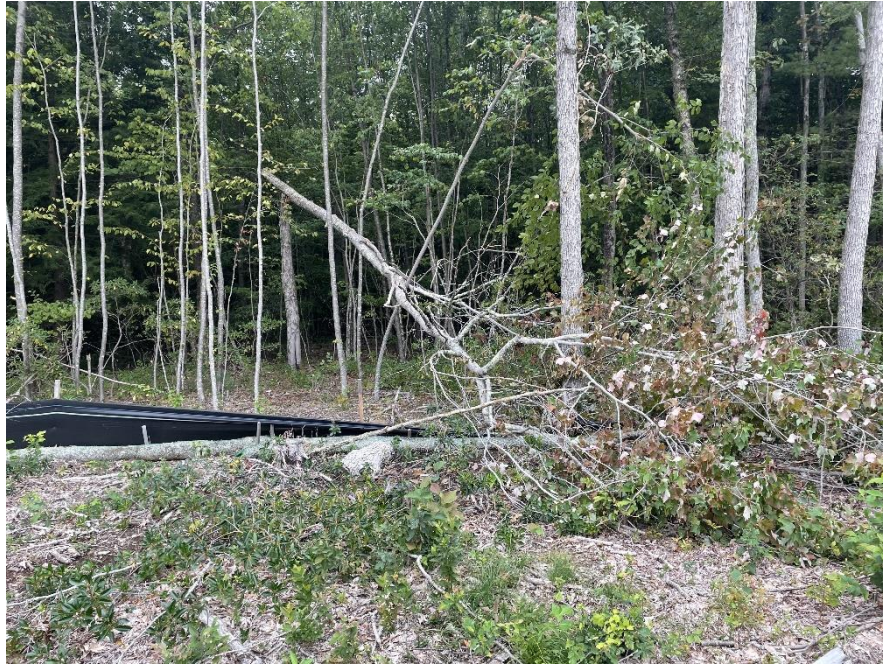
Photo 1

2. Stabilized Construction Entrance (Site Entrance – Access Road)	No (As of 9/2/2021)	No		<p>A tree was knocked over and laying on the silt fence on the on the northwestern portion of the site in Zone 5.</p>

View of tree fallen on northwestern portion of Zone 5.

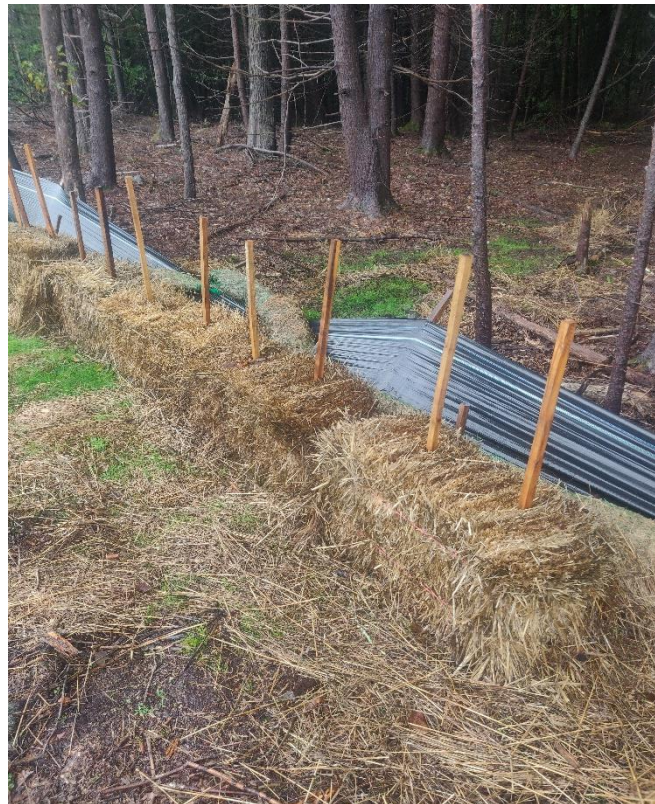
Photo 2

View of area downgradient of Discharge 2—facing west.

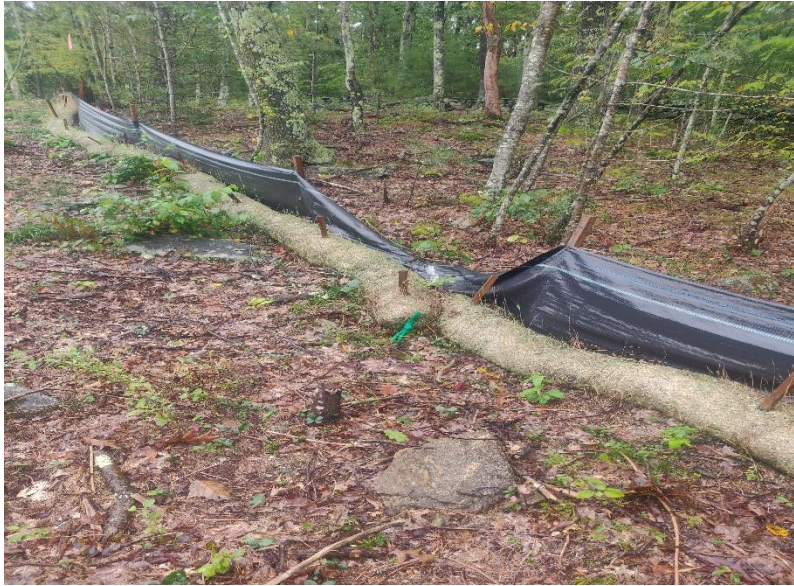
Photo 3

Type/Location of E&S Control	Maintenance Needed?*	Corrective Action Required?*	Date on Which Maintenance or Corrective Action First Identified?	Notes
1. Silt Fence and Straw Wattles	Yes (As of 9/2/2021)	No	9/2/2021	<p>A breach was observed at Discharge 2. Although the double row of straw bales is intact, silt fence was observed to be knocked over and signs of stormwater flow were detected in the area beyond the fence.</p> <p>A minor tear was identified in a section of silt fence on the southern side of the Site with no erosion observed.</p> <p>Minor degradation of a straw wattle was observed on the southeastern side of the Site; no erosion was observed but pools of water were found to be forming behind the straw wattle.</p>

View of the damaged silt fence in southern perimeter of Site —facing south.
