Inspection Report for North Sturbridge Road Solar Facility

NPDES ID No.: MAR10031G

Inspection Date: 09/29/2021

PHOTOGRAPHIC DOCUMENTATION
North Sturbridge Road Solar Facility
Charlton, Massachusetts
Photographs Documented 09.29.2021

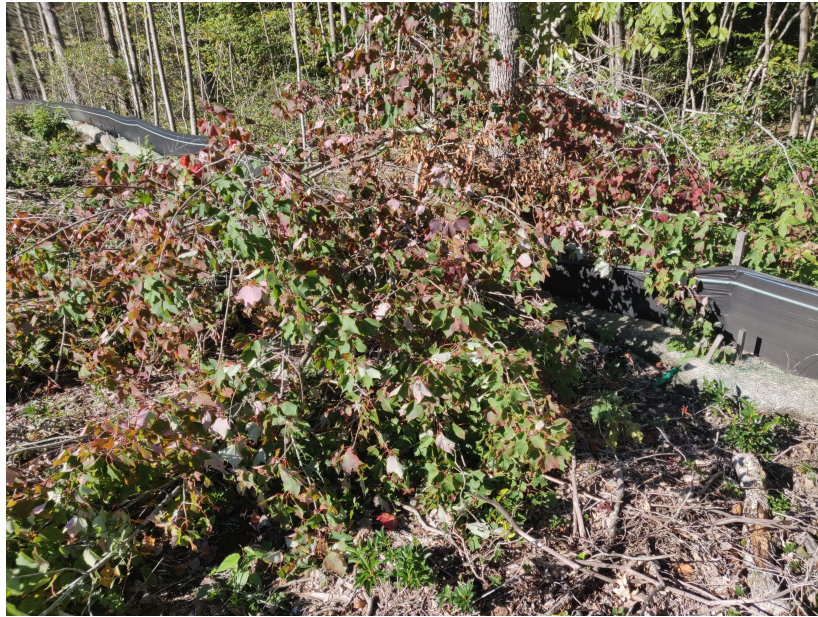
Photo 1

2. Stabilized Construction Entrance (Site Entrance – Access Road)	No (As of 9/2/2021)	No		<p>A tree was knocked over and laying on the silt fence on the on the northwestern portion of the site in Zone 5.</p> <p>Hydroseed was applied to exposed soil in this area and continues to germinate, some grass seedlings are now observed.</p>

View of tree fallen on northwestern portion of Zone 5.

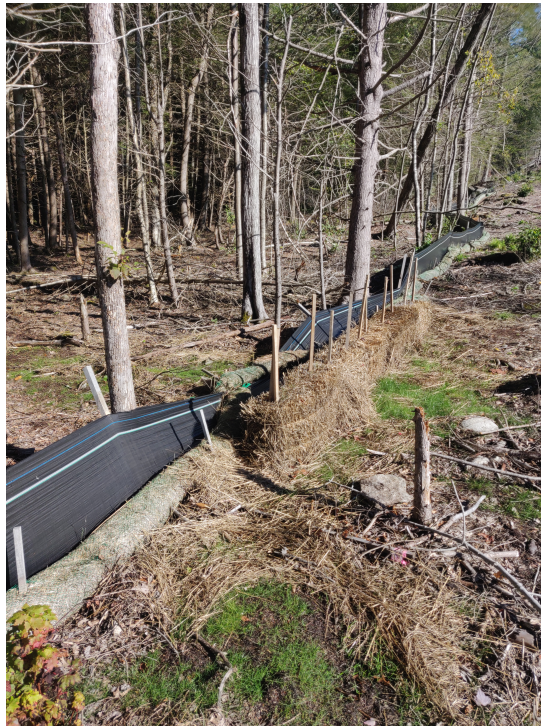
Photo 2

View of area downgradient of Discharge 2—facing north west.

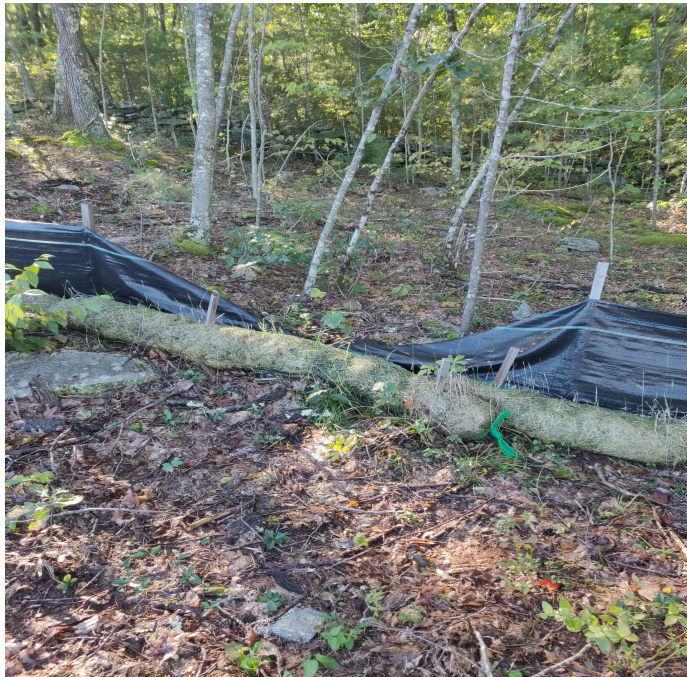
Photo 3

Condition and Effectiveness of Erosion and Sediment (E&S) Controls (CGP Part 2.2)				
Type/Location of E&S Control	Maintenance Needed?*			
1. Silt Fence and Straw Wattles	Yes (As of 9/2/2021)	No	9/2/2021	<p>A breach was observed at Discharge 2. Although the double row of straw bales is intact, silt fence was observed to be knocked over and signs of stormwater flow were detected in the area beyond the fence.</p> <p>A minor tear was identified in a section of silt fence on the southern side of the Site with no erosion observed.</p> <p>Minor degradation of a straw wattle was observed on the southeastern side of the Site; no erosion was observed but pools of water were found to be forming behind the straw wattle.</p>

View of the damaged silt fence in southern perimeter of Site —facing south.

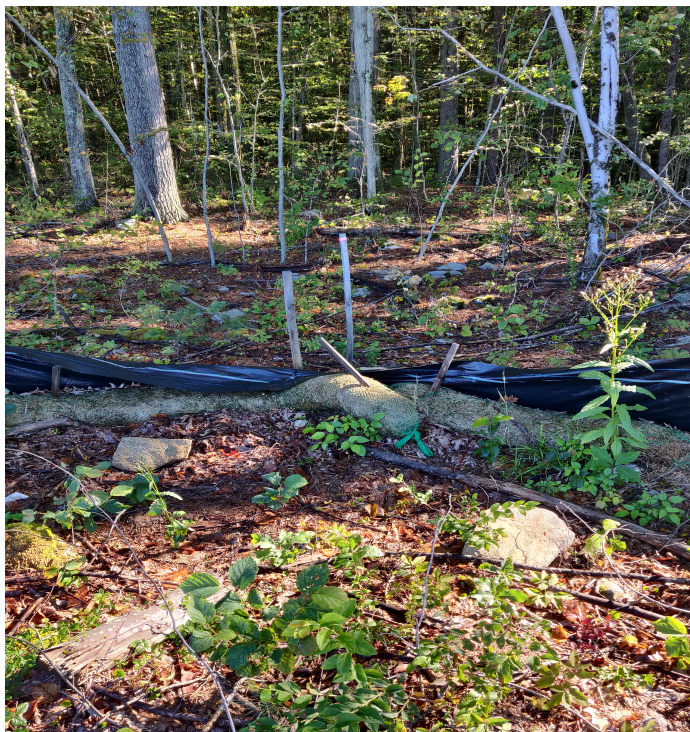
View of damaged silt fence in south east portion of the Site —facing south east
