| | General Information | | | | | | | |
|---|---|--|---|---|---|---|--|--|
| Inspection Location North Sturbridge Road Solar Fa | | | acility – Entirety of Site | (0 North Sturbridge Road, Charl | ton, MA 01507) | | | |

### Inspection Report for North Sturbridge Road Solar Facility NPDES ID No.: MAR10031G Inspection Date: 09/29/2021

PHOTOGRAPHIC DOCUMENTATION North Sturbridge Road Solar Facility Charlton, Massachusetts Photographs Documented 09.29.2021

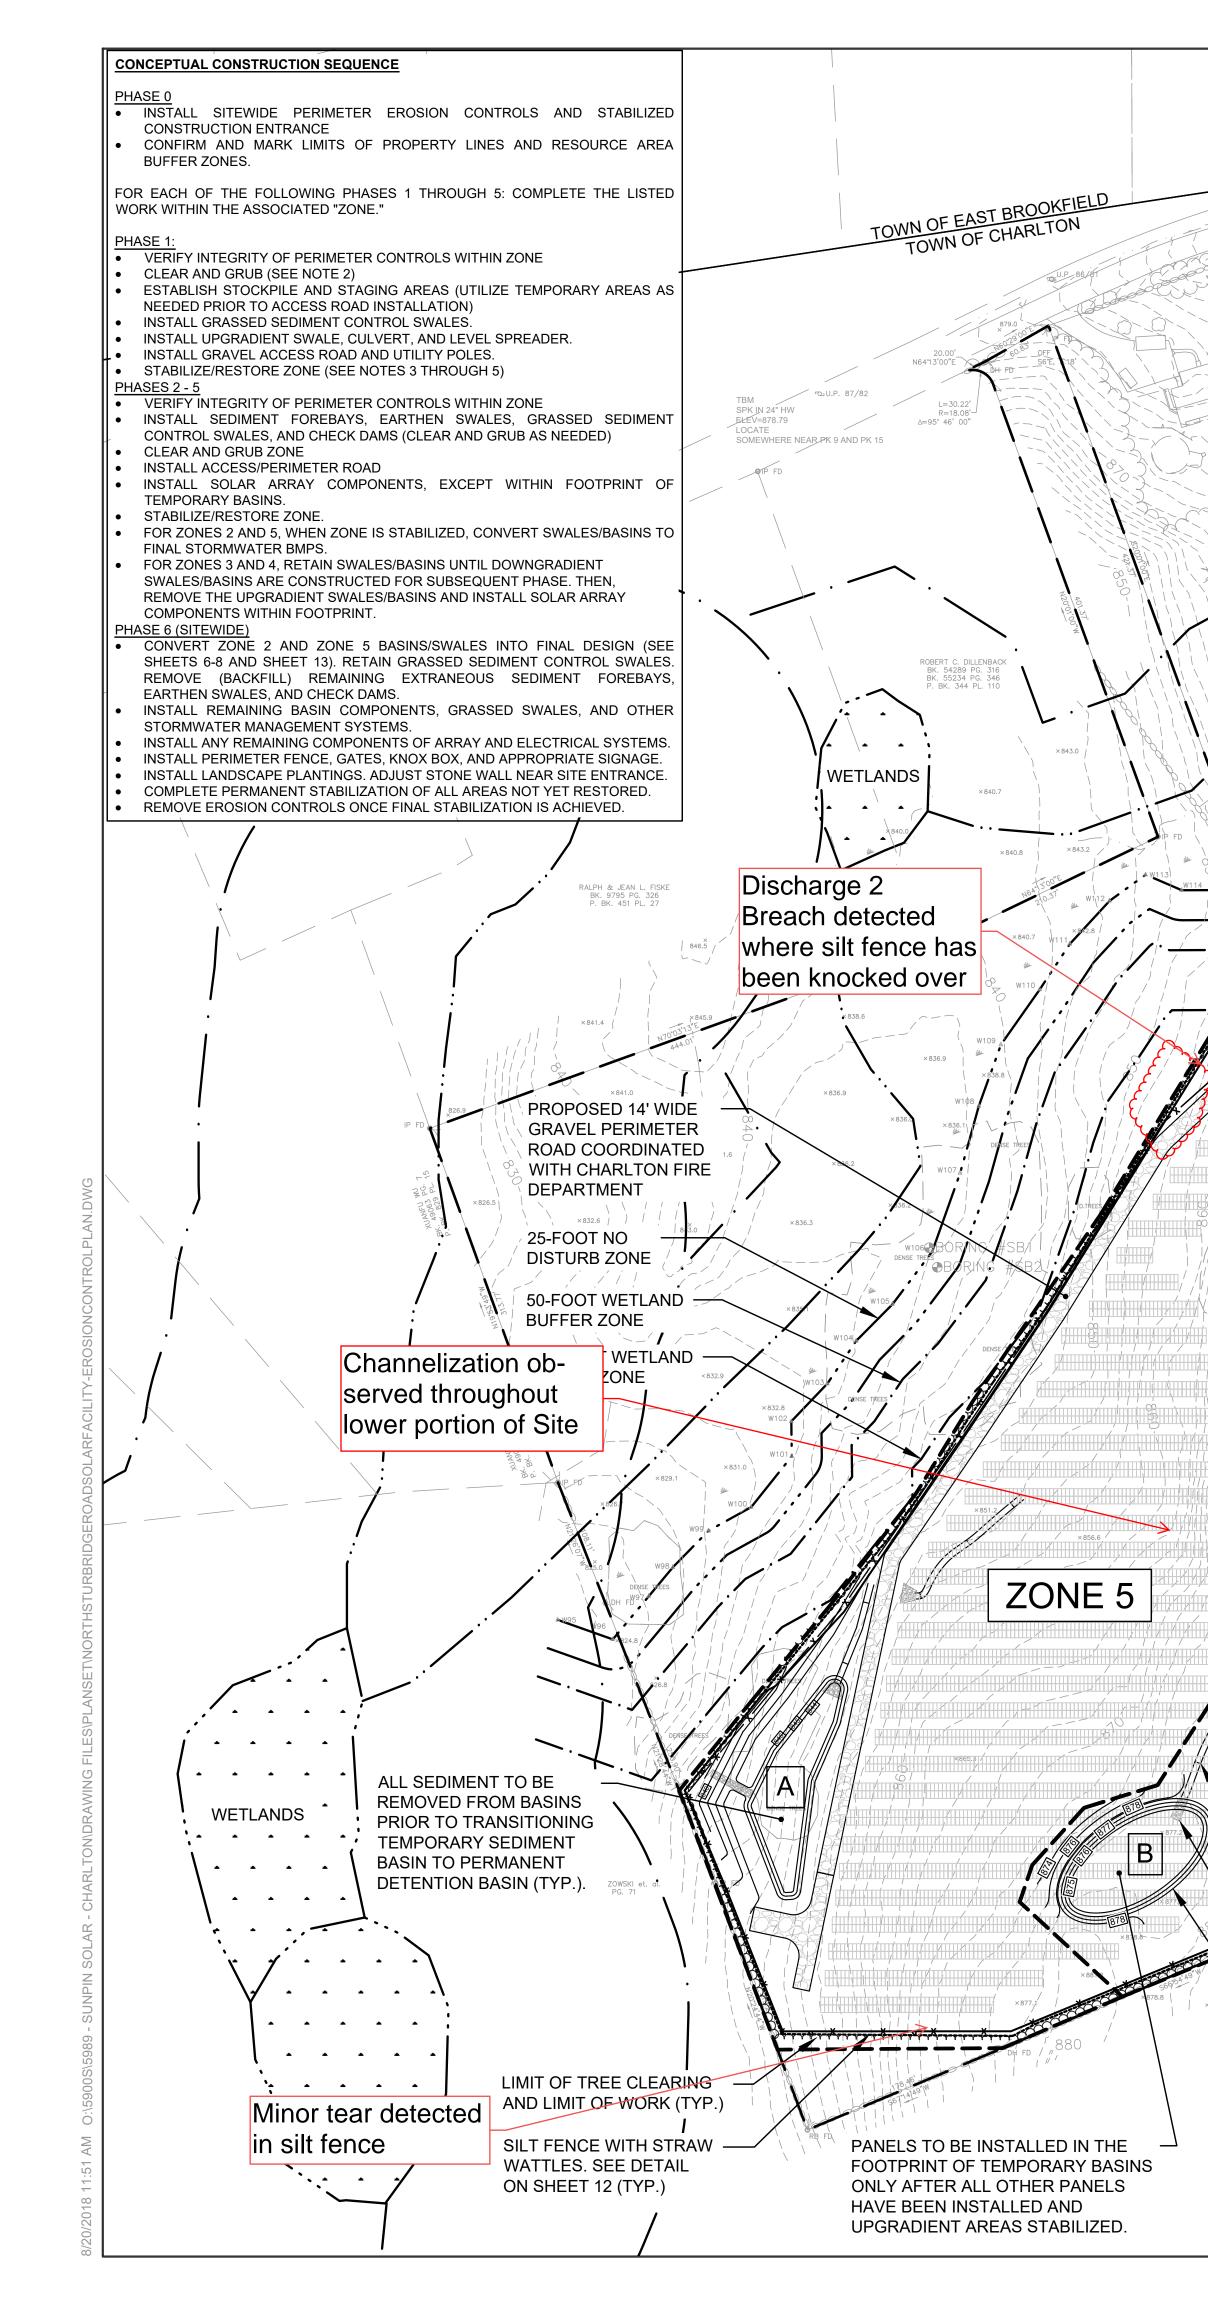
| Stabilization of Exposed Soil (CGP Part 2.2.14) | | | | | |
|---|---|---|---|--|--|
| 2. Informal access road along northern portion of the Site | Straw mulch or hydroseed | □Yes [Enter date] ⊠No | Erosion channels are beginning to form within upgradient<br>portions of the informal access road (Figure 1). The<br>contractor indicated that stabilization by smoothing out soils<br>and seeding or spreading mulch would occur on 7/30/2021.<br>Stabilization of this area has not been initiated. After<br>inspection of the area on 8/24/2021, it was determined that | | |

# Discharge 1 (ADDRESSED) ZONE Location of channelization within machinery tracks ZONE 2 F ZONE 3 ZONE 4

| nspection Date: 09/29/2021 | | | |
|---|---|---|---|
| | | | temporary swales would likely alleviate the issue of<br>channelization in this area; however, these swales will not be<br>constructed until work resumes at the Site in October<br>(pending local approval) This area will continue to be<br>monitored; however, stabilization is not required since the<br>area is not discharging sediment beyond the limits of work. |

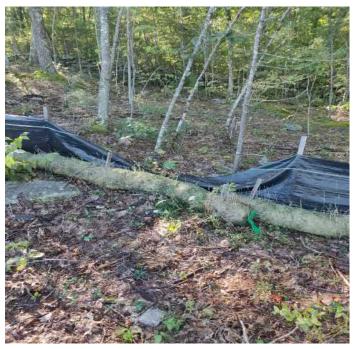
# Photo 3

| | Condition and Effectiveness of Erosion and Sediment (E&S) Controls (CGP Part 2.2) | | | | | |
|--|---|---|---|---|--|--|
| 1. Silt Fence and Straw Wattles | Yes (As of<br>9/2/2021) | No | 9/2/<br>2021 | A breach was observed at Discharge 2. Although the double row of<br>straw bales is intact, silt fence was observed to be knocked over<br>and signs of stormwater flow were detected in the area beyond the<br>fence.<br>A minor tear was identified in a section of silt fence on the southern<br>side of the Site with no erosion observed.<br>Minor degradation of a straw wattle was observed on the<br>southeastern side of the Site; no erosion was observed but pools of<br>water were found to be forming behind the straw wattle. | | |

View of the damaged silt fence in southern perimeter of Site —facing south.

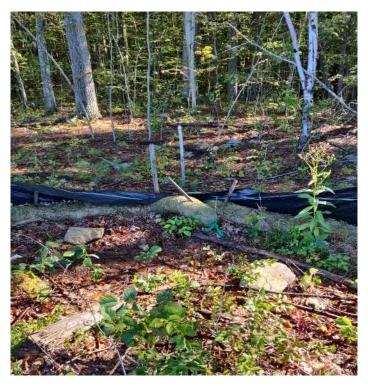
View of damaged silt fence in south east portion of the Site -facing south east
