Inspection Report for North Sturbridge Road Solar Facility

NPDES ID No.: MAR10031G

Inspection Date: 10/05/2021

PHOTOGRAPHIC DOCUMENTATION
North Sturbridge Road Solar Facility
Charlton, Massachusetts
Photographs Documented 10.05.2021

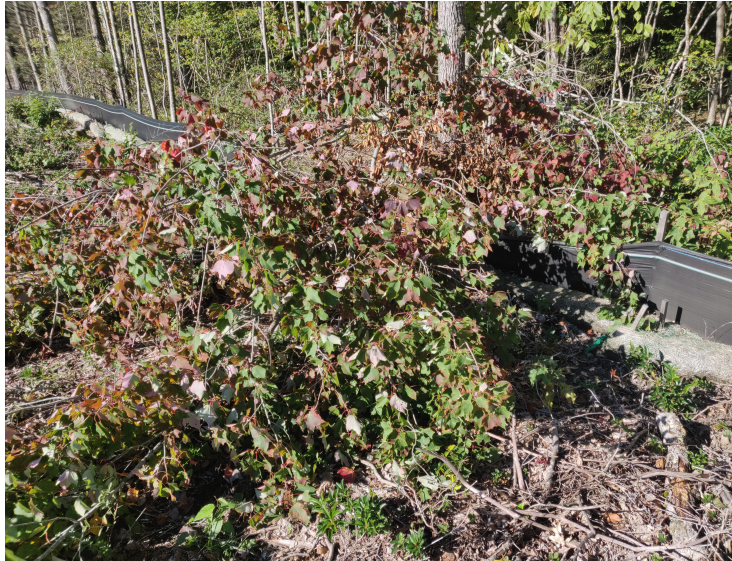
Photo 1

2. Stabilized Construction Entrance (Site Entrance – Access Road)	No (As of 9/2/2021)	No		<p>A tree was knocked over and laying on the silt fence on the on the northwestern portion of the site in Zone 5.</p> <p>Hydroseed was applied to exposed soil in this area and continues to germinate, some grass seedlings are now observed.</p>

View of tree fallen on northwestern portion of Zone 5.

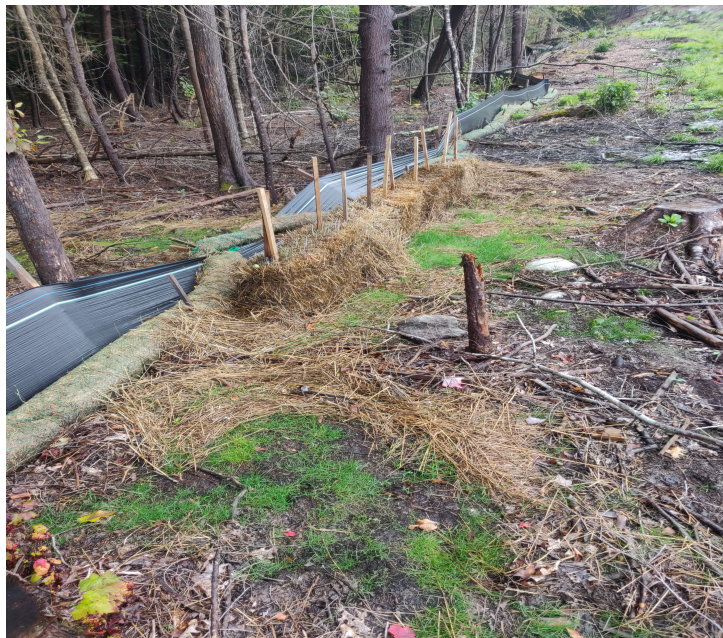
Photo 2

Type/Location of E&S Control	Maintenance Needed?*			
1. Silt Fence and Straw Wattles	Yes (As of 9/2/2021)	No	9/2/2021	<p>A breach was observed at Discharge 2. Although the double row of straw bales is intact, silt fence was observed to be knocked over and signs of stormwater flow were detected in the area beyond the fence.</p> <p>A minor tear was identified in a section of silt fence on the southern side of the Site with no erosion observed.</p> <p>Minor degradation of a straw wattle was observed on the southeastern side of the Site; no erosion was observed but pools of water were found to be forming behind the straw wattle.</p>

View of area downgradient of Discharge 2—facing north west.

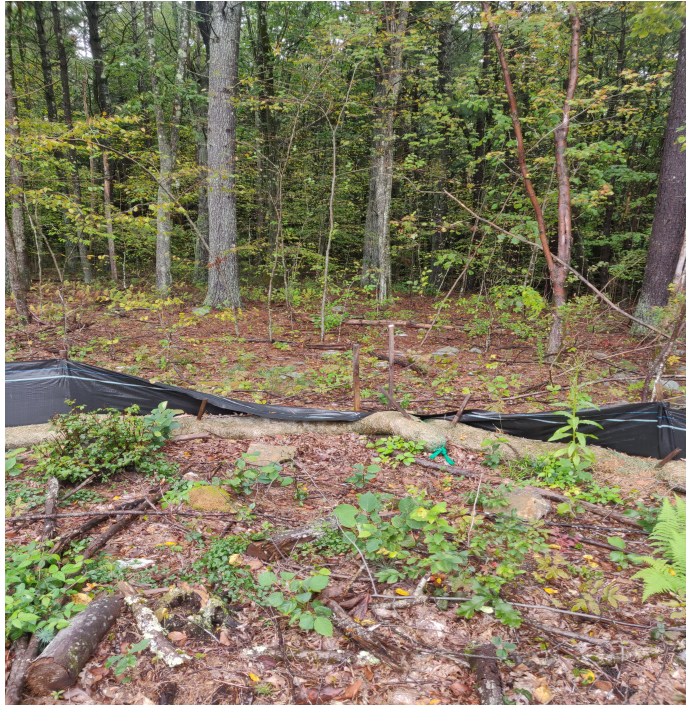
Photo 3

View of the damaged silt fence in southern perimeter of Site —facing south.

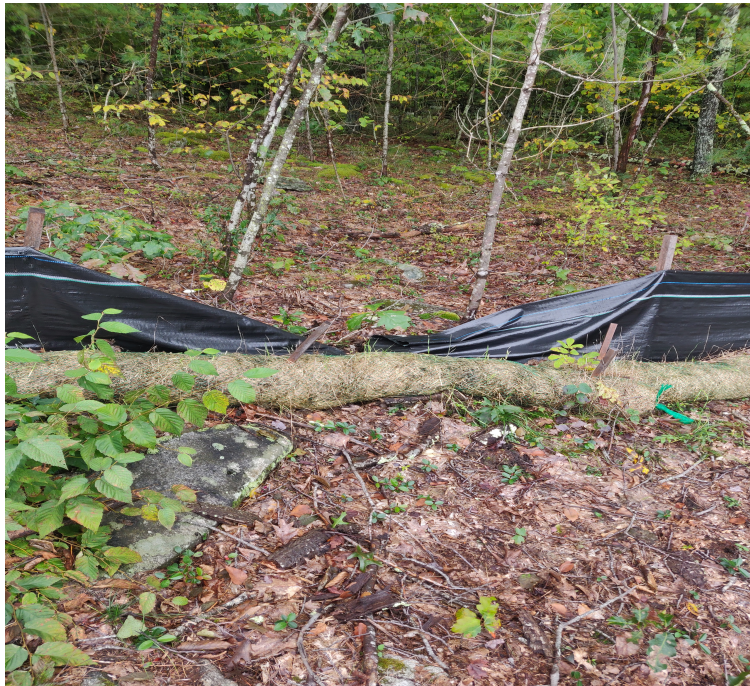
View of damaged silt fence in south east portion of the Site —facing south east
