#### Inspection Report for North Sturbridge Road Solar Facility NPDES ID No.: MAR10031G Inspection Date: 10/05/2021

PHOTOGRAPHIC DOCUMENTATION North Sturbridge Road Solar Facility Charlton, Massachusetts Photographs Documented 10.18.2021

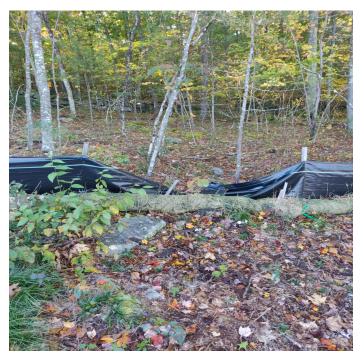
### Photo 3

View of the damaged silt fence in southern perimeter of Site —facing south.

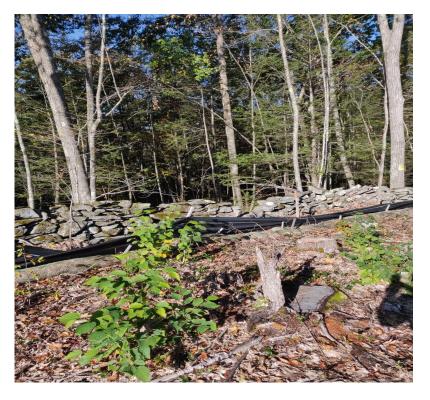
View of damaged silt fence in south west portion of the Site -facing south west

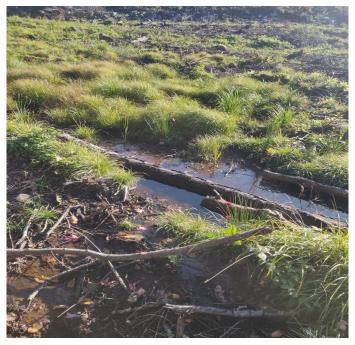
# Photo 3

Condition and Effectiveness of Erosion and Sediment (E&S) Controls (CGP Part 2.2)					
Type/Location of E&S Control	Maintenance Needed?*					
1. Silt Fence and Straw Wattles	Yes (As of 9/2/2021)	No	9/2/ 2021	A breach was observed at Discharge 2. Although the double row of straw bales is intact, silt fence was observed to be knocked over and signs of stormwater flow were detected in the area beyond the fence. A minor tear was identified in a section of silt fence on the southern side of the Site with no erosion observed. Minor degradation of a straw wattle was observed on the southeastern side of the Site; no erosion was observed but pools of water were found to be forming behind the straw wattle.

View of the water pooling in western perimeter of Site —facing east.
