Inspection Report for North Sturbridge Road Solar Facility

NPDES ID No.: MAR10031G

Inspection Date: 10/18/2021

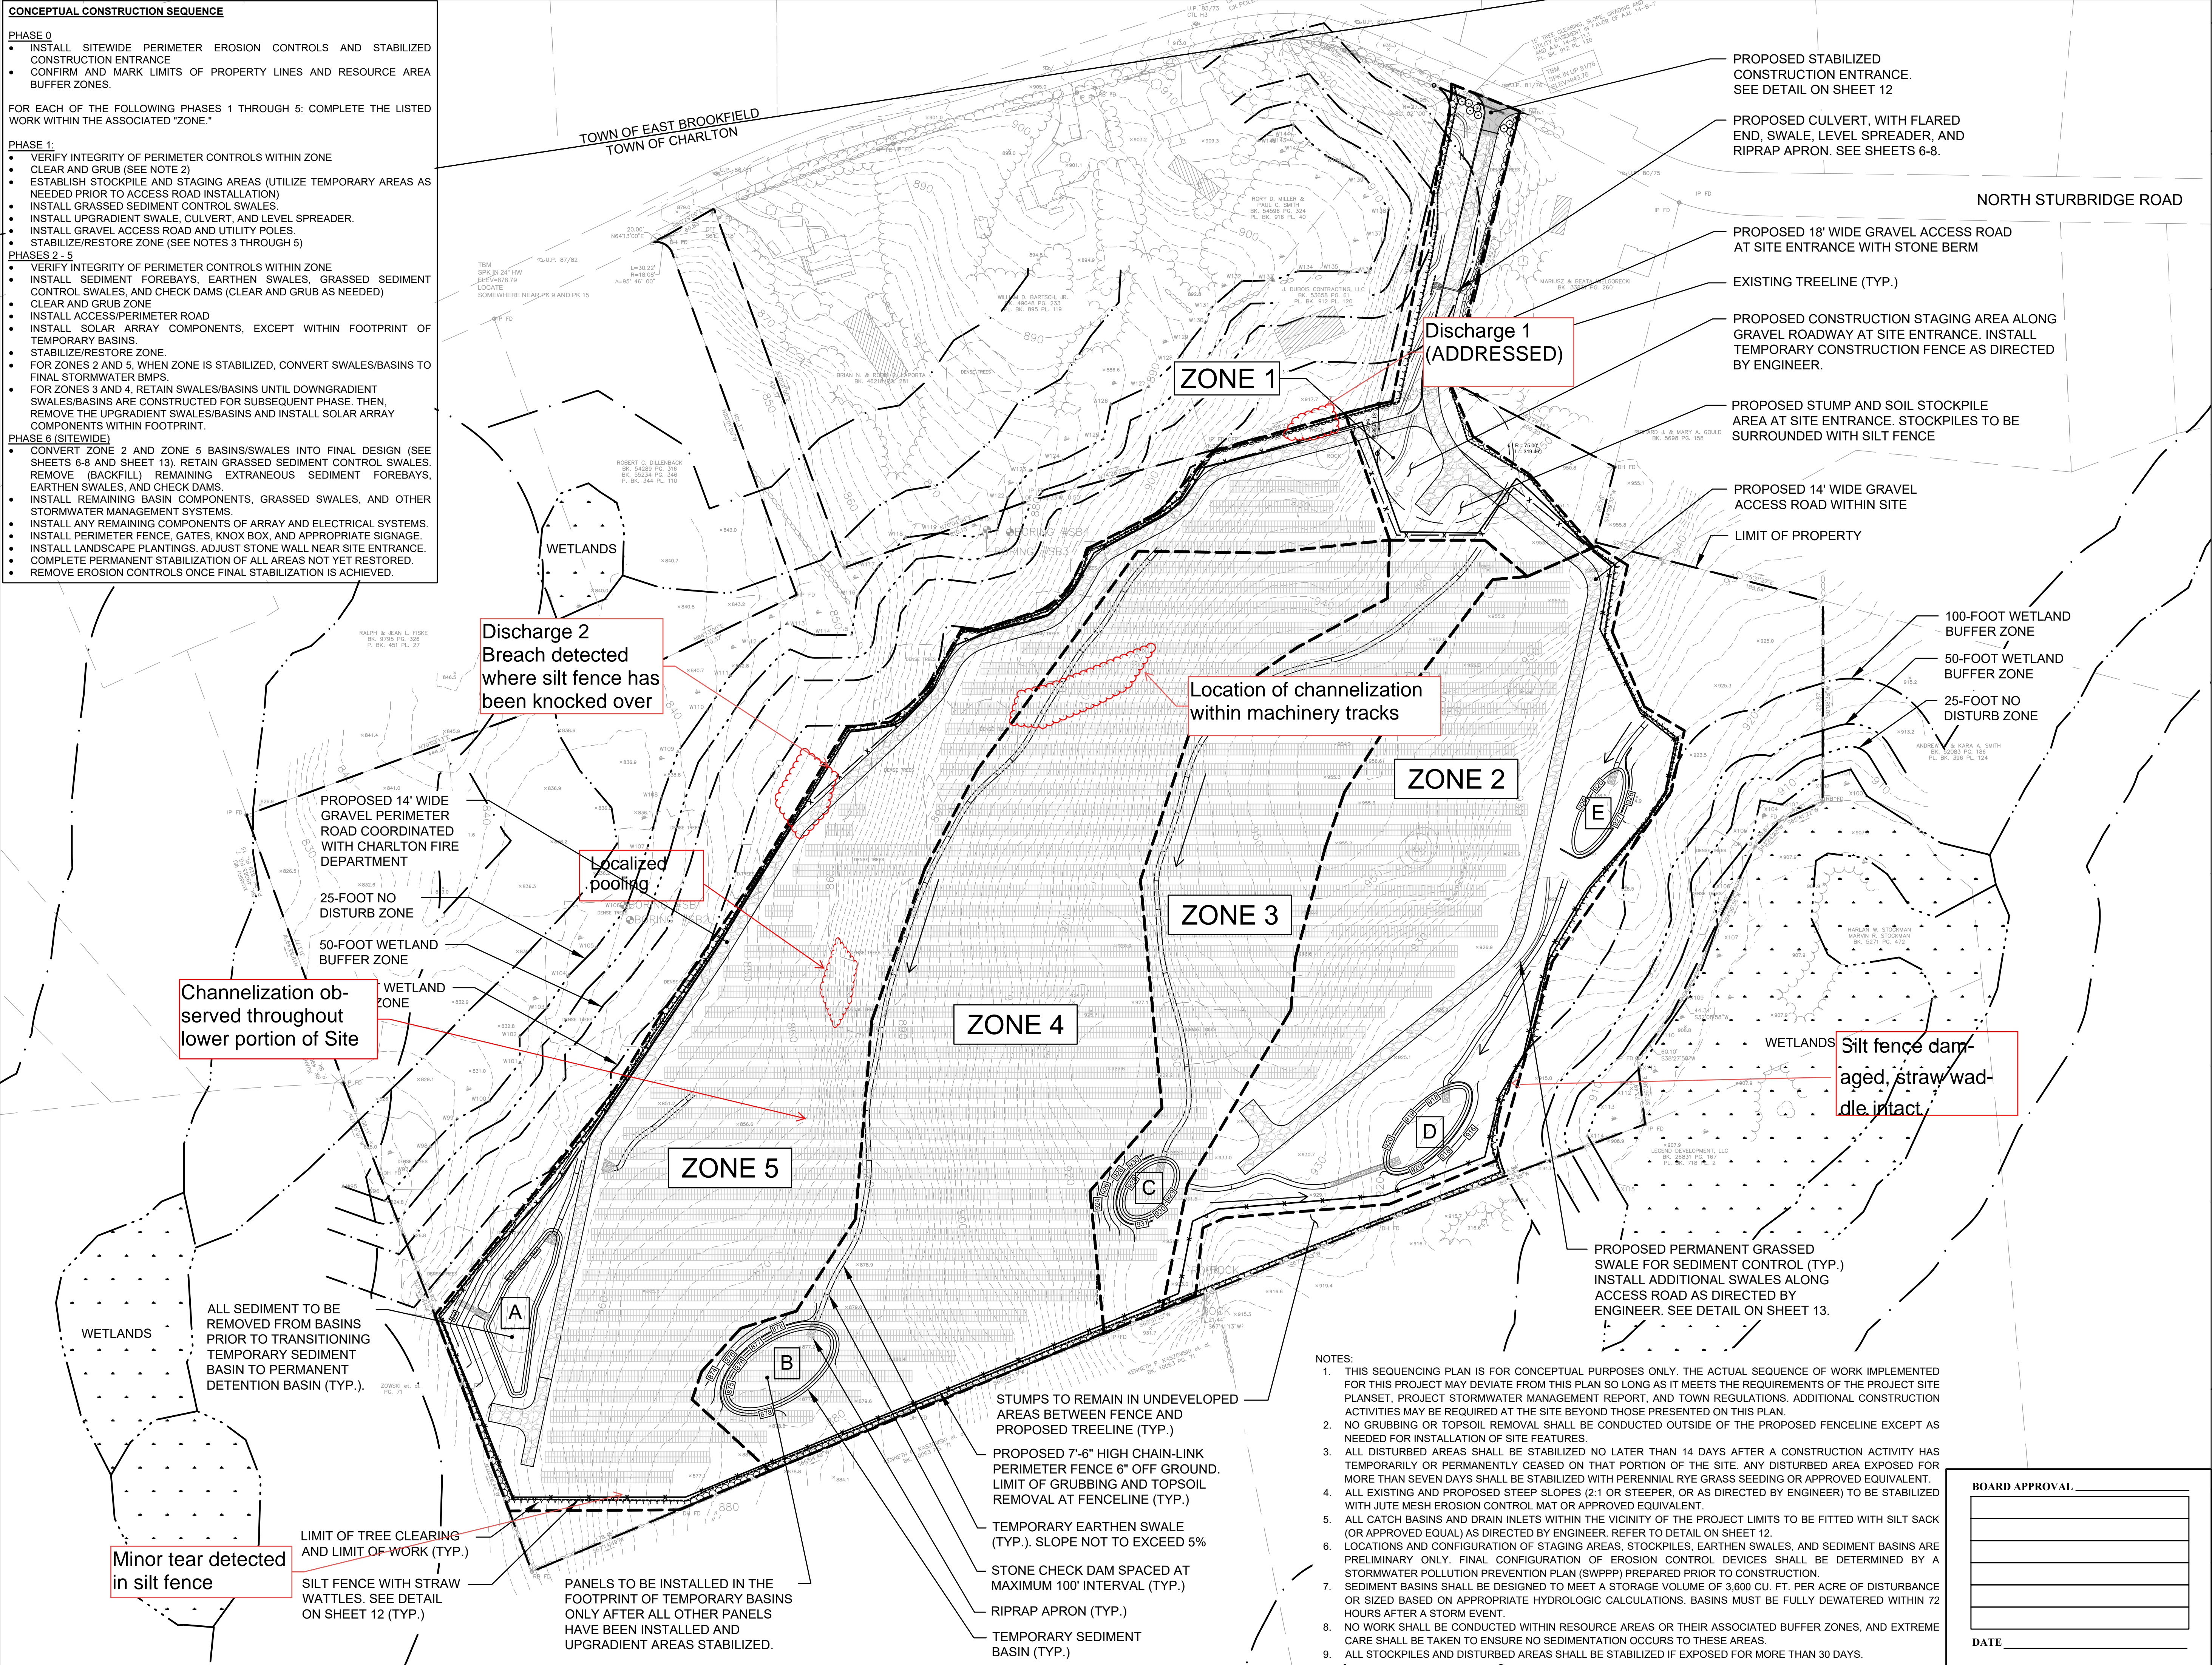
FIGURE 1: SWPPP INSPECTION SKETCH 10/18/2021

2. Informal access road along northern portion of the Site	Straw mulch or hydroseed	<input type="checkbox"/> Yes [Enter date] <input checked="" type="checkbox"/> No	Erosion channels are beginning to form within upgradient portions of the informal access road (Figure 1). The contractor indicated that stabilization by smoothing out soils and seeding or spreading mulch would occur on 7/30/2021. Stabilization of this area has not been initiated. After inspection of the area on 8/24/2021, it was determined that

Silt fence damaged, straw wad-dle intact

Minor tear detected in silt fence

Channelization observed throughout lower portion of Site

Localized pooling

Location of channelization within machinery tracks

Discharge 2 Breach detected where silt fence has been knocked over

Discharge 1 (ADDRESSSED)

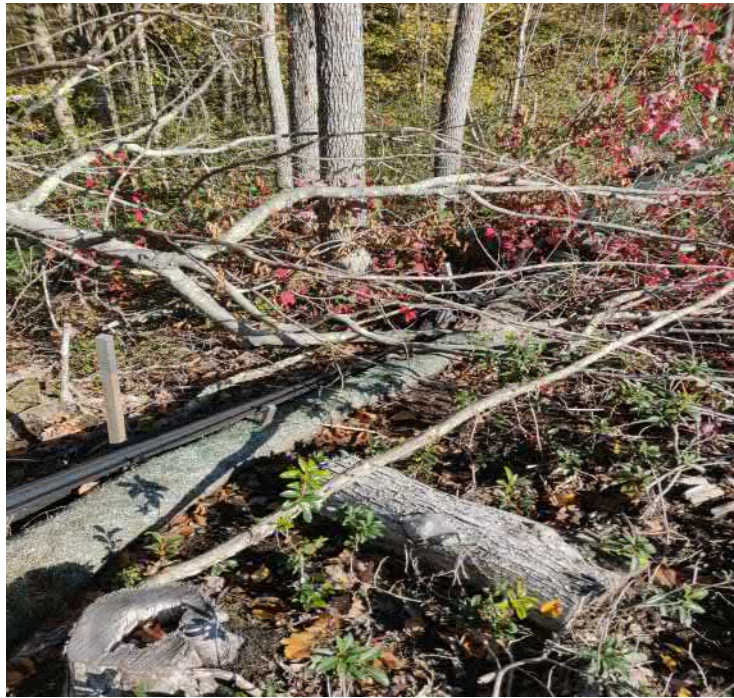
Photo 1

2. Stabilized Construction Entrance (Site Entrance – Access Road)	No (As of 9/2/2021)	No		<p>A tree was knocked over and laying on the silt fence on the on the northwestern portion of the site in Zone 5.</p> <p>Hydroseed was applied to exposed soil in this area and continues to germinate, some grass seedlings are now observed.</p>

View of tree fallen on northwestern portion of Zone 5.

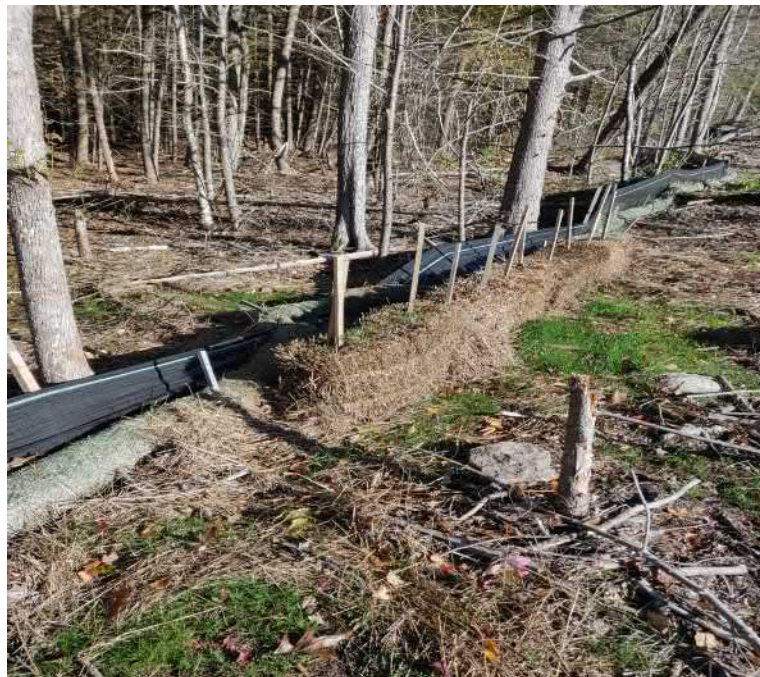
Photo 2

View of area downgradient of Discharge 2—facing north west.

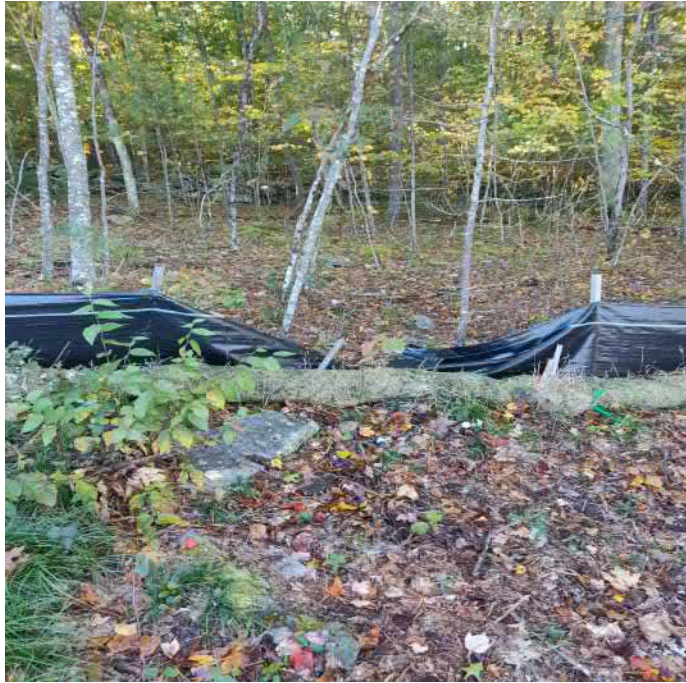
Photo 3

View of the damaged silt fence in southern perimeter of Site —facing south.

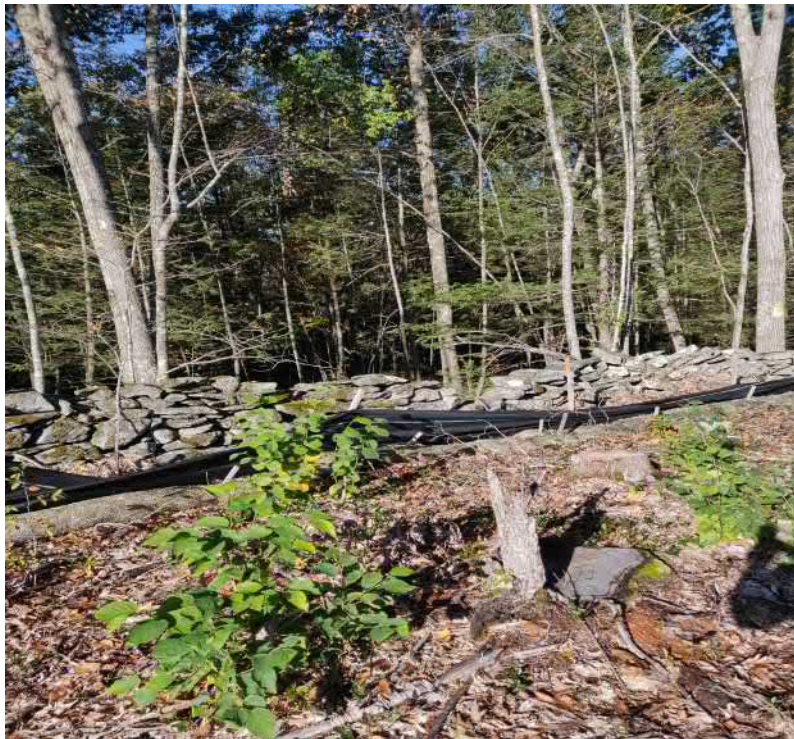
Photo 4

View of damaged silt fence in south west portion of the Site —facing south west

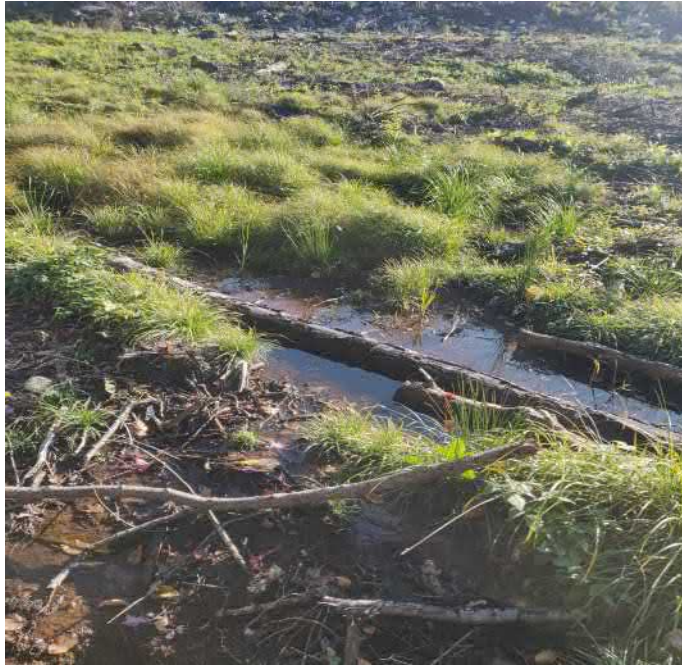
Photo 5

View of the water pooling in western perimeter of Site —facing east.
