Inspection Report for North Sturbridge Road Solar Facility

NPDES ID No.: MAR10031G

Inspection Date: 10/29/2021

PHOTOGRAPHIC DOCUMENTATION
North Sturbridge Road Solar Facility
Charlton, Massachusetts
Photographs Documented 10.29.2021

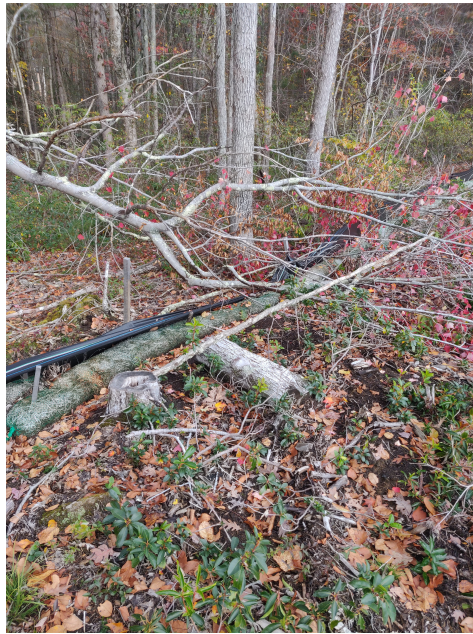
Photo 1

2. Stabilized Construction Entrance (Site Entrance – Access Road)	No (As of 9/2/2021)	No		<p>A tree was knocked over and laying on the silt fence on the on the northwestern portion of the site in Zone 5.</p> <p>Hydroseed was applied to exposed soil in this area and continues to germinate, some grass seedlings are now observed.</p>

View of tree fallen on northwestern portion of Zone 5.

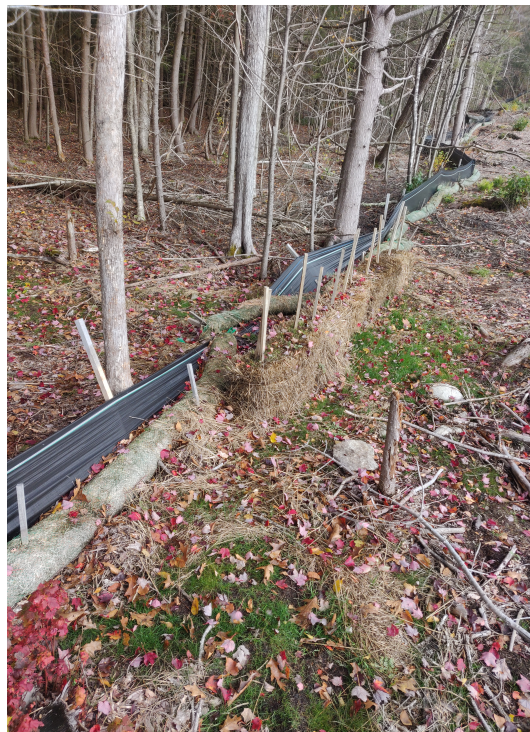
Photo 2

Type/Location of E&S Control	Maintenance Needed?*			
1. Silt Fence and Straw Wattles	Yes (As of 9/2/2021)	No	9/2/2021	<p>A breach was observed at Discharge 2. Although the double row of straw bales is intact, silt fence was observed to be knocked over and signs of stormwater flow were detected in the area beyond the fence.</p> <p>A minor tear was identified in a section of silt fence on the southern side of the Site with no erosion observed.</p> <p>Minor degradation of a straw wattle was observed on the southeastern side of the Site; no erosion was observed but pools of water were found to be forming behind the straw wattle.</p>

View of area downgradient of Discharge 2—facing north west.

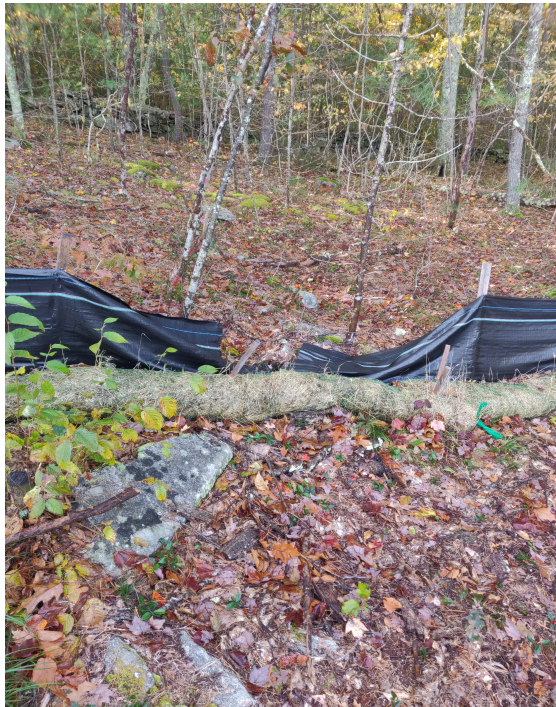
Photo 3

View of the damaged silt fence in southern perimeter of Site —facing south.

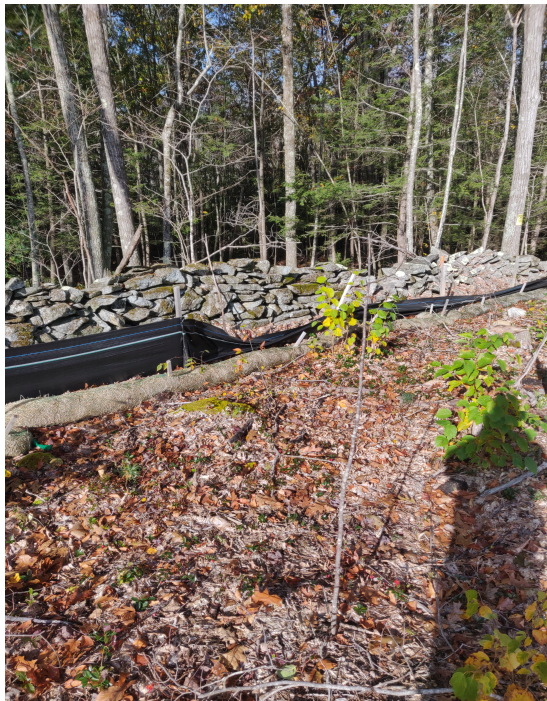
Photo 4

View of damaged silt fence in south west portion of the Site —facing south west

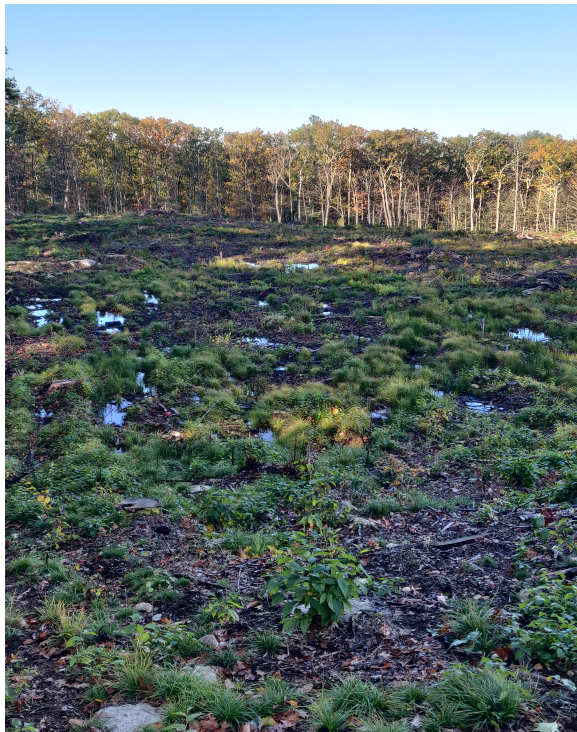
Photo 5

7. Topsoil Re-Use	N/A	N/A	10/05/ 2021	observed within areas of disturbed soils within the limits of work; however, little to no germination was observed within the disturbed area downgradient of the limit of work. Additional seed should be hand-applied in this area.
8. Storm Drain Inlets (North Brookfield Road)	N/A	N/A		The areas downgradient of Discharges 1 and 2 have been stabilized with straw and seed. These areas will be monitored for germination and stabilization.
9. Temporary Drainage Swales (Throughout Site)	N/A	N/A	10/29/ 2021	Seedling growth is observed
10. Temporary Sediment Basins	N/A	N/A		Localized pooling is observed in the eastern portion of the site.

View of the water pooling in eastern perimeter of Site —facing south east.

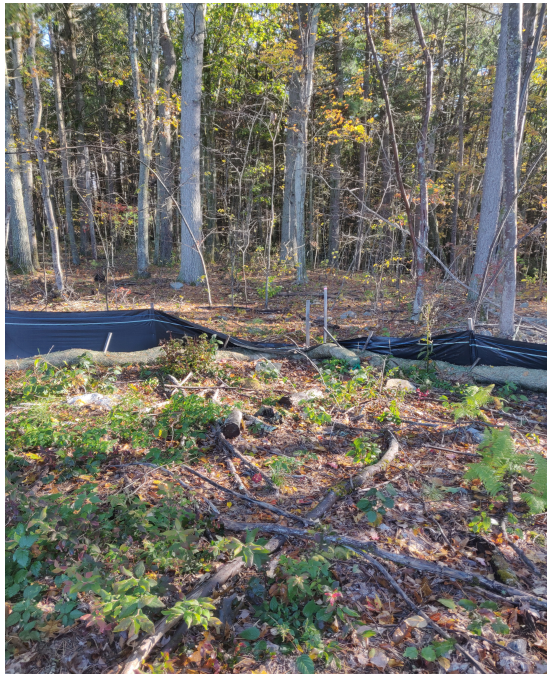
Photo 6

View of damaged silt fence in south east portion of the Site —facing south east

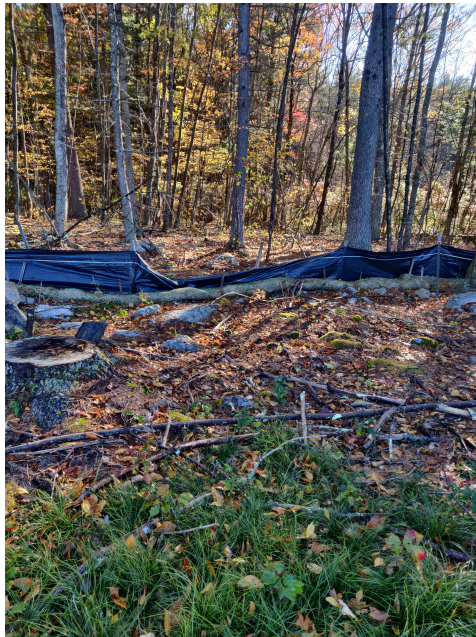
Photo 7

3. Stump and Soil Stockpile Area	No (As of 7/22/2021)	No	10/29/2021	<p>Minor tears were observed in the silt fence along the eastern boundaries of the Site, due to staples becoming dislodged from wooden stakes. The straw wattles are still intact.</p>

View of damaged silt fence in eastern portion of the Site —facing east

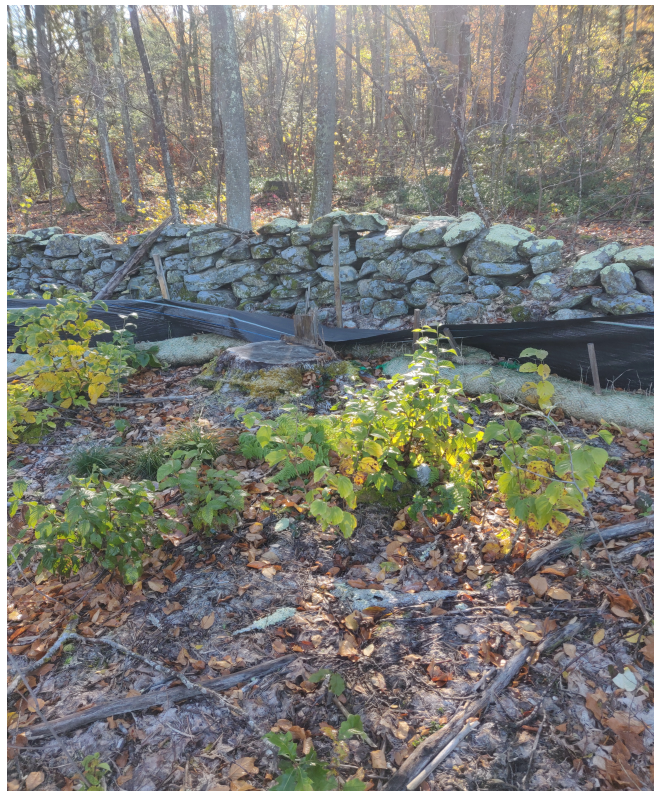
Photo 8

View of damaged silt fence in eastern portion of the Site —facing east

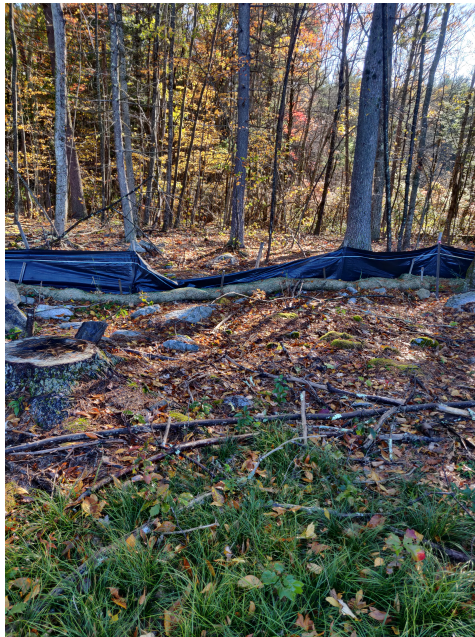
Photo 9

View of damaged silt fence in eastern portion of the Site —facing east

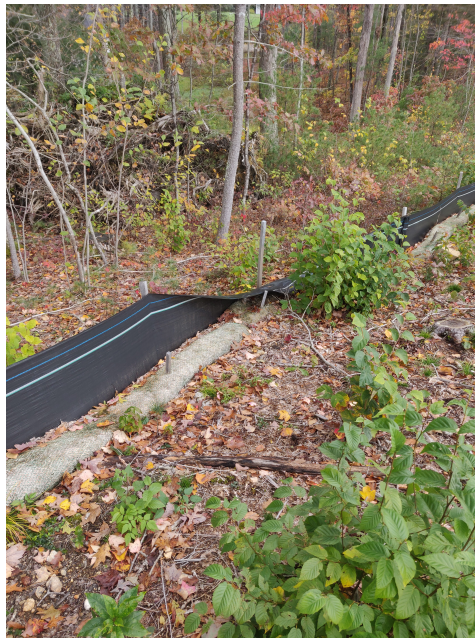
Photo 10

View of damaged silt fence in north western portion of the Site —facing north west
