Inspection Report for North Sturbridge Road Solar Facility

NPDES ID No.: MAR10031G

Inspection Date: 10/29/2021

**FIGURE 1:
SWPPP
INSPECTION
SKETCH
10/29/2021**

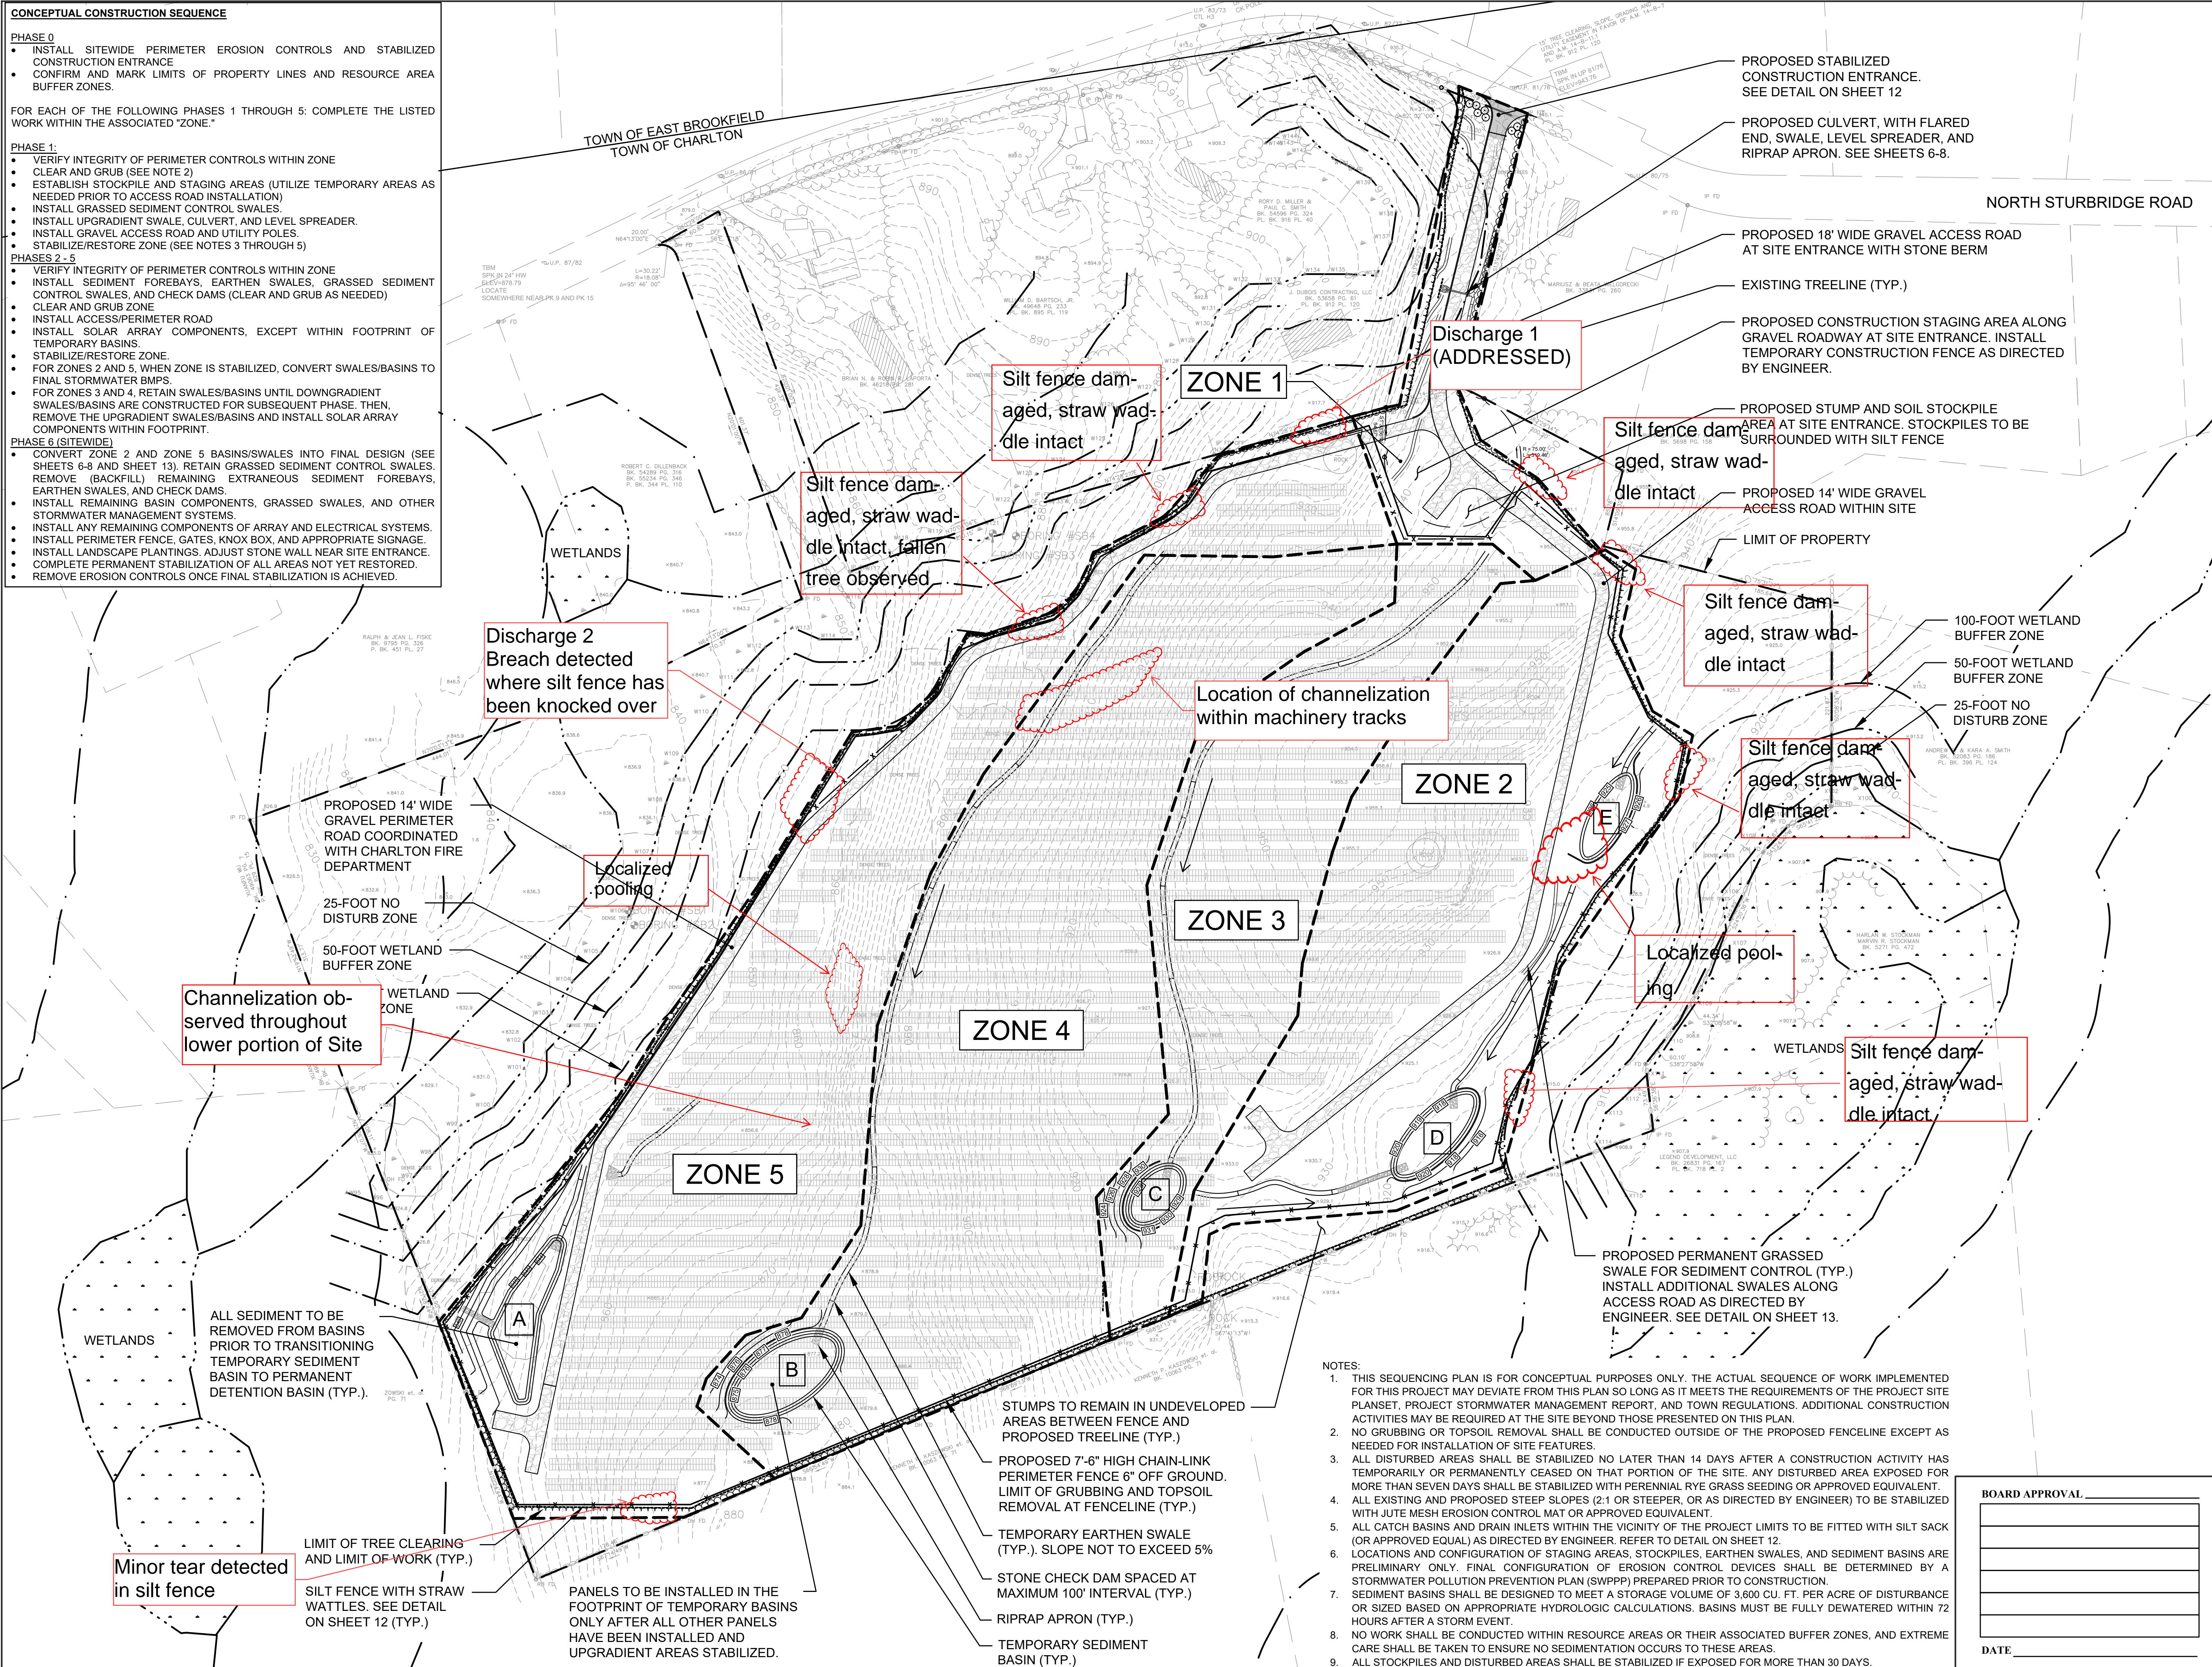
2. Informal access road along northern portion of the Site	Straw mulch or hydroseed	<input type="checkbox"/> Yes [Enter date] <input checked="" type="checkbox"/> No	Erosion channels are beginning to form within upgradient portions of the informal access road (Figure 1). The contractor indicated that stabilization by smoothing out soils and seeding or spreading mulch would occur on 7/30/2021. Stabilization of this area has not been initiated. After inspection of the area on 8/24/2021, it was determined that

Minor tear detected in silt fence

Channelization observed throughout lower portion of Site

Localized pooling

Location of channelization within machinery tracks

Silt fence damaged, straw wattle intact, fallen tree observed

Silt fence damaged, straw wattle intact

Discharge 2 Breach detected where silt fence has been knocked over

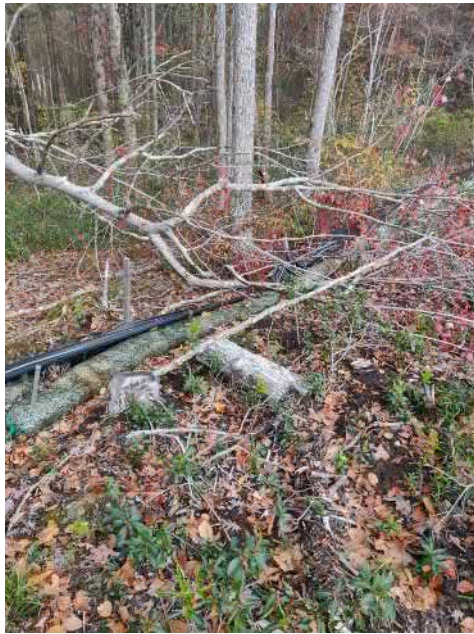
Photo 1

2. Stabilized Construction Entrance (Site Entrance – Access Road)	No (As of 9/2/2021)	No		<p>A tree was knocked over and laying on the silt fence on the on the northwestern portion of the site in Zone 5.</p> <p>Hydroseed was applied to exposed soil in this area and continues to germinate, some grass seedlings are now observed.</p>

View of tree fallen on northwestern portion of Zone 5.

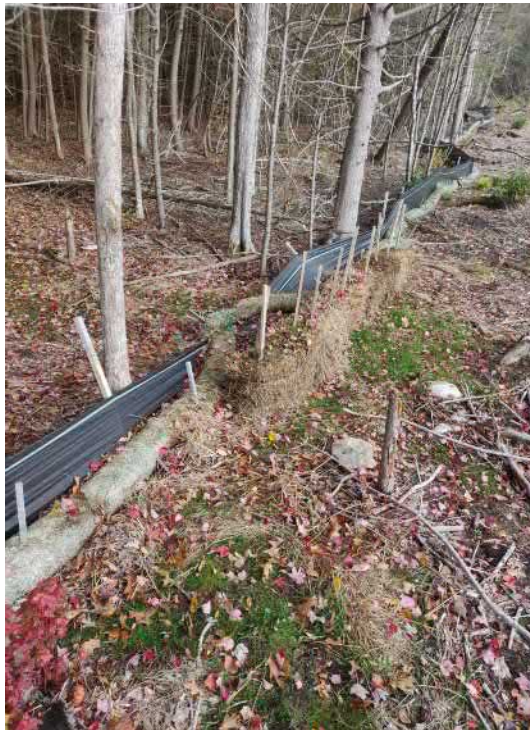
Photo 2

Type/Location of E&S Control	Maintenance Needed?*			
1. Silt Fence and Straw Wattles	Yes (As of 9/2/2021)	No	9/2/2021	<p>A breach was observed at Discharge 2. Although the double row of straw bales is intact, silt fence was observed to be knocked over and signs of stormwater flow were detected in the area beyond the fence.</p> <p>A minor tear was identified in a section of silt fence on the southern side of the Site with no erosion observed.</p> <p>Minor degradation of a straw wattle was observed on the southeastern side of the Site; no erosion was observed but pools of water were found to be forming behind the straw wattle.</p>

View of area downgradient of Discharge 2—facing north west.

Discharge Location	Observations
<p>Discharge 1</p>	<p>Describe the discharge: Breach in silt fence allowed runoff to bypass erosion controls.</p> <p>At points of discharge and the channels and banks of surface waters in the immediate vicinity, are there any visible signs of erosion and/or sediment accumulation that can be attributed to your discharge? <input checked="" type="checkbox"/> Yes <input type="checkbox"/> No</p> <p>If yes, describe what you see, specify the location(s) where these conditions were found, and indicate whether modification, maintenance, or corrective action is needed to resolve the issue: Small areas of bare soil observed in area immediately beyond perimeter controls. Repairs to erosion controls and re-seeding of damaged areas is required.</p>

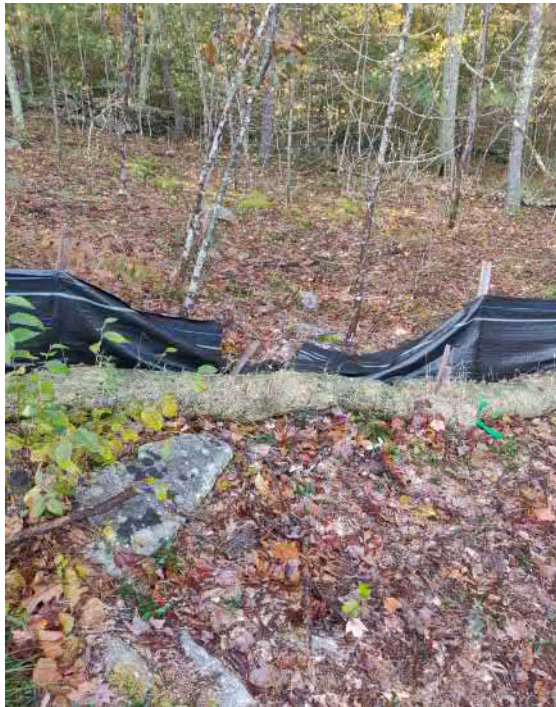
Photo 3

View of the damaged silt fence in southern perimeter of Site —facing south.

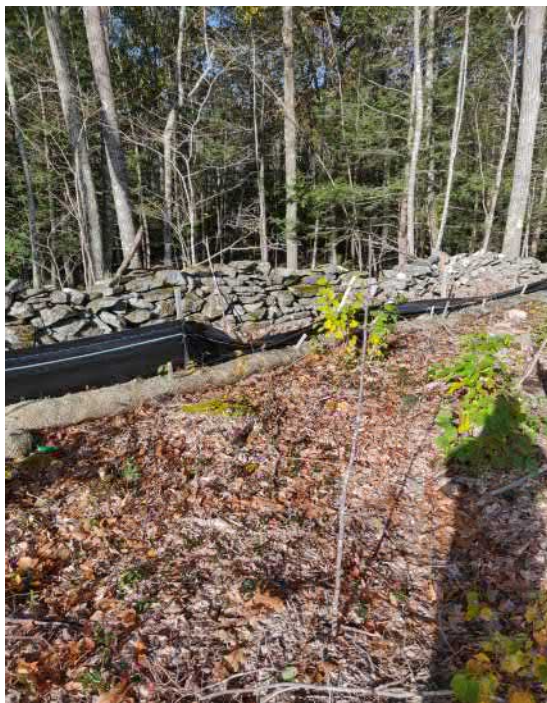
Photo 4

View of damaged silt fence in south west portion of the Site —facing south west

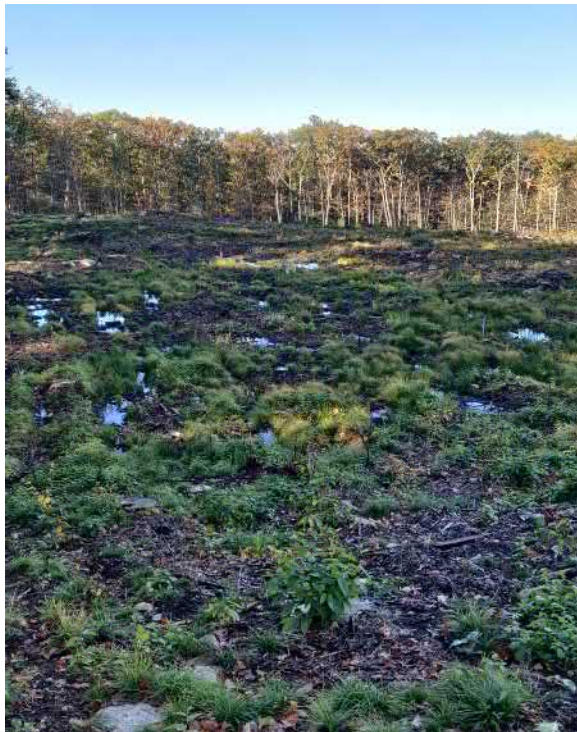
Photo 5

7. Topsoil Re-Use	N/A	N/A	10/05/ 2021	observed within areas of disturbed soils within the limits of work; however, little to no germination was observed within the disturbed area downgradient of the limit of work. Additional seed should be hand-applied in this area.
8. Storm Drain Inlets (North Brookfield Road)	N/A	N/A		The areas downgradient of Discharges 1 and 2 have been stabilized with straw and seed. These areas will be monitored for germination and stabilization.
9. Temporary Drainage Swales (Throughout Site)	N/A	N/A	10/29/ 2021	Seedling growth is observed
10. Temporary Sediment Basins	N/A	N/A		Localized pooling is observed in the eastern portion of the site.

View of the water pooling in eastern perimeter of Site —facing south east.

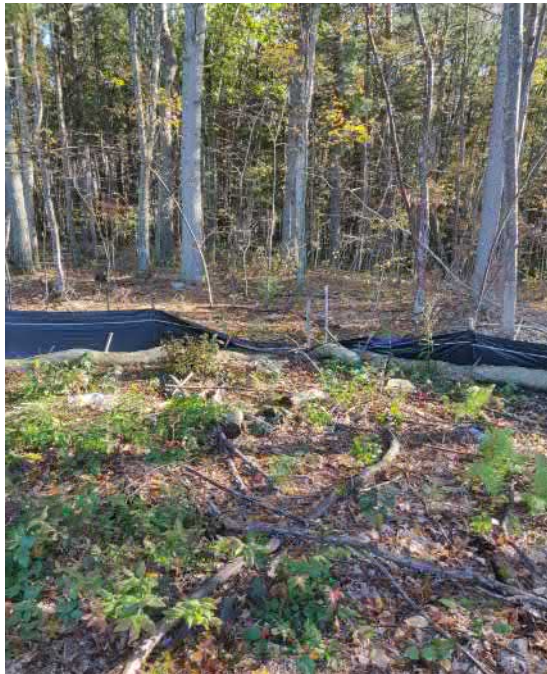
Photo 6

View of damaged silt fence in south east portion of the Site —facing south east

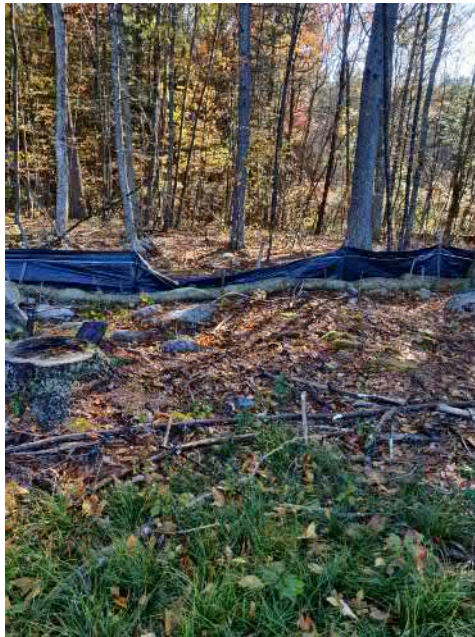
Photo 7

3. Stump and Soil Stockpile Area	No (As of 7/22/2021)	No	10/29/2021	<p>Minor tears were observed in the silt fence along the eastern boundaries of the Site, due to staples becoming dislodged from wooden stakes. The straw wattles are still intact.</p>

View of damaged silt fence in eastern portion of the Site —facing east

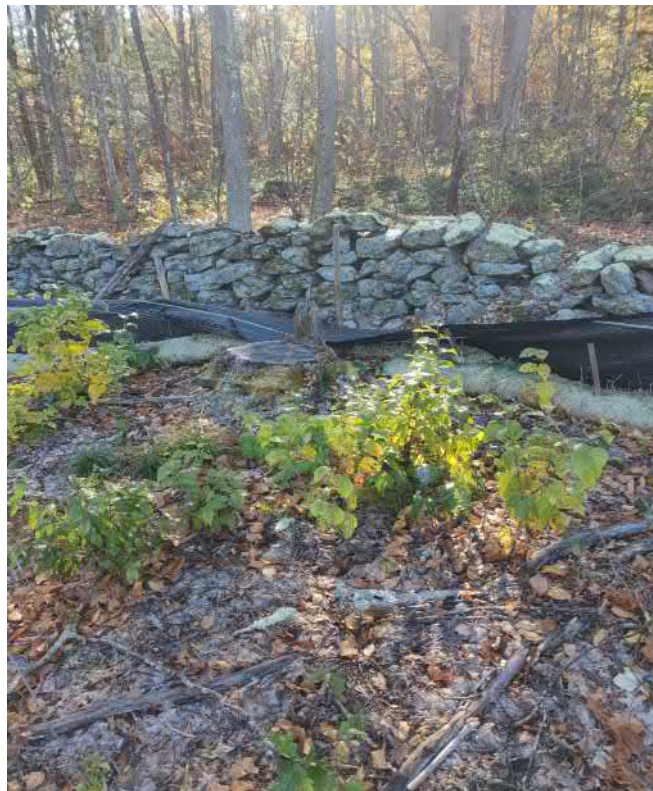
Photo 8

View of damaged silt fence in eastern portion of the Site —facing east

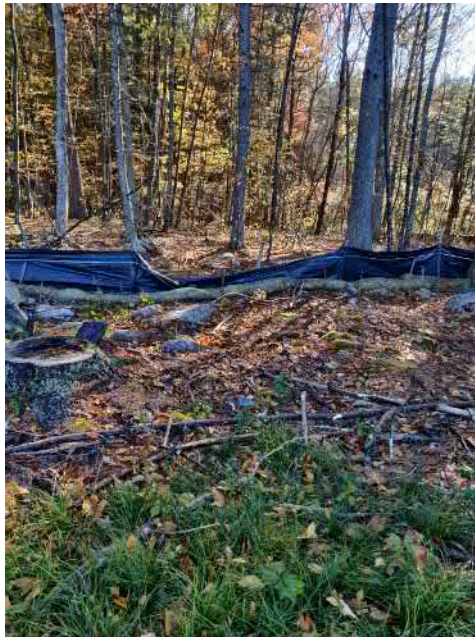
Photo 9

View of damaged silt fence in eastern portion of the Site —facing east

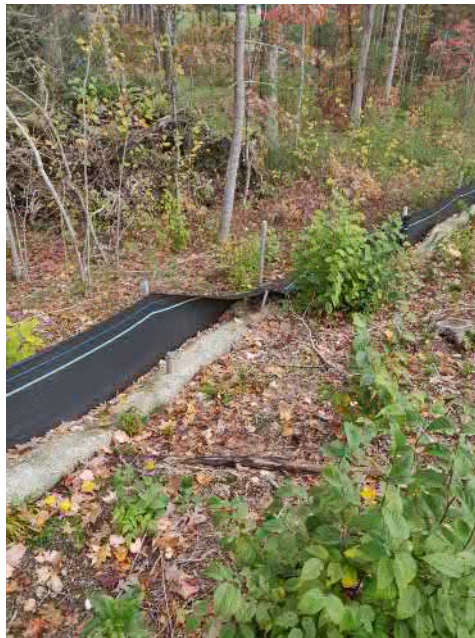
Photo 10

View of damaged silt fence in north western portion of the Site —facing north west
