Inspection Report for North Sturbridge Road Solar Facility

NPDES ID No.: MAR10031G

Inspection Date: 11/01/2021

PHOTOGRAPHIC DOCUMENTATION
North Sturbridge Road Solar Facility
Charlton, Massachusetts
Photographs Documented 11.01.2021

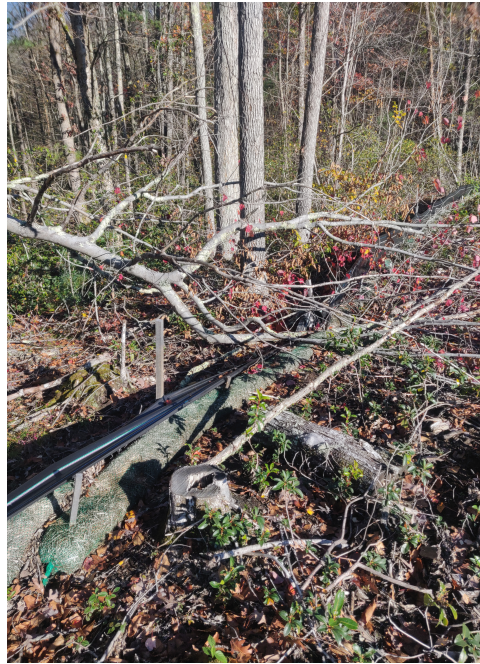
Photo 1

2. Stabilized Construction Entrance (Site Entrance – Access Road)	No (As of 9/2/2021)	No		<p>A tree was knocked over and laying on the silt fence on the on the northwestern portion of the site in Zone 5.</p> <p>Hydroseed was applied to exposed soil in this area and continues to germinate, some grass seedlings are now observed.</p>

View of tree fallen on northwestern portion of Zone 5.

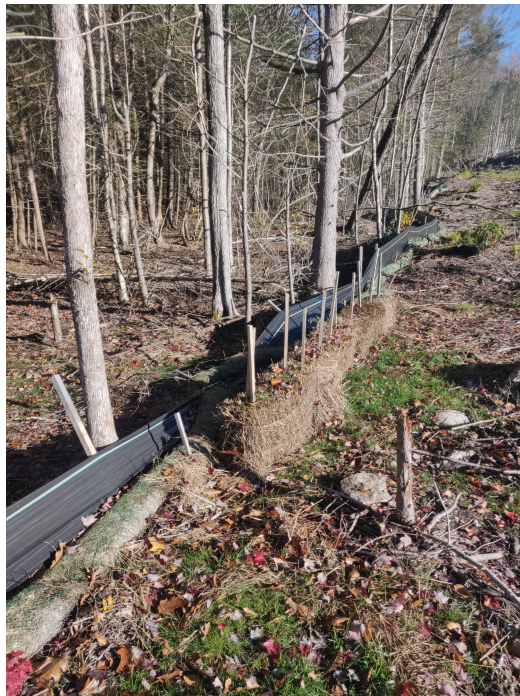
Photo 2

Type/Location of E&S Control	Maintenance Needed?*			
1. Silt Fence and Straw Wattles	Yes (As of 9/2/2021)	No	9/2/2021	<p>A breach was observed at Discharge 2. Although the double row of straw bales is intact, silt fence was observed to be knocked over and signs of stormwater flow were detected in the area beyond the fence.</p> <p>A minor tear was identified in a section of silt fence on the southern side of the Site with no erosion observed.</p> <p>Minor degradation of a straw wattle was observed on the southeastern side of the Site; no erosion was observed but pools of water were found to be forming behind the straw wattle.</p>

View of area downgradient of Discharge 2—facing north west.

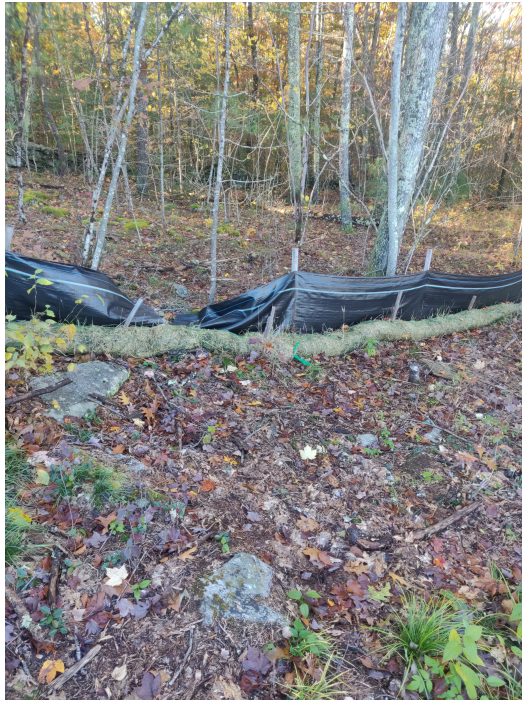
Photo 3

View of the damaged silt fence in southern perimeter of Site —facing south.

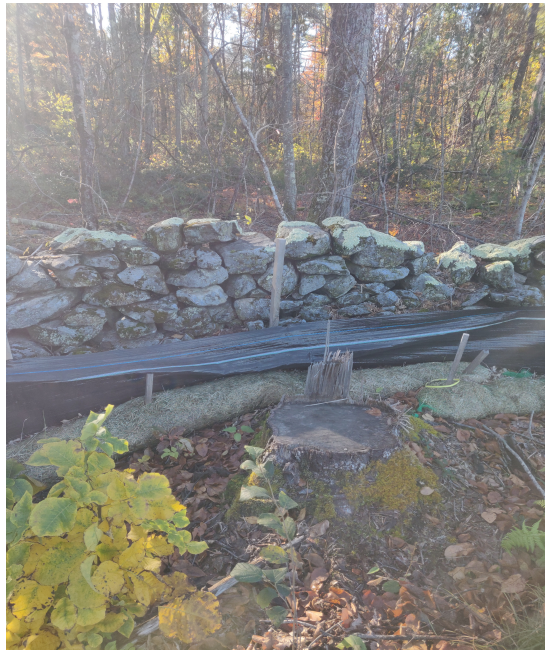
Photo 4

View of damaged silt fence in south west portion of the Site —facing south west

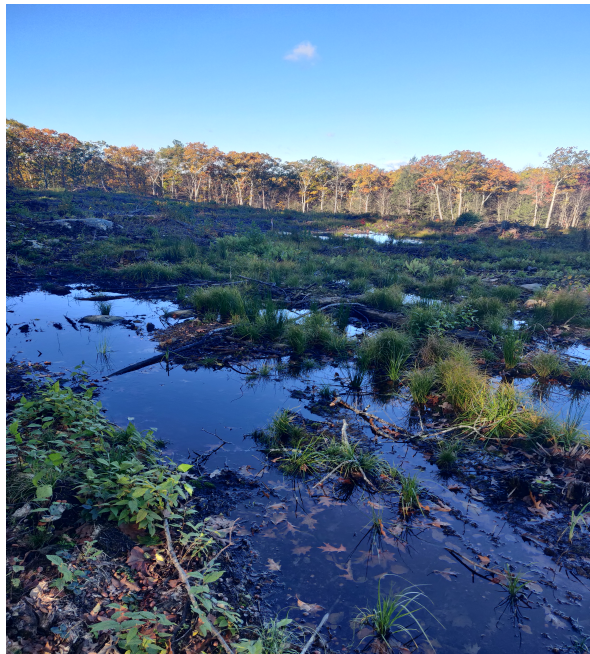
Photo 5

7. Topsoil Re-Use	N/A	N/A	10/05/ 2021	observed within areas of disturbed soils within the limits of work; however, little to no germination was observed within the disturbed area downgradient of the limit of work. Additional seed should be hand-applied in this area.
8. Storm Drain Inlets (North Brookfield Road)	N/A	N/A		The areas downgradient of Discharges 1 and 2 have been stabilized with straw and seed. These areas will be monitored for germination and stabilization.
9. Temporary Drainage Swales (Throughout Site)	N/A	N/A	10/29/ 2021	Seedling growth is observed
10. Temporary Sediment Basins	N/A	N/A		Localized pooling is observed in the eastern portion of the site.

View of the water pooling in eastern perimeter of Site —facing south east.

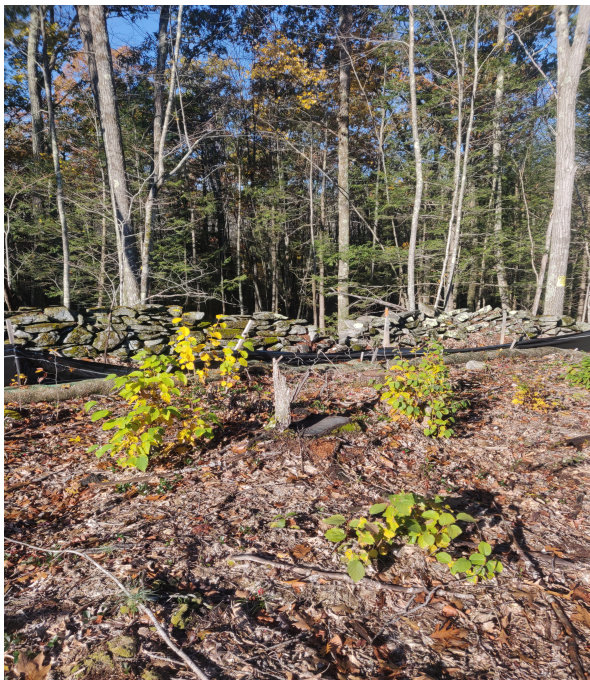
Photo 6

View of damaged silt fence in south west portion of the Site —facing south west

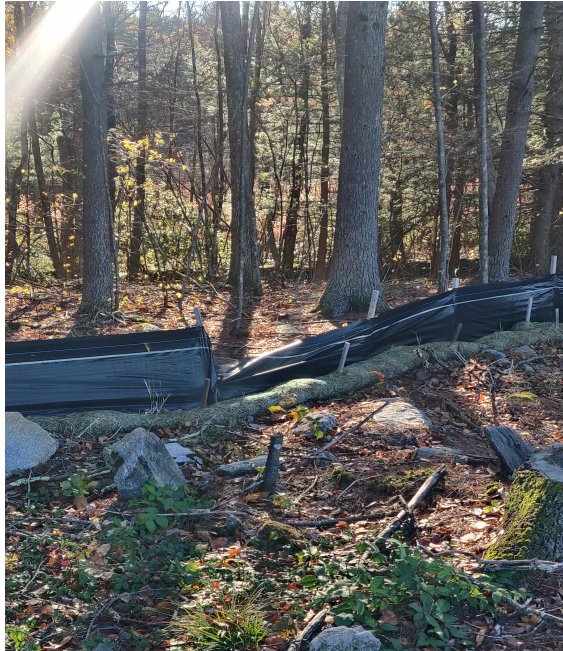
Photo 7

3. Stump and Soil Stockpile Area	No (As of 7/22/2021)	No	10/29/2021	<p>Minor tears were observed in the silt fence along the eastern boundaries of the Site, due to staples becoming dislodged from wooden stakes. The straw wattles are still intact.</p>

View of damaged silt fence in eastern portion of the Site —facing east

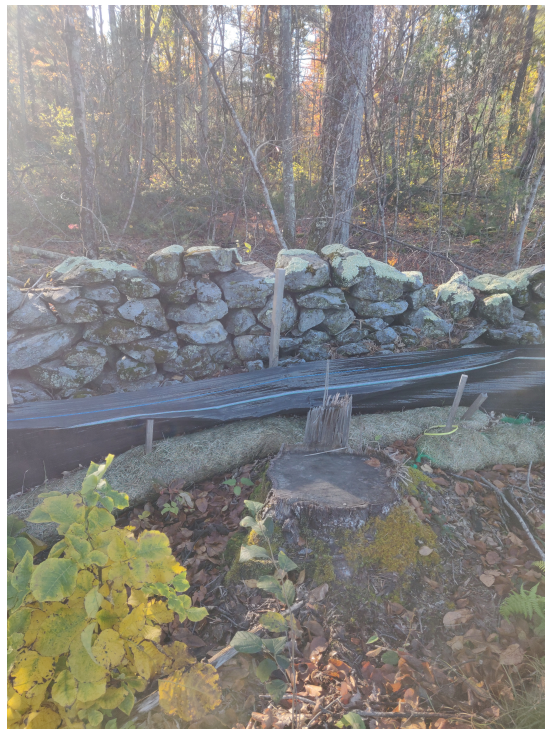
Photo 8

View of damaged silt fence in eastern portion of the Site —facing east

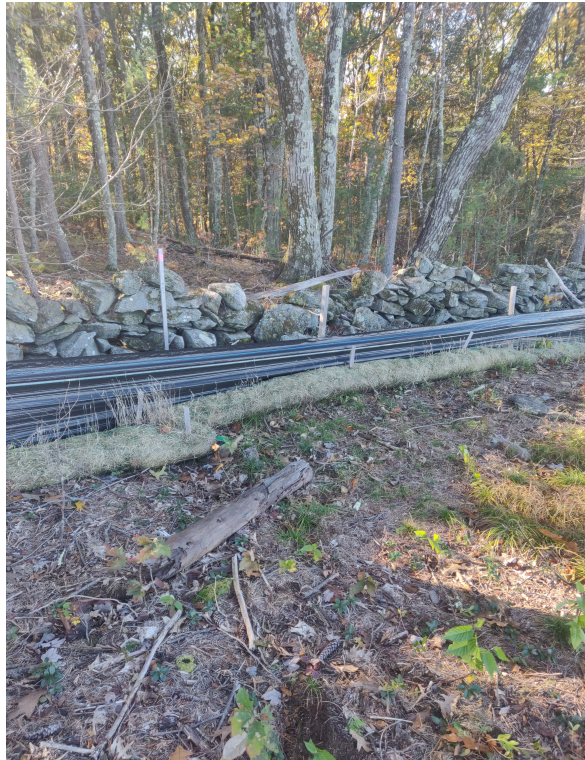
Photo 9

View of damaged silt fence in eastern portion of the Site —facing east

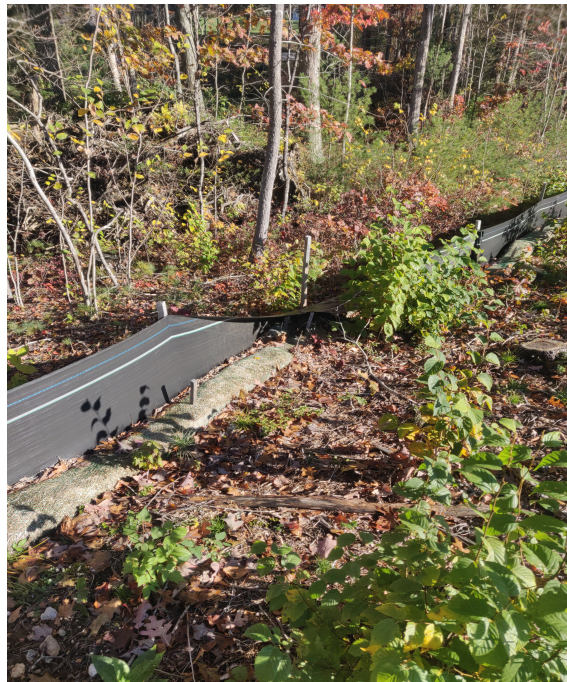
Photo 10

View of damaged silt fence in north western portion of the Site —facing north west
