Inspection Report for North Sturbridge Road Solar Facility

NPDES ID No.: MAR10031G

Inspection Date: 11/01/2021

**FIGURE 1:
 SWPPP
 INSPECTION
 SKETCH
 11/01/2021**

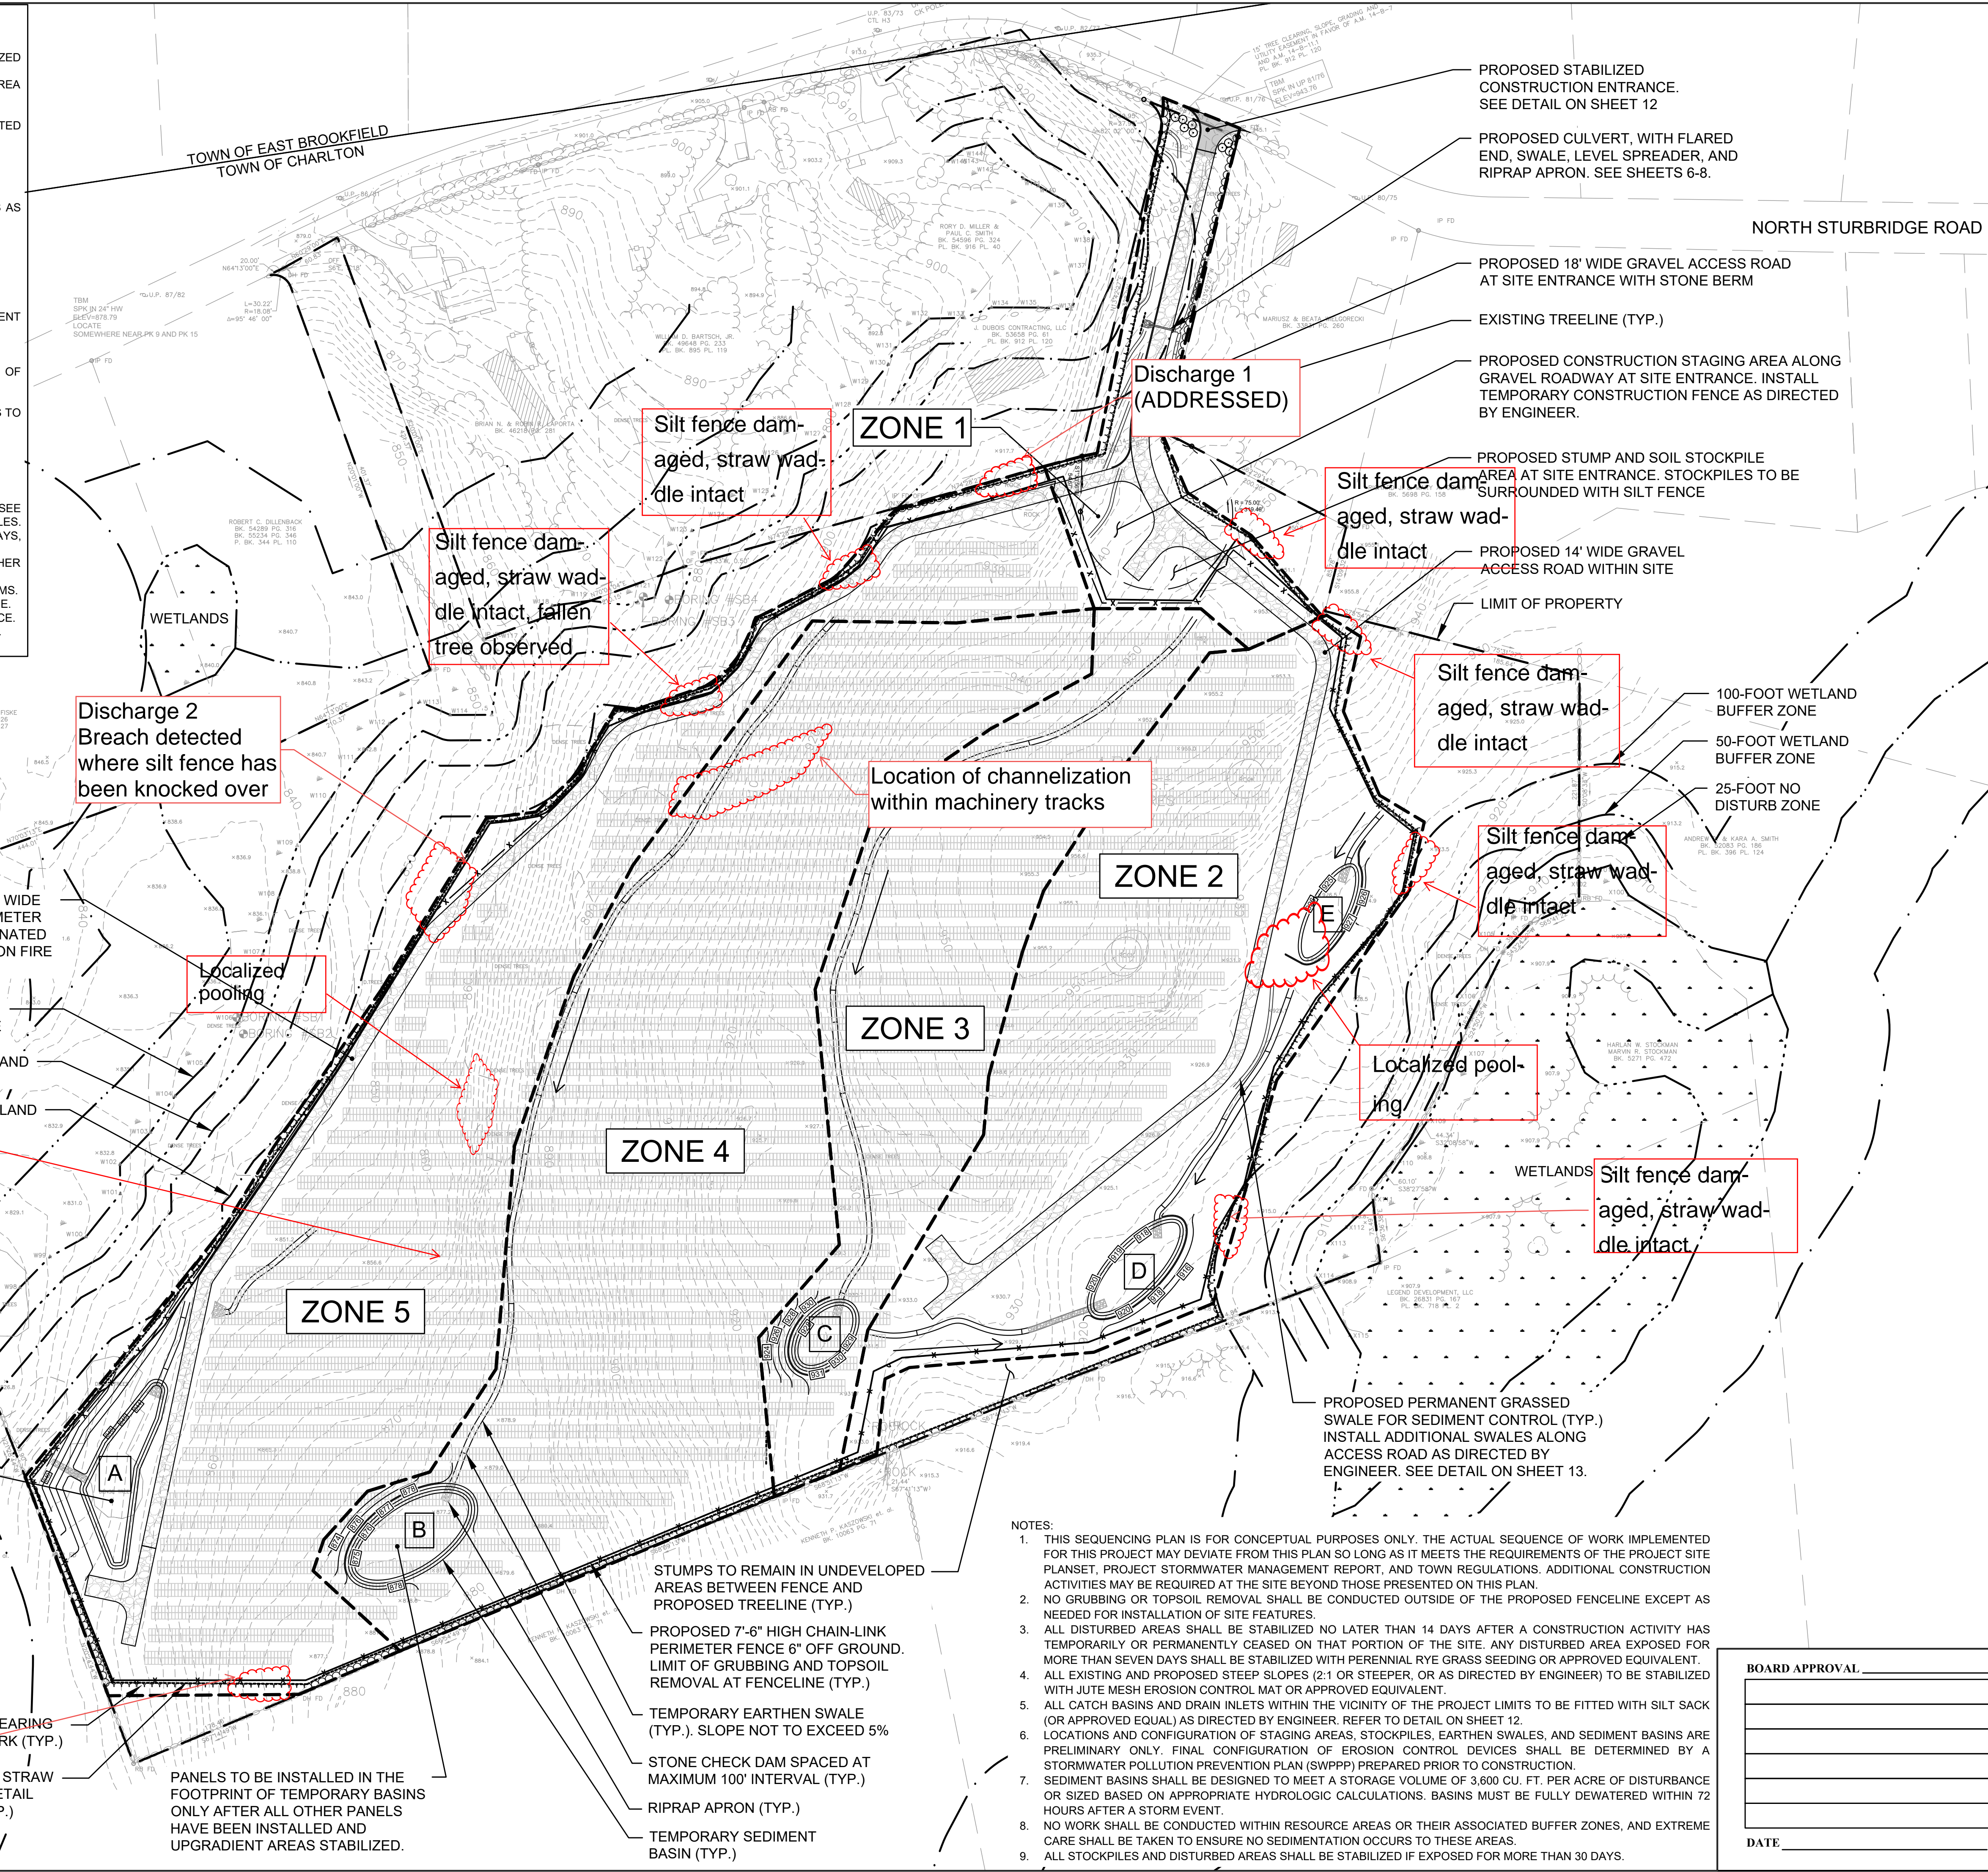
Silt fence damaged, straw wad-dle intact

Silt fence damaged, straw wad-dle intact, fallen tree observed

Discharge 2 Breach detected where silt fence has been knocked over

Location of channelization within machinery tracks

Localized pooling

Channelization observed throughout lower portion of Site

Minor tear detected in silt fence

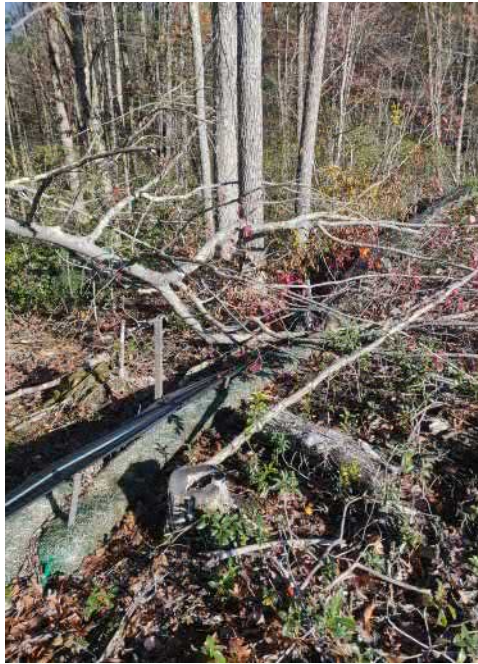
Photo 1

2. Stabilized Construction Entrance (Site Entrance – Access Road)	No (As of 9/2/2021)	No		<p>A tree was knocked over and laying on the silt fence on the on the northwestern portion of the site in Zone 5.</p> <p>Hydroseed was applied to exposed soil in this area and continues to germinate, some grass seedlings are now observed.</p>

View of tree fallen on northwestern portion of Zone 5.

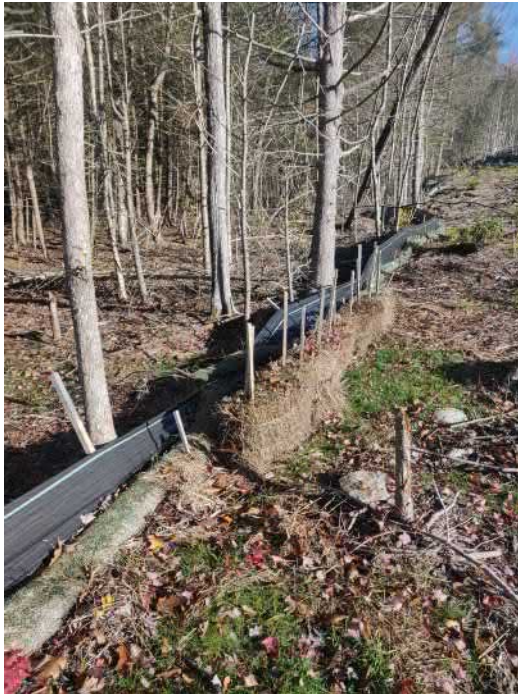
Photo 2

Type/Location of E&S Control	Maintenance Needed?*			
1. Silt Fence and Straw Wattles	Yes (As of 9/2/2021)	No	9/2/2021	<p>A breach was observed at Discharge 2. Although the double row of straw bales is intact, silt fence was observed to be knocked over and signs of stormwater flow were detected in the area beyond the fence.</p> <p>A minor tear was identified in a section of silt fence on the southern side of the Site with no erosion observed.</p> <p>Minor degradation of a straw wattle was observed on the southeastern side of the Site; no erosion was observed but pools of water were found to be forming behind the straw wattle.</p>

View of area downgradient of Discharge 2—facing north west.

Discharge Location	Observations
<p>Discharge 1</p>	<p>Describe the discharge: Breach in silt fence allowed runoff to bypass erosion controls.</p> <p>At points of discharge and the channels and banks of surface waters in the immediate vicinity, are there any visible signs of erosion and/or sediment accumulation that can be attributed to your discharge? <input checked="" type="checkbox"/> Yes <input type="checkbox"/> No</p> <p>If yes, describe what you see, specify the location(s) where these conditions were found, and indicate whether modification, maintenance, or corrective action is needed to resolve the issue: Small areas of bare soil observed in area immediately beyond perimeter controls. Repairs to erosion controls and re-seeding of damaged areas is required.</p>

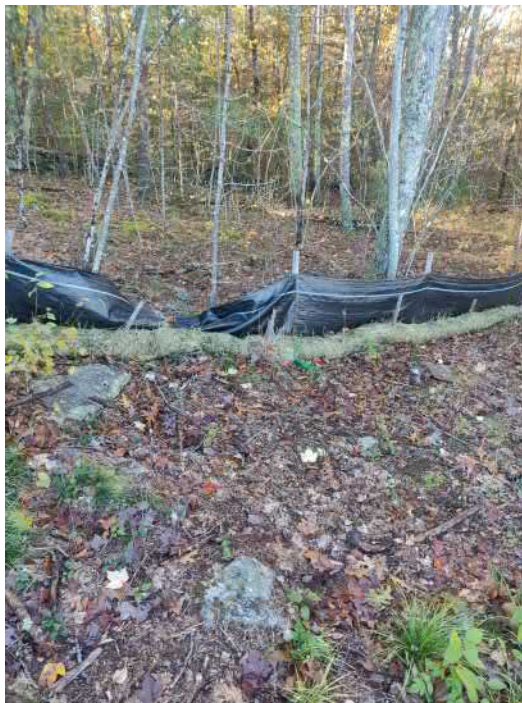
Photo 3

View of the damaged silt fence in southern perimeter of Site —facing south.

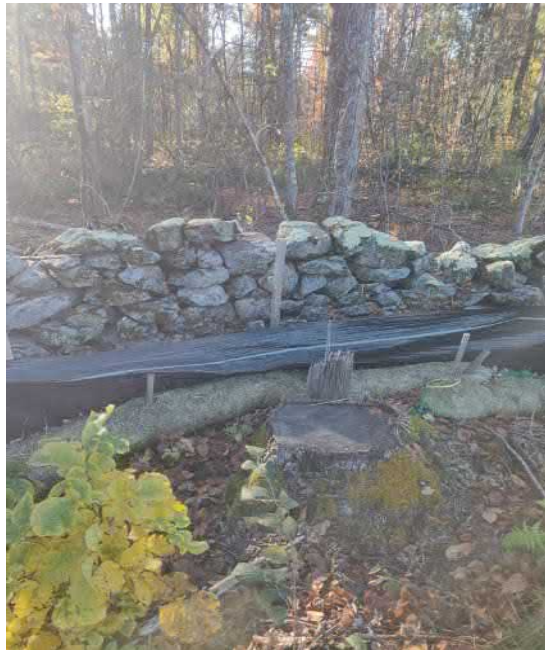
Photo 4

View of damaged silt fence in south west portion of the Site —facing south west

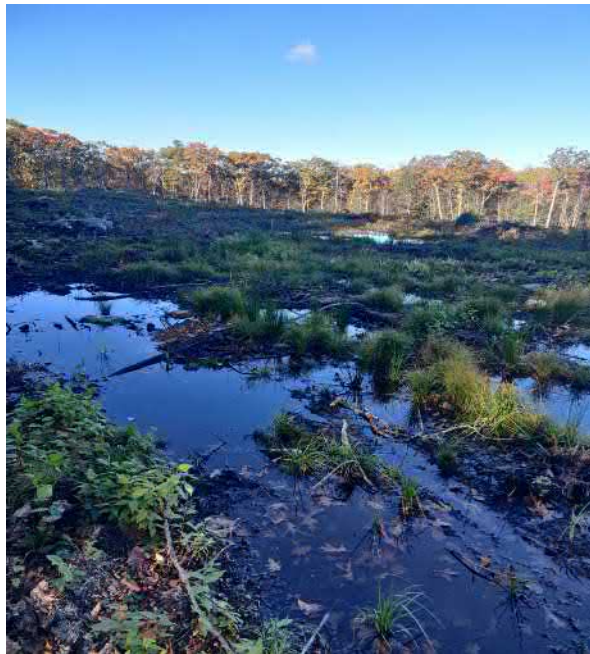
Photo 5

View of the water pooling in eastern perimeter of Site —facing south east.

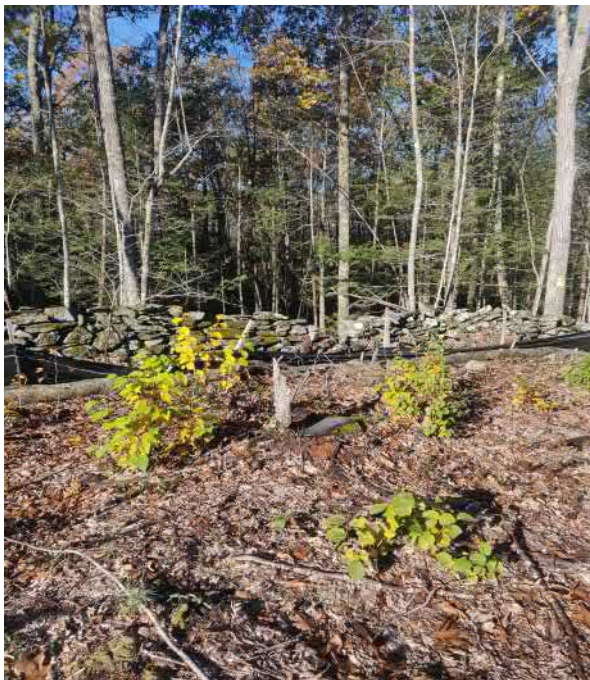
Photo 6

View of damaged silt fence in south west portion of the Site —facing south west

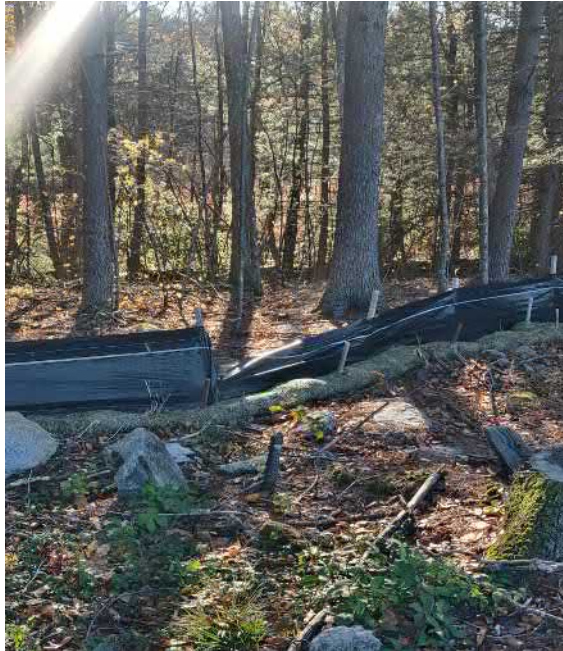
Photo 7

3. Stump and Soil Stockpile Area	No (As of 7/22/2021)	No	10/29/2021	<p>Minor tears were observed in the silt fence along the eastern boundaries of the Site, due to staples becoming dislodged from wooden stakes. The straw wattles are still intact.</p>

View of damaged silt fence in eastern portion of the Site —facing east

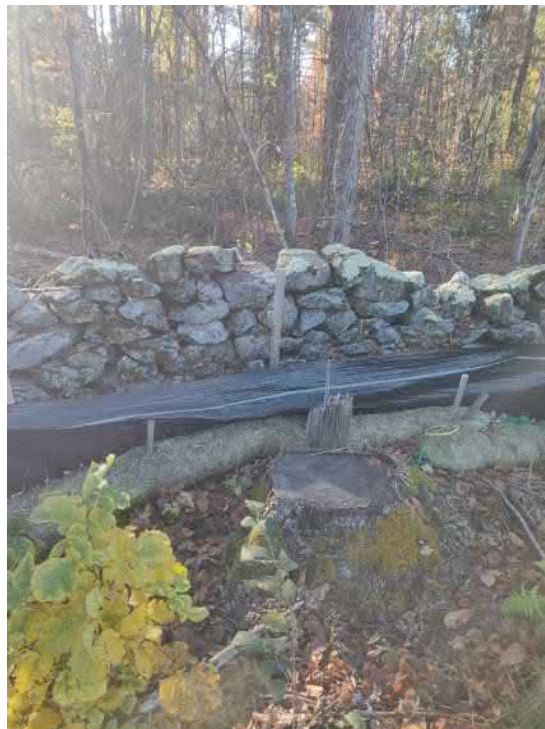
Photo 8

View of damaged silt fence in eastern portion of the Site —facing east

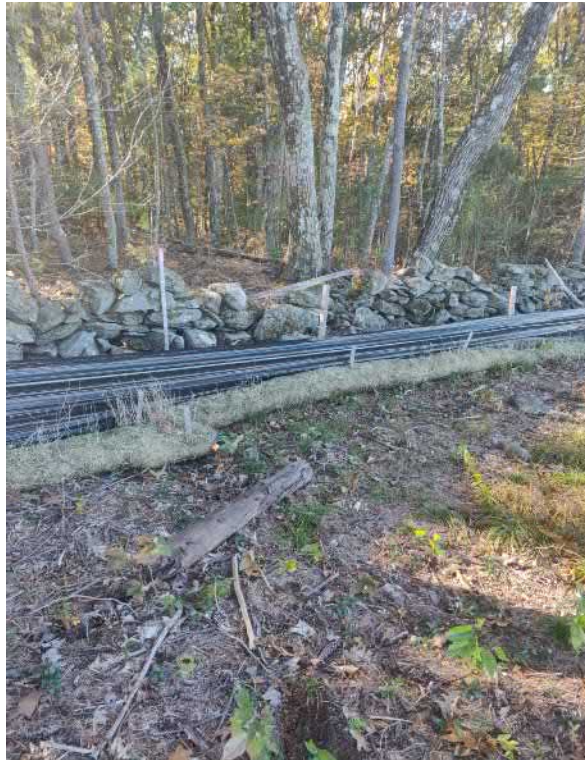
Photo 9

View of damaged silt fence in eastern portion of the Site —facing east

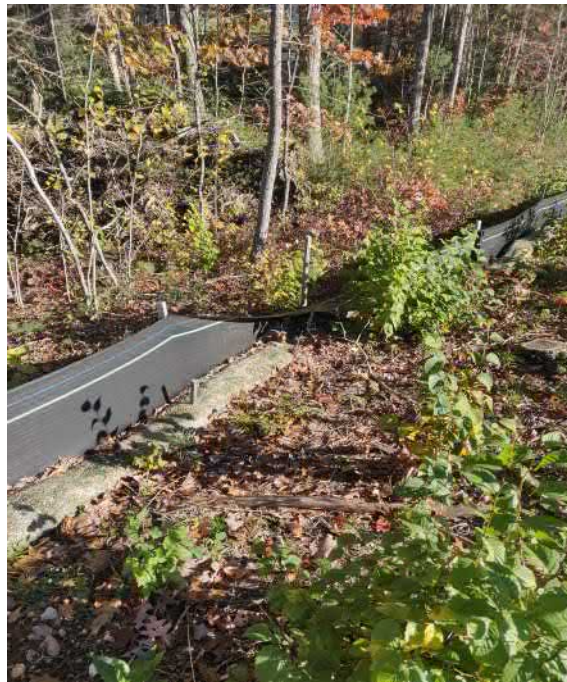
Photo 10

View of damaged silt fence in north western portion of the Site —facing north west
