Inspection Report for North Sturbridge Road Solar Facility

NPDES ID No.: MAR10031G

Inspection Date: 11/12/2021

**FIGURE 1:
 SWPPP
 INSPECTION
 SKETCH
 11/12/2021**

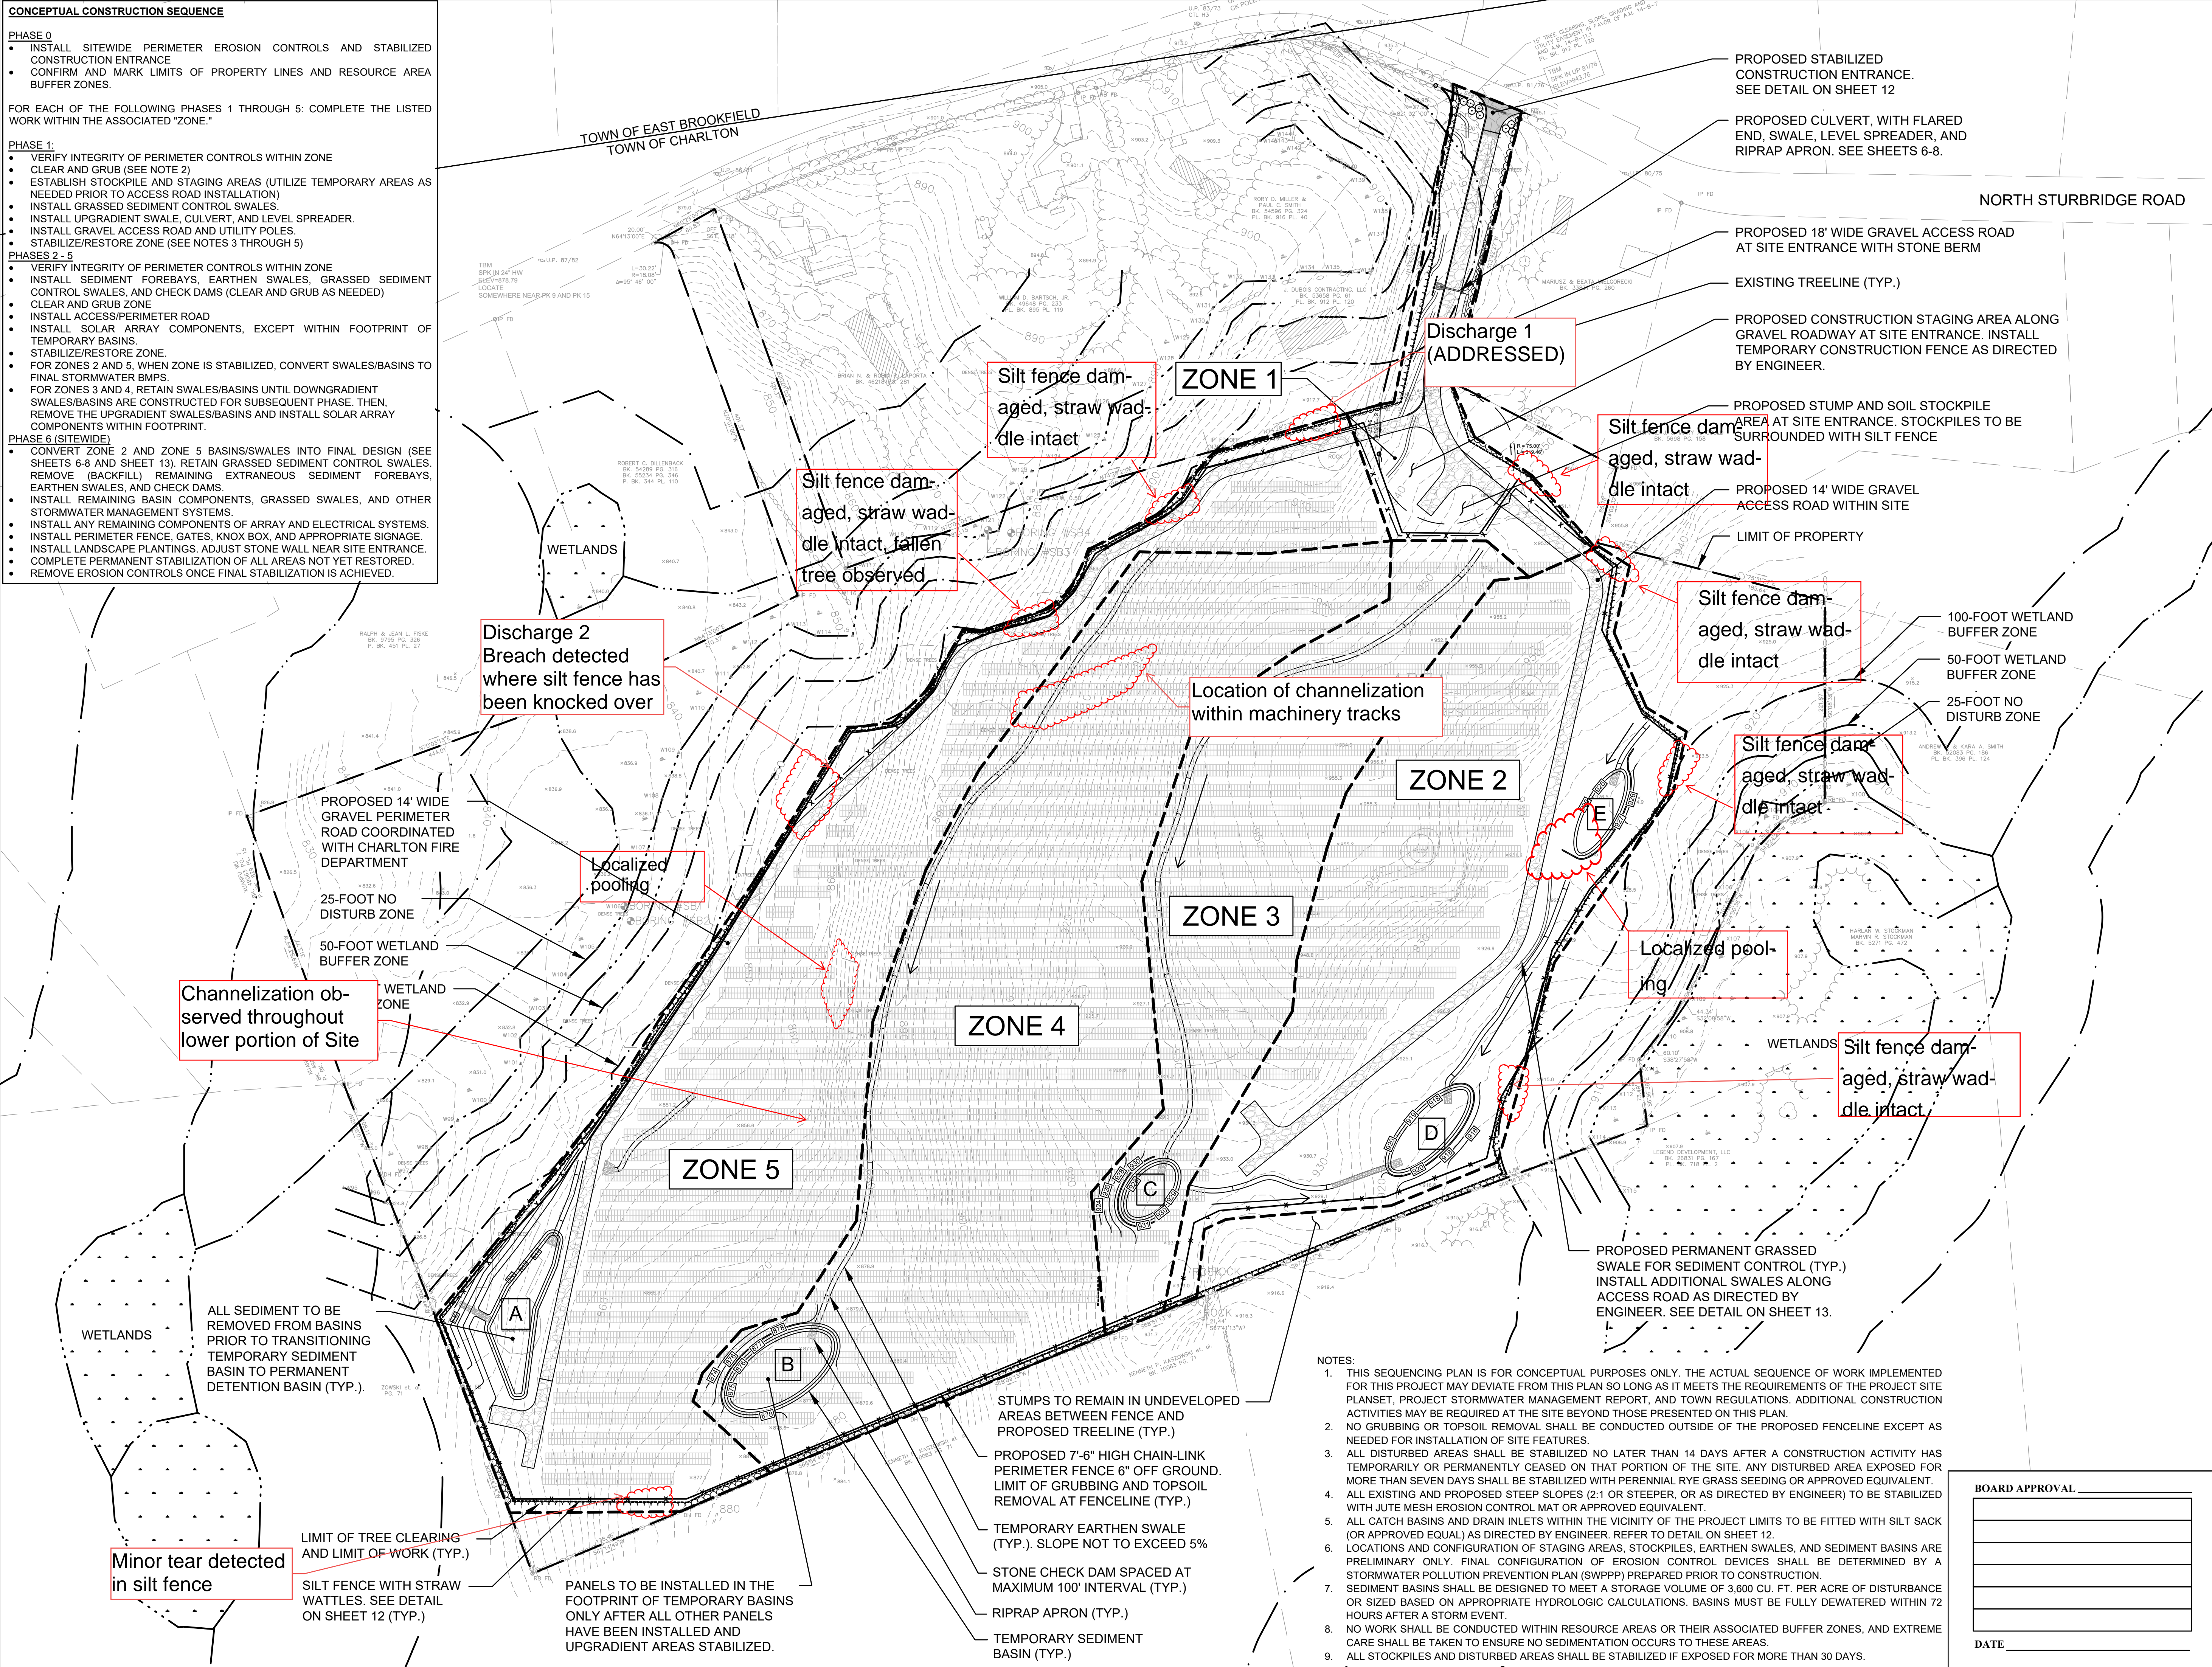
2. Informal access road along northern portion of the Site	Straw mulch or hydroseed	<input type="checkbox"/> Yes [Enter date] <input checked="" type="checkbox"/> No	Erosion channels are beginning to form within upgradient portions of the informal access road (Figure 1). The contractor indicated that stabilization by smoothing out soils and seeding or spreading mulch would occur on 7/30/2021. Stabilization of this area has not been initiated. After inspection of the area on 8/24/2021, it was determined that

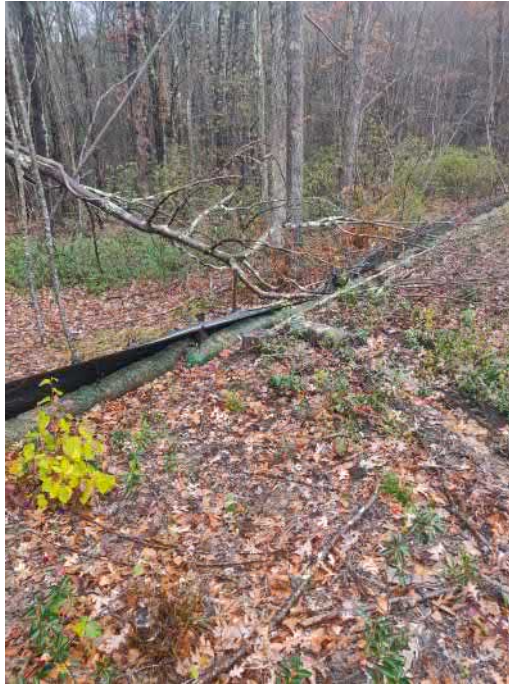
Photo 1

2. Stabilized Construction Entrance (Site Entrance – Access Road)	No (As of 9/2/2021)	No		<p>A tree was knocked over and laying on the silt fence on the on the northwestern portion of the site in Zone 5.</p> <p>Hydroseed was applied to exposed soil in this area and continues to germinate, some grass seedlings are now observed.</p>

View of tree fallen on northwestern portion of Zone 5.

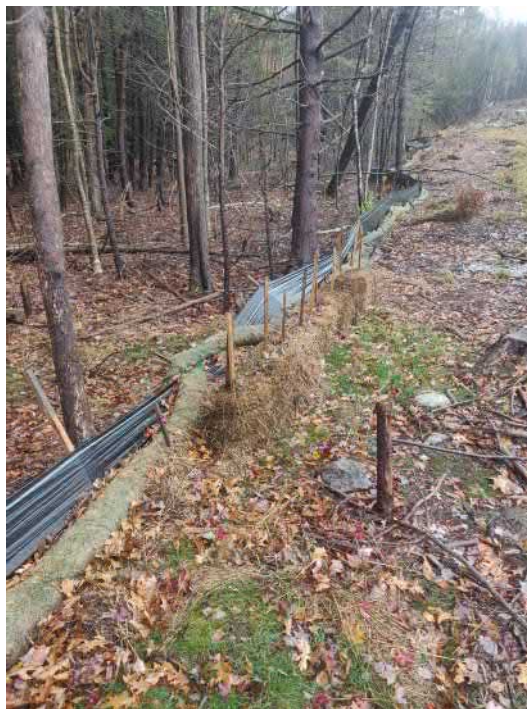
Photo 2

Type/Location of E&S Control	Maintenance Needed?*			
1. Silt Fence and Straw Wattles	Yes (As of 9/2/2021)	No	9/2/2021	<p>A breach was observed at Discharge 2. Although the double row of straw bales is intact, silt fence was observed to be knocked over and signs of stormwater flow were detected in the area beyond the fence.</p> <p>A minor tear was identified in a section of silt fence on the southern side of the Site with no erosion observed.</p> <p>Minor degradation of a straw wattle was observed on the southeastern side of the Site; no erosion was observed but pools of water were found to be forming behind the straw wattle.</p>

View of area downgradient of Discharge 2—facing north west.

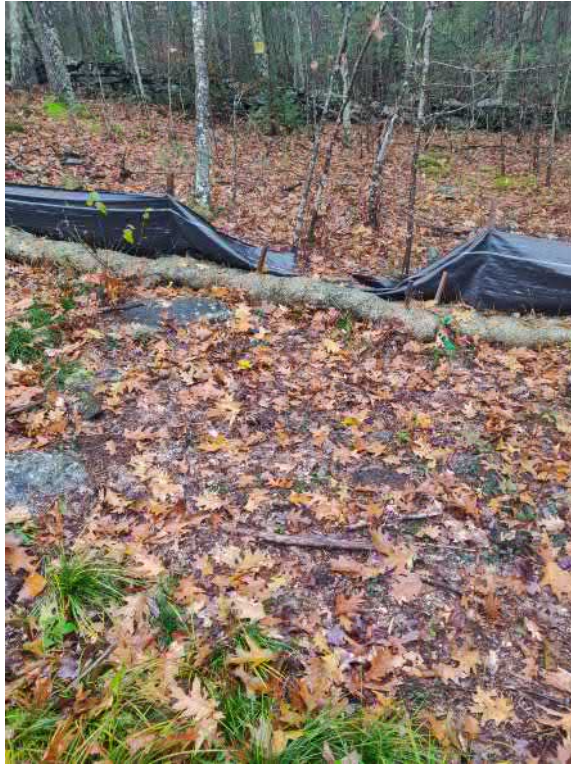
Photo 3

View of the damaged silt fence in southern perimeter of Site —facing south.

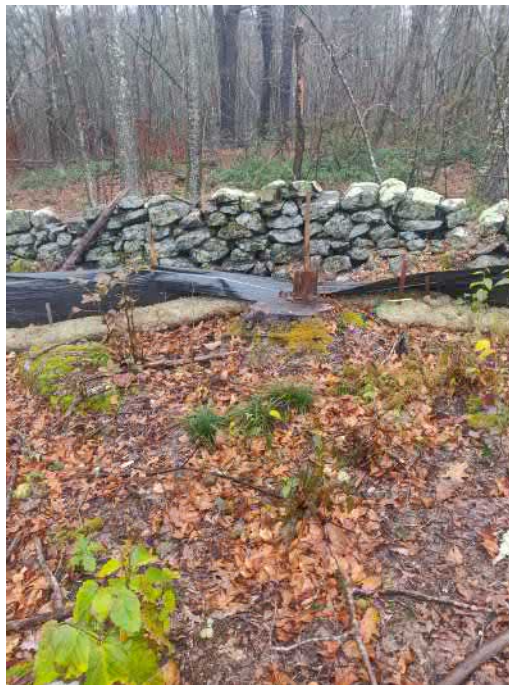
Photo 4

View of damaged silt fence in south west portion of the Site —facing south west

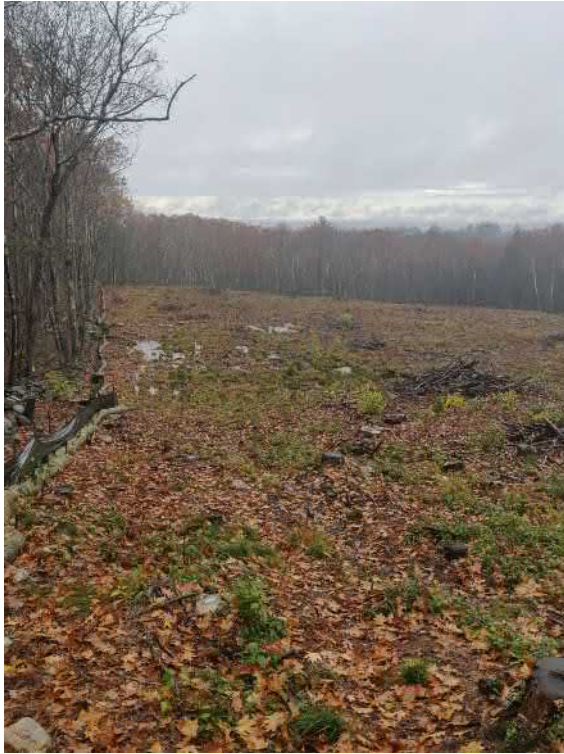
Photo 5

View of the water pooling in eastern perimeter of Site —facing south east.

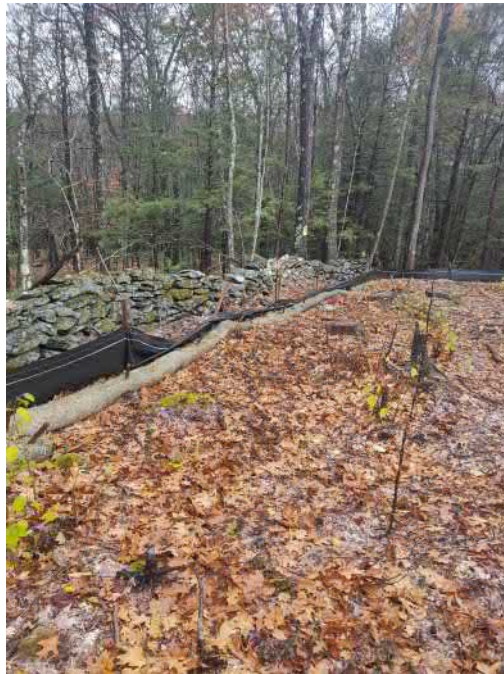
Photo 6

View of damaged silt fence in south west portion of the Site —facing south west

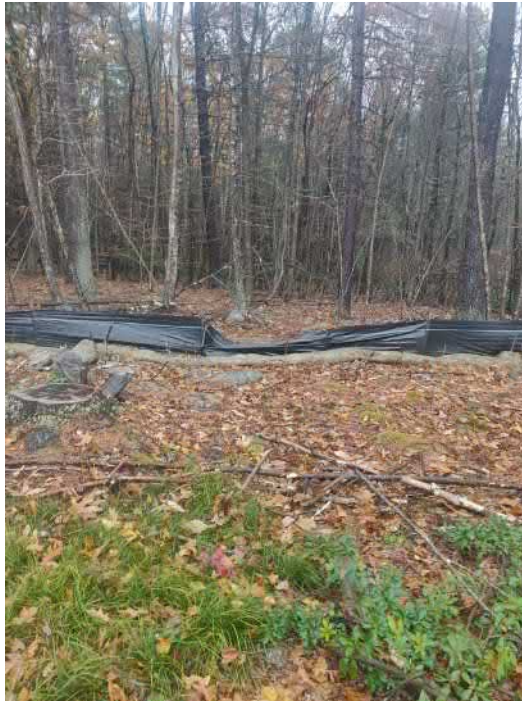
Photo 7

3. Stump and Soil Stockpile Area	No (As of 7/22/2021)	No	10/29/2021	<p>Minor tears were observed in the silt fence along the eastern boundaries of the Site, due to staples becoming dislodged from wooden stakes. The straw wattles are still intact.</p>

View of damaged silt fence in eastern portion of the Site —facing east

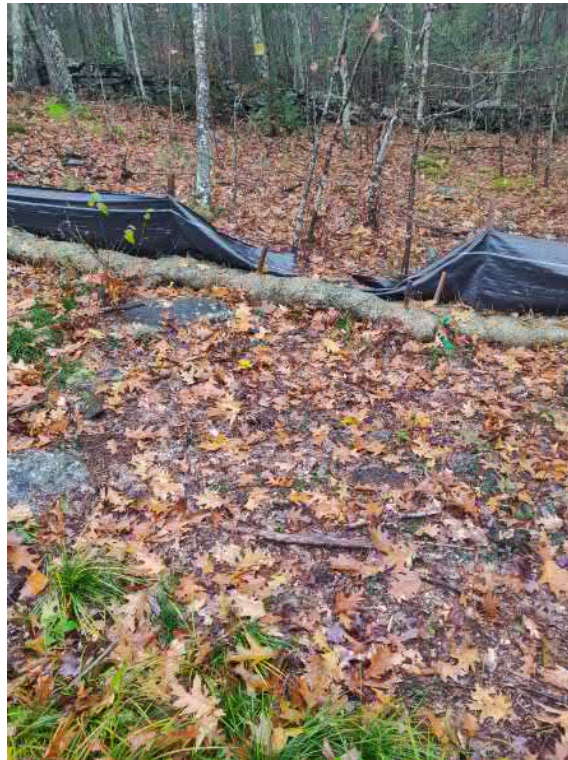
Photo 8

View of damaged silt fence in eastern portion of the Site —facing east

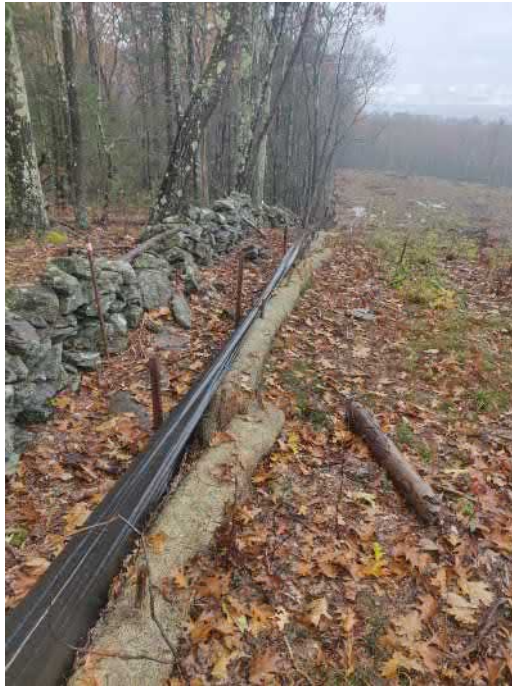
Photo 9

View of damaged silt fence in eastern portion of the Site —facing east

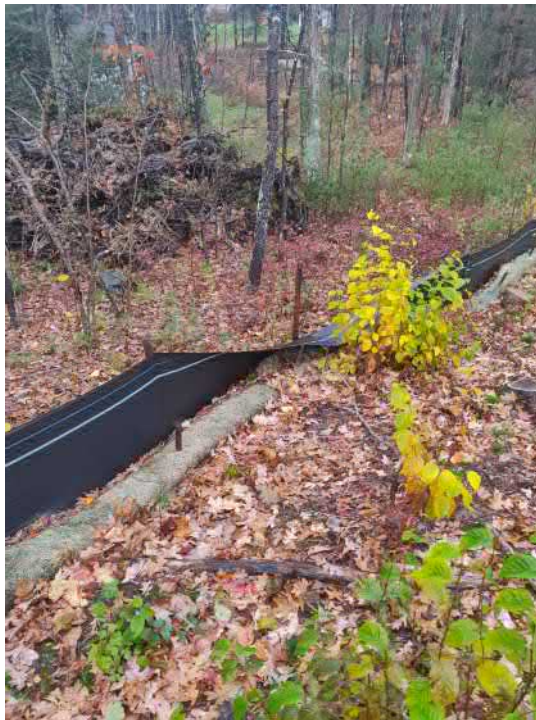
Photo 10

View of damaged silt fence in north western portion of the Site —facing north west
