Inspection Report for North Sturbridge Road Solar Facility

NPDES ID No.: MAR10031G

Inspection Date: 11/15/2021

**FIGURE 1:  
SWPPP  
INSPECTION  
SKETCH  
11/15/2021**

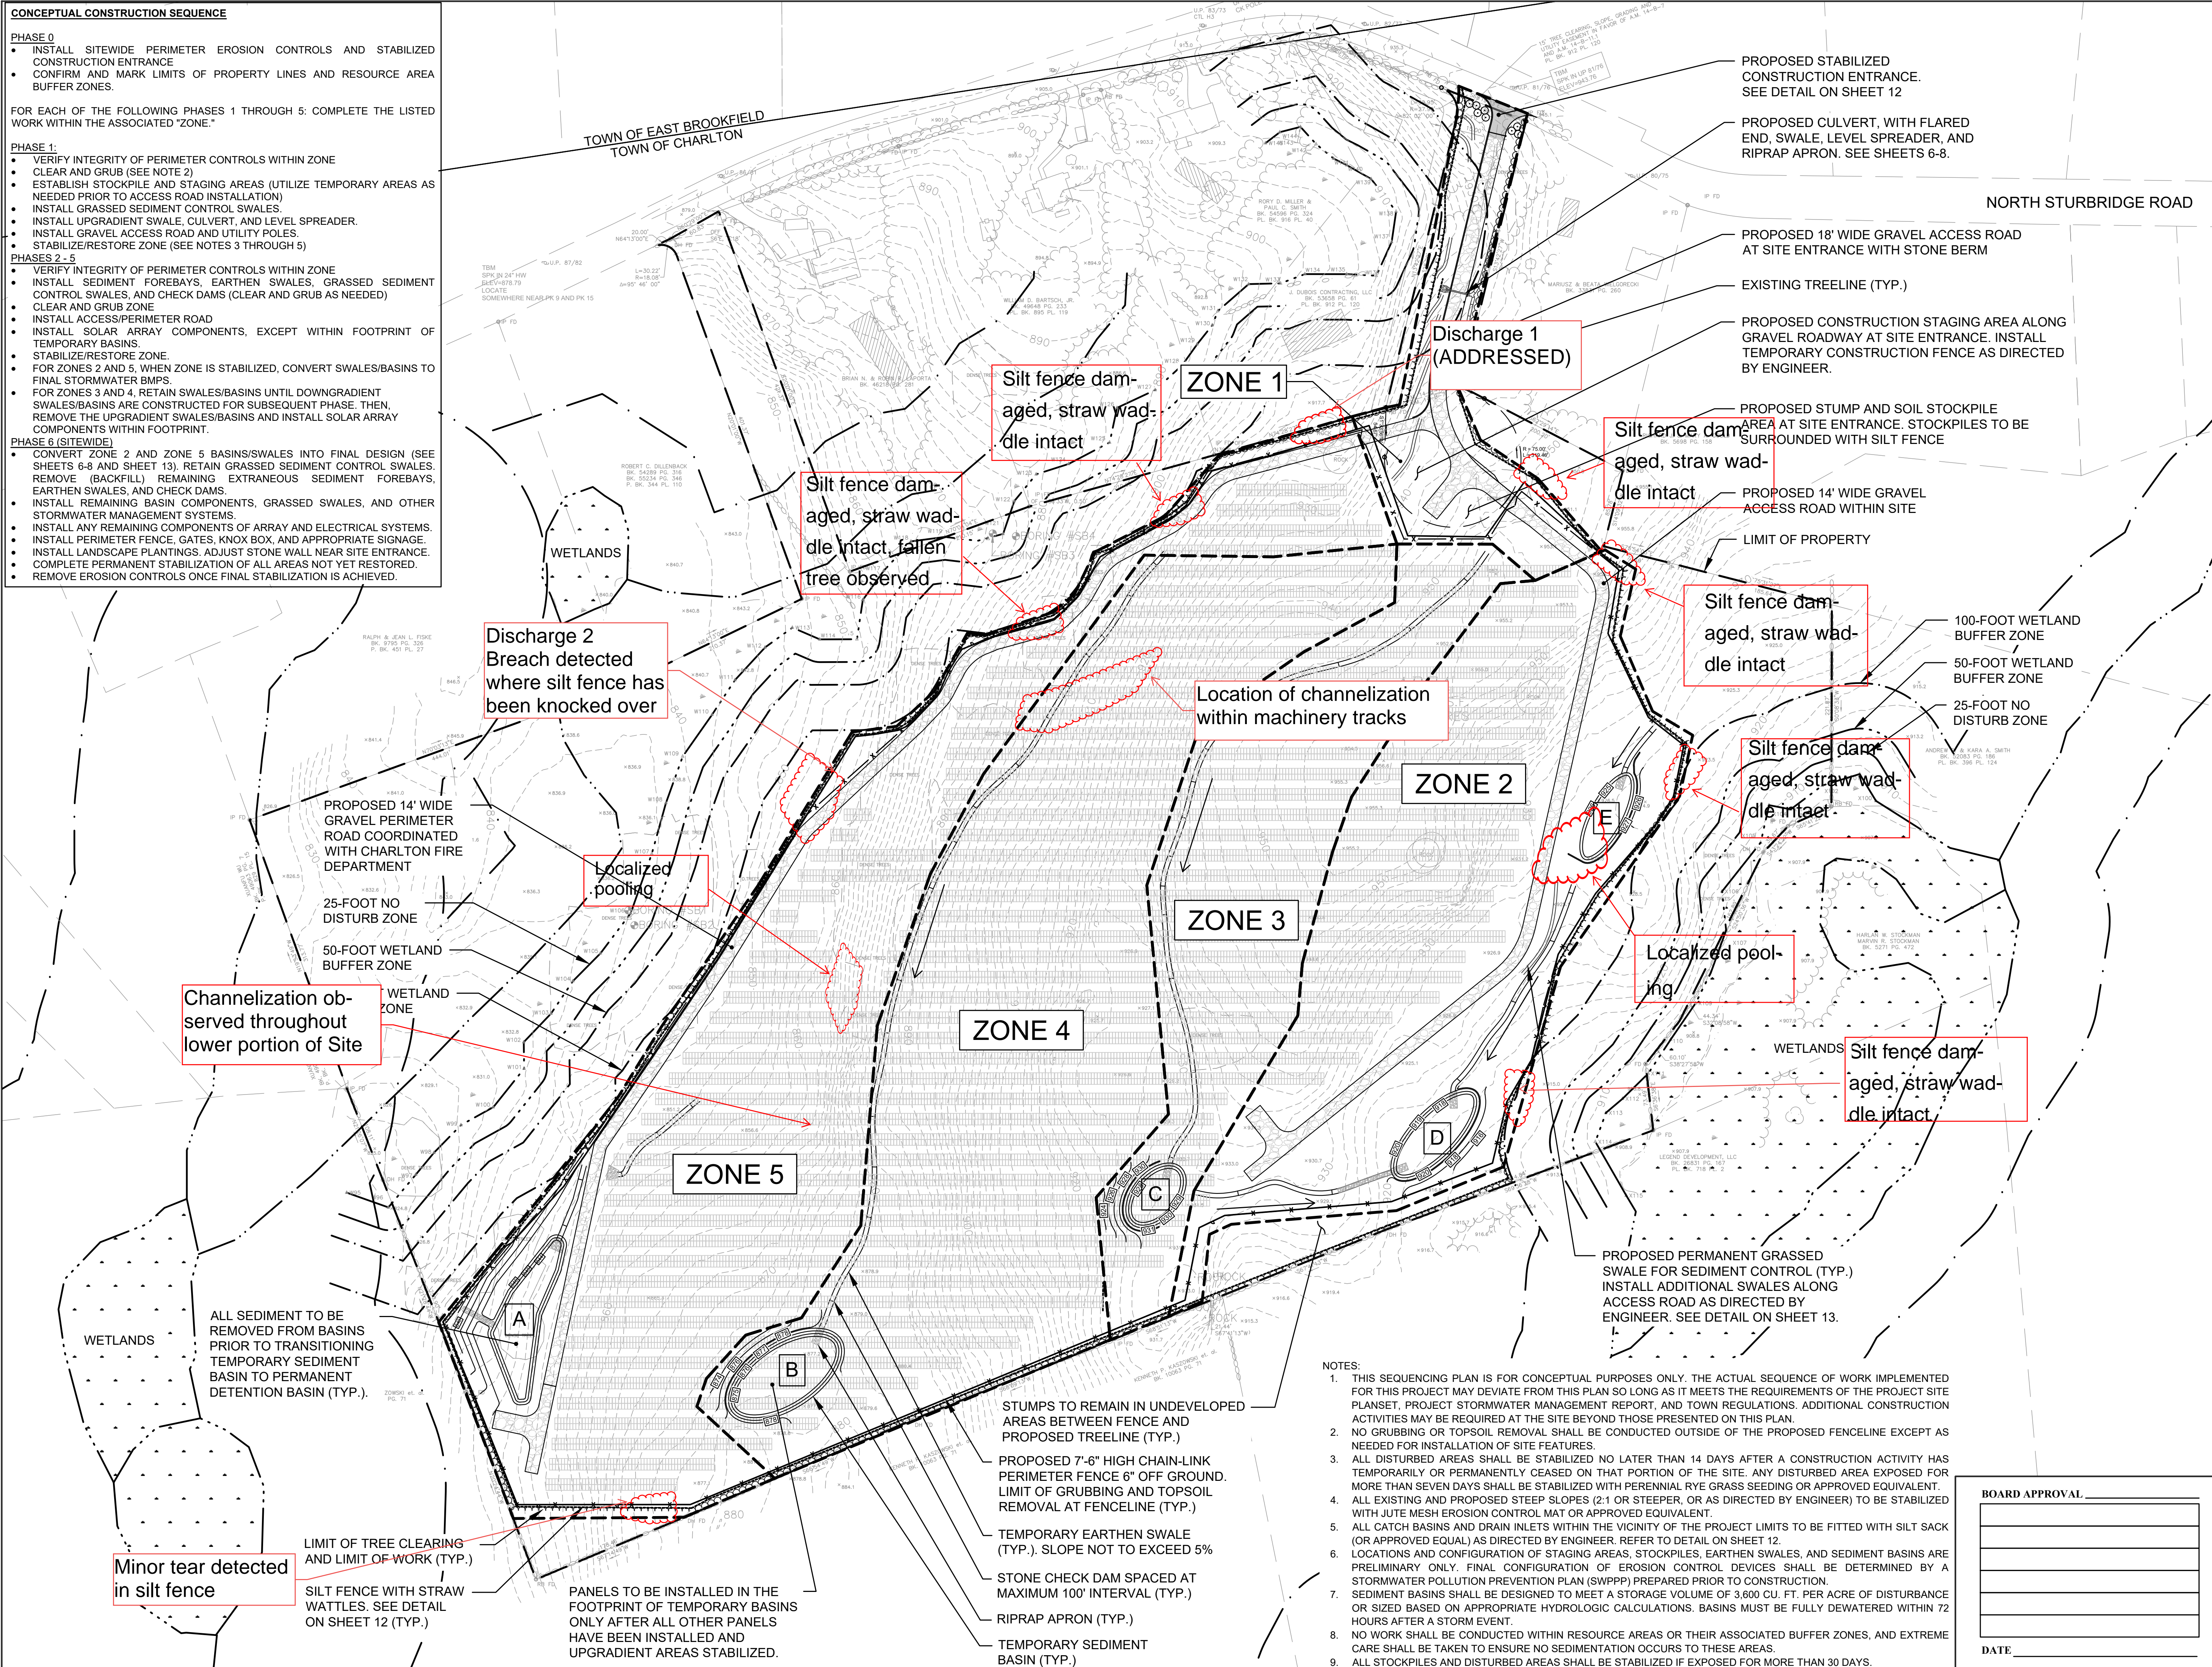
Localized pooling

Silt fence damaged, straw wad-dle intact

Minor tear detected in silt fence

Channelization observed throughout lower portion of Site

Location of channelization within machinery tracks

Silt fence damaged, straw wad-dle intact, fallen tree observed

Discharge 2 Breach detected where silt fence has been knocked over

Discharge 1 (ADDRESSED)

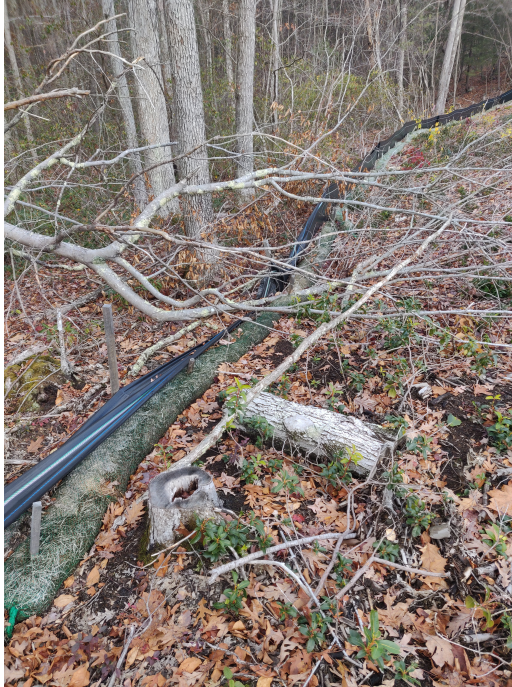
Photo 1

| Type/Location of E&S Control | Maintenance Needed?* | | | |
|---|---|---|---|--|
| 2. Stabilized Construction Entrance (Site Entrance – Access Road) | No (As of 9/2/2021) | No | | <p>A tree was knocked over and laying on the silt fence on the on the northwestern portion of the site in Zone 5.</p> <p>Hydroseed was applied to exposed soil in this area and continues to germinate, some grass seedlings are now observed.</p> |

View of tree fallen on northwestern portion of Zone 5.

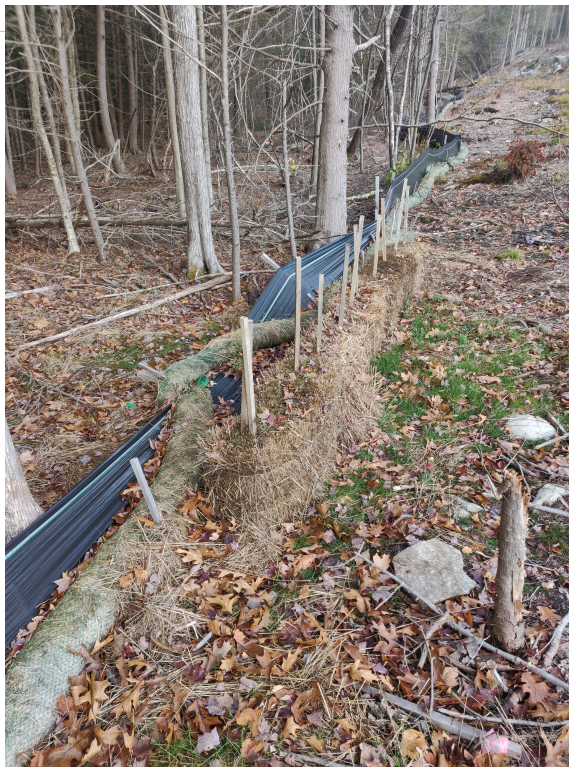
Photo 2

| Type/Location of E&S Control | Maintenance Needed?* | | | |
|---|---|---|---|--|
| 1. Silt Fence and Straw Wattles | Yes (As of 9/2/2021) | No | 9/2/2021 | <p>A breach was observed at Discharge 2. Although the double row of straw bales is intact, silt fence was observed to be knocked over and signs of stormwater flow were detected in the area beyond the fence.</p> <p>A minor tear was identified in a section of silt fence on the southern side of the Site with no erosion observed.</p> <p>Minor degradation of a straw wattle was observed on the southeastern side of the Site; no erosion was observed but pools of water were found to be forming behind the straw wattle.</p> |

View of area downgradient of Discharge 2—facing north west.

| <p>4. Area beyond limits of work at Discharge 2</p> | <p>Hand application of seed</p> | <p><input type="checkbox"/> Yes Enter Date <input checked="" type="checkbox"/> No</p> | <p>Stabilization required</p> |

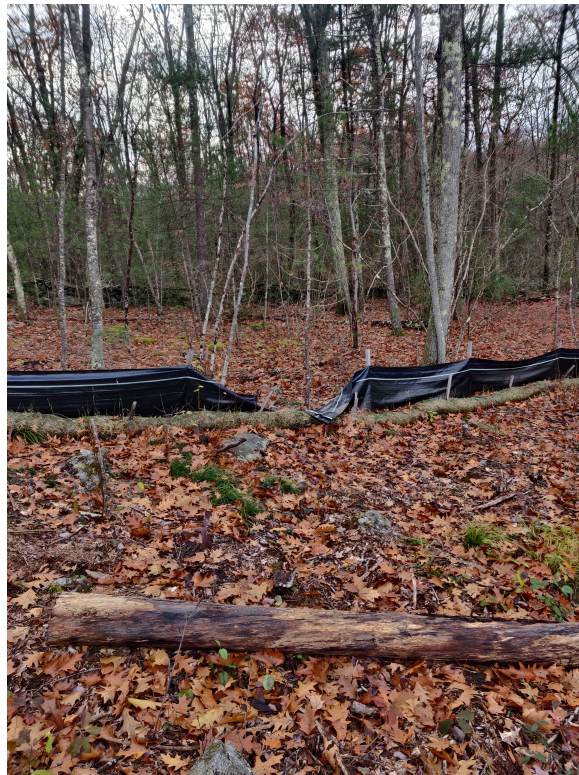
Photo 3

View of the damaged silt fence in southern perimeter of Site —facing south.

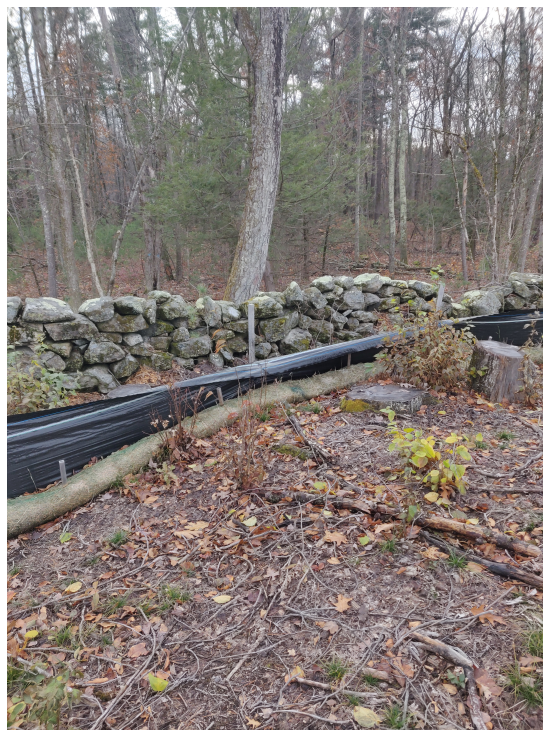
Photo 4

View of damaged silt fence in south west portion of the Site —facing south west

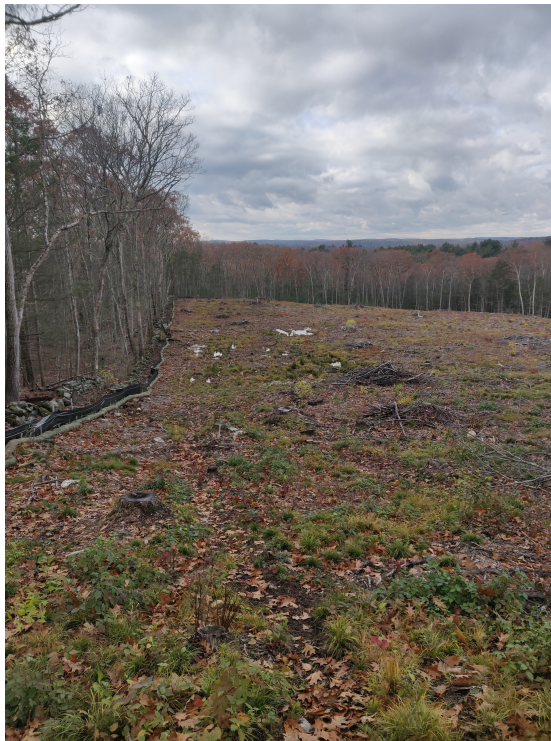
Photo 5

| 10. Temporary Sediment Basins | N/A | N/A | | Localized pooling is observed in the eastern portion of the site. |

View of the water pooling in eastern perimeter of Site —facing south east.

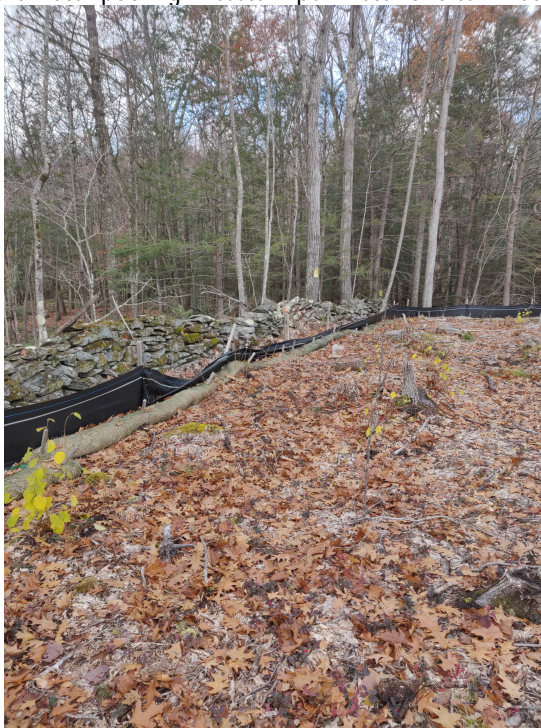
Photo 6

View of damaged silt fence in south west portion of the Site —facing south west

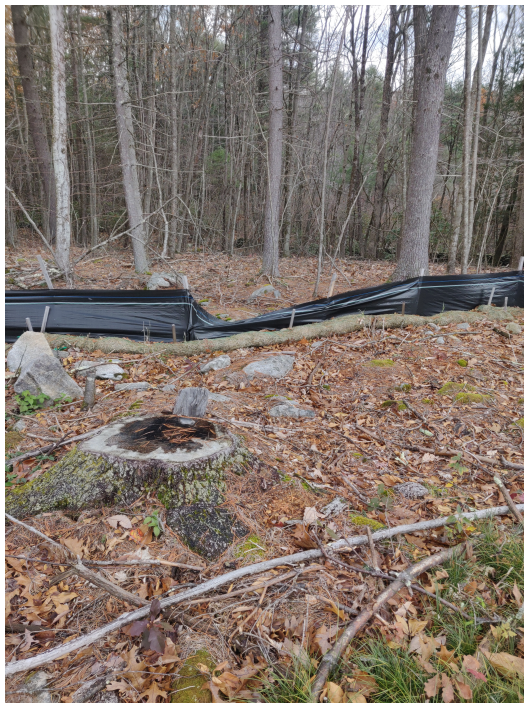
Photo 7

| Type/Location of E&S Control | Maintenance Needed?* | | | |
|---|---|---|---|--|
| 3. Stump and Soil Stockpile Area | No (As of 7/22/2021) | No | 10/29/2021 | <p>Minor tears were observed in the silt fence along the eastern boundaries of the Site, due to staples becoming dislodged from wooden stakes. The straw wattles are still intact.</p> |

View of damaged silt fence in eastern portion of the Site —facing east

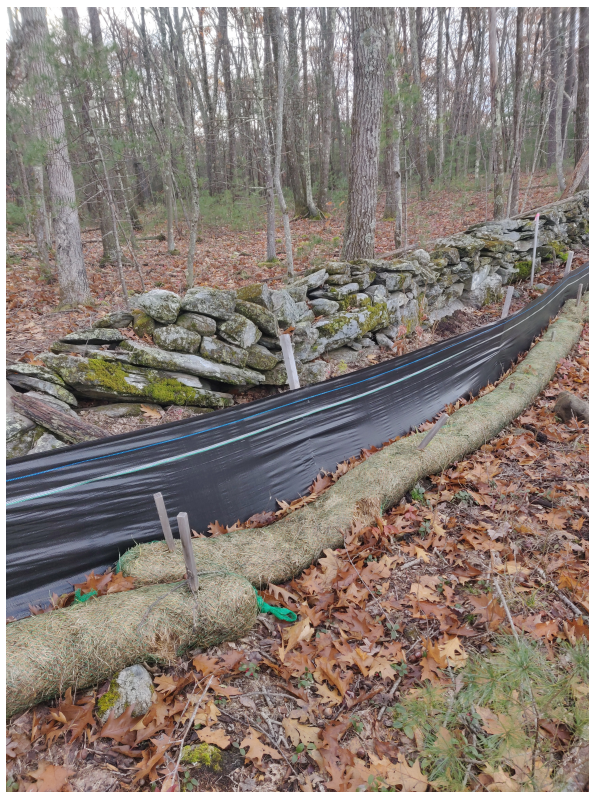
Photo 8

View of damaged silt fence in eastern portion of the Site —facing east

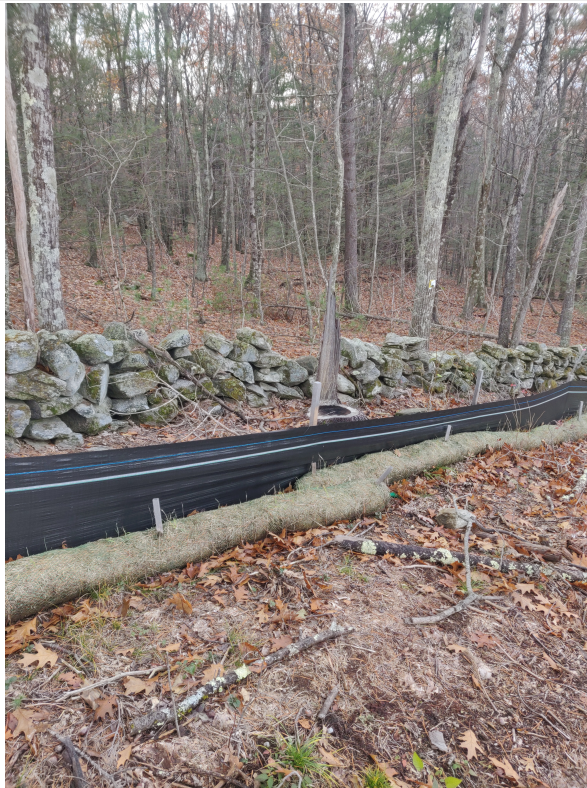
Photo 9

View of damaged silt fence in eastern portion of the Site —facing east

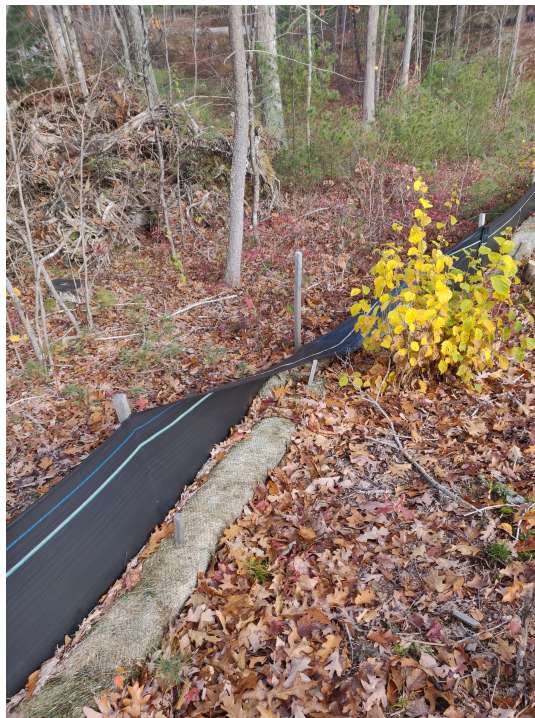
Photo 10

View of damaged silt fence in north western portion of the Site —facing north west
