Inspection Report for North Sturbridge Road Solar Facility

NPDES ID No.: MAR10031G

Inspection Date: 11/15/2021

PHOTOGRAPHIC DOCUMENTATION
North Sturbridge Road Solar Facility
Charlton, Massachusetts
Photographs Documented 11.15.2021

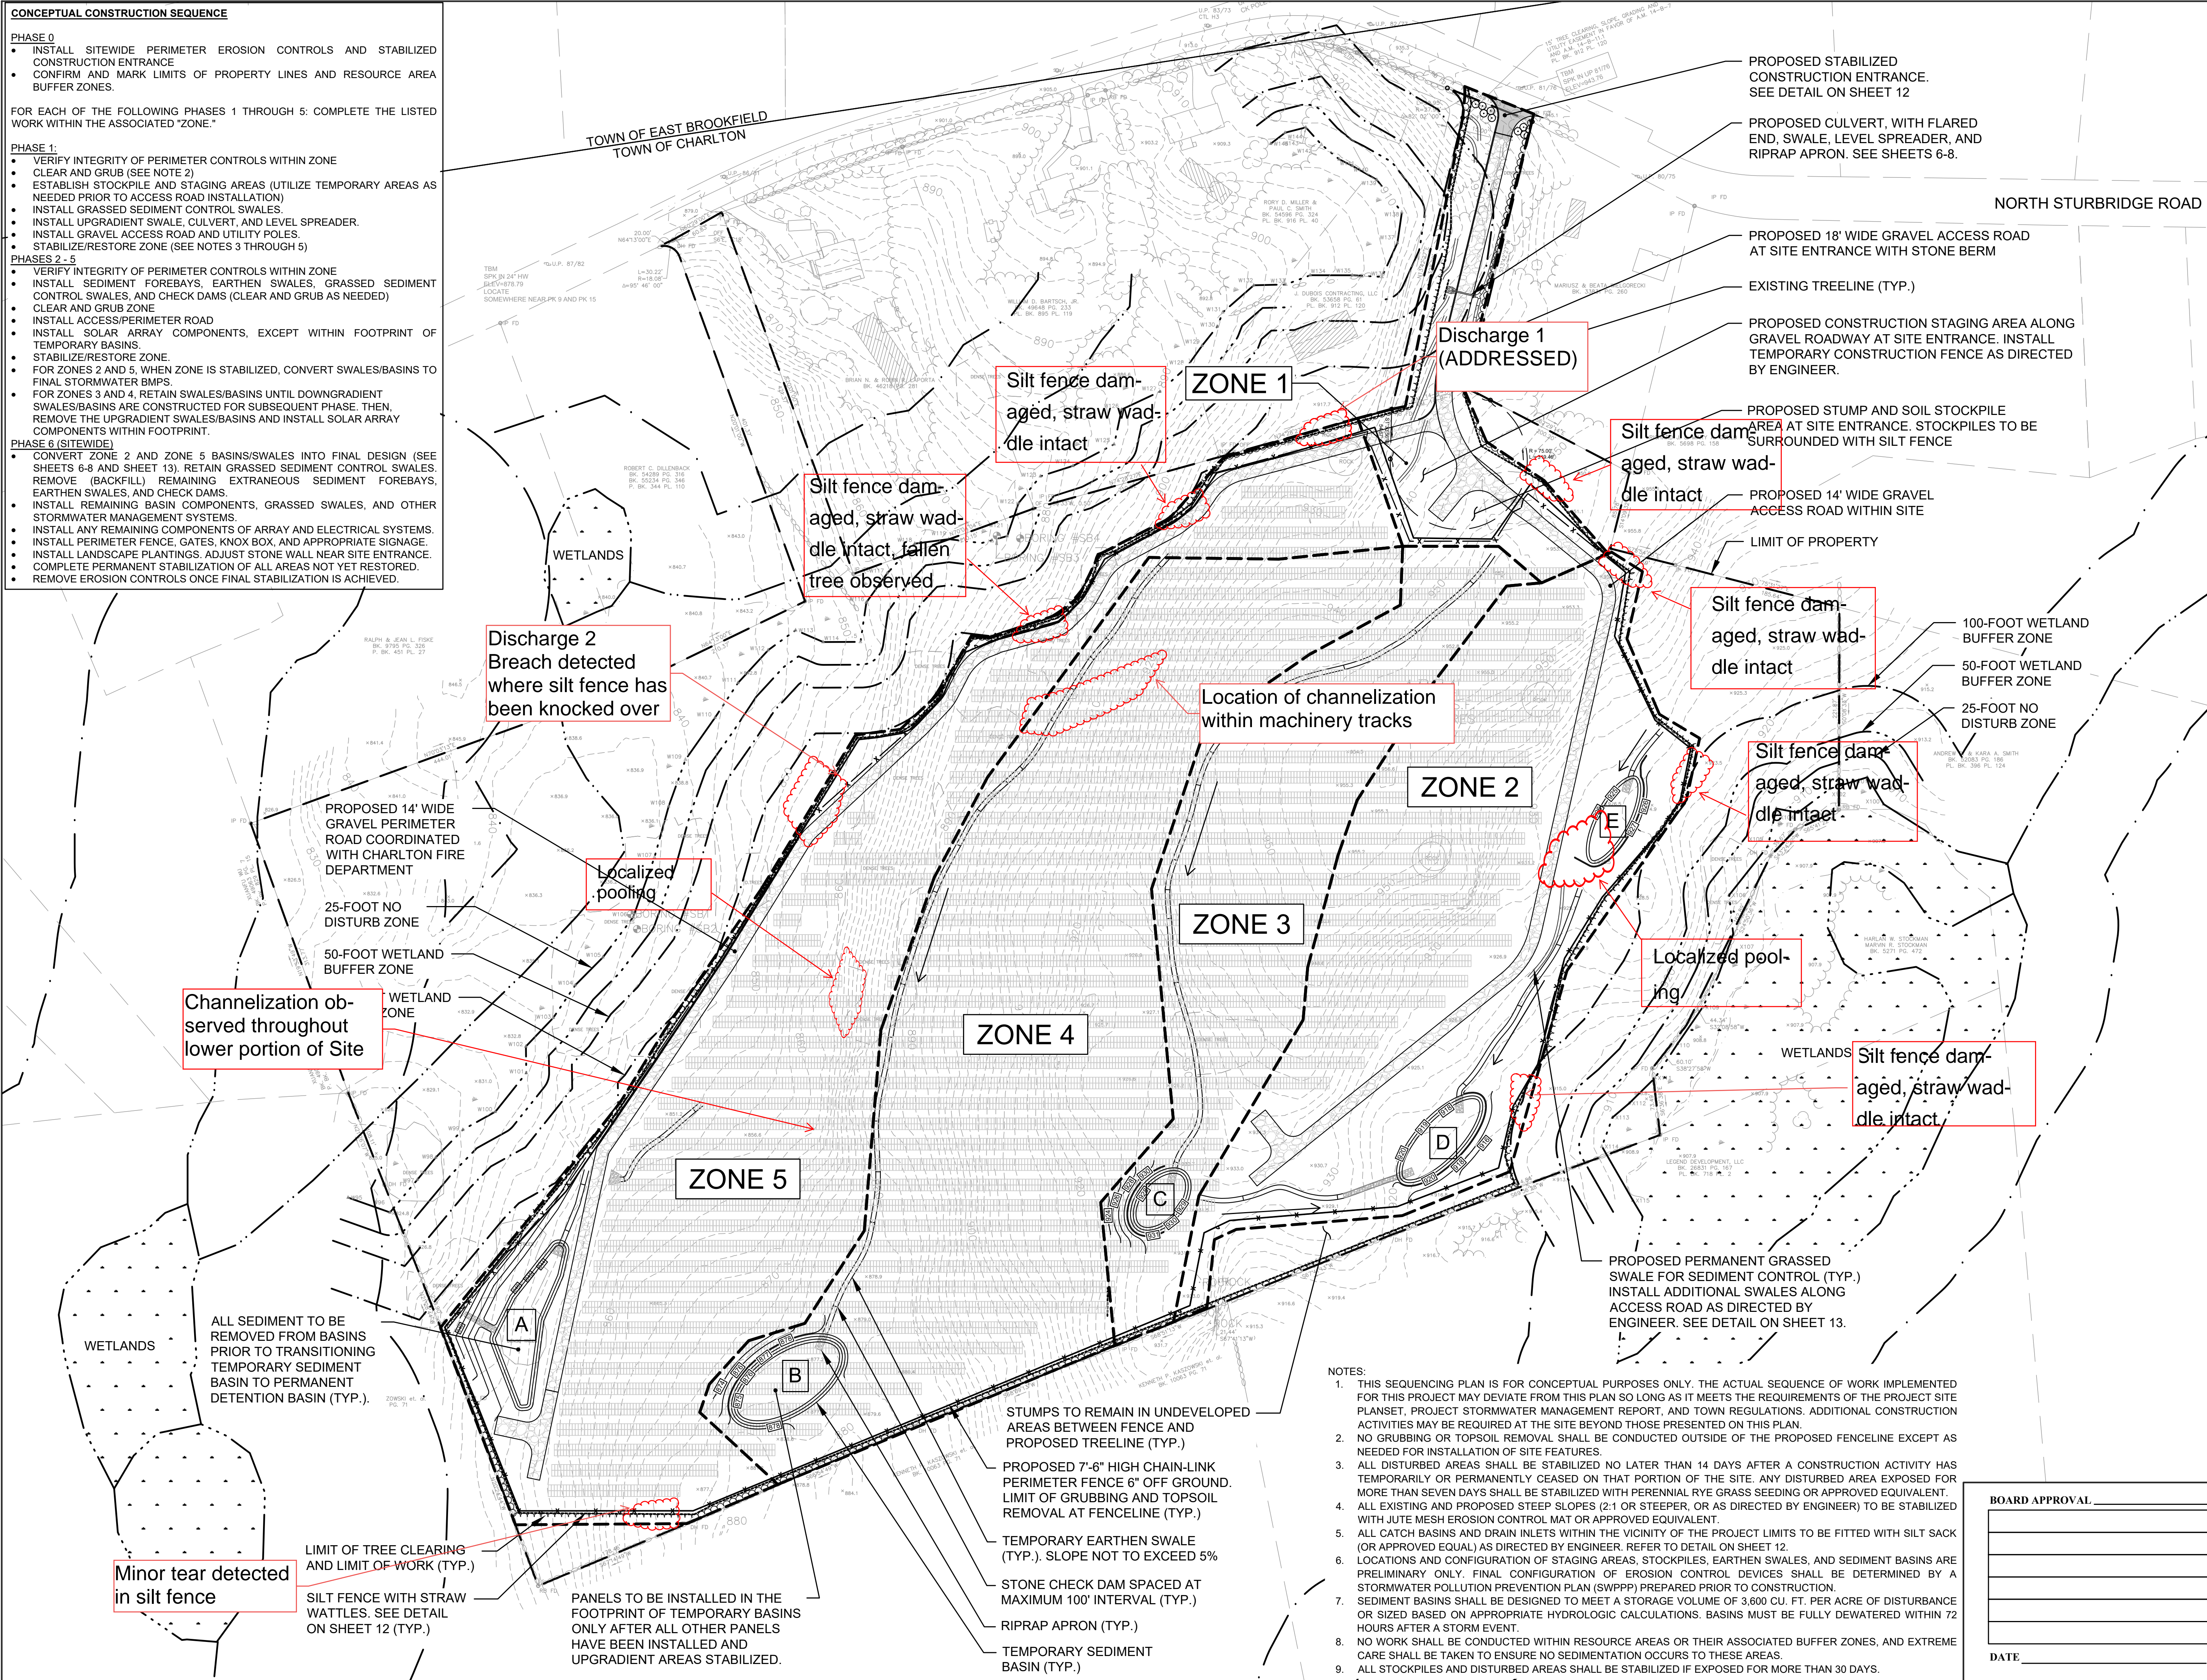
**FIGURE 1:
 SWPPP
 INSPECTION
 SKETCH
 11/15/2021**

2. Informal access road along northern portion of the Site	Straw mulch or hydroseed	<input type="checkbox"/> Yes [Enter date] <input checked="" type="checkbox"/> No	Erosion channels are beginning to form within upgradient portions of the informal access road (Figure 1). The contractor indicated that stabilization by smoothing out soils and seeding or spreading mulch would occur on 7/30/2021. Stabilization of this area has not been initiated. After inspection of the area on 8/24/2021, it was determined that

Channelization observed throughout lower portion of Site

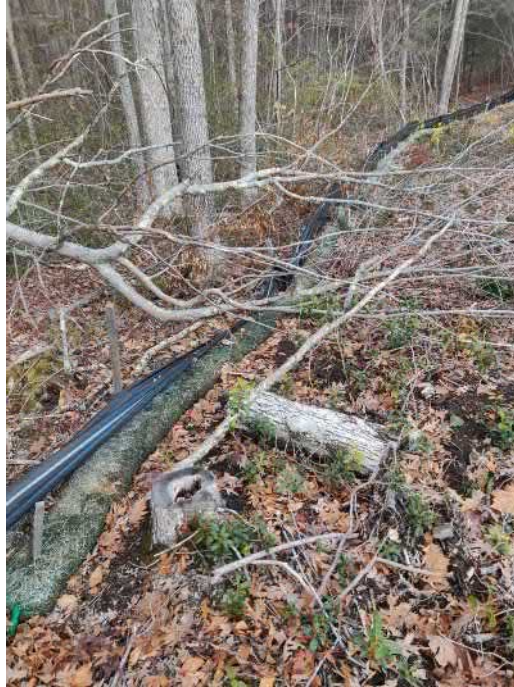
Photo 1

2. Stabilized Construction Entrance (Site Entrance – Access Road)	No (As of 9/2/2021)	No		<p>A tree was knocked over and laying on the silt fence on the on the northwestern portion of the site in Zone 5.</p> <p>Hydroseed was applied to exposed soil in this area and continues to germinate, some grass seedlings are now observed.</p>

View of tree fallen on northwestern portion of Zone 5.

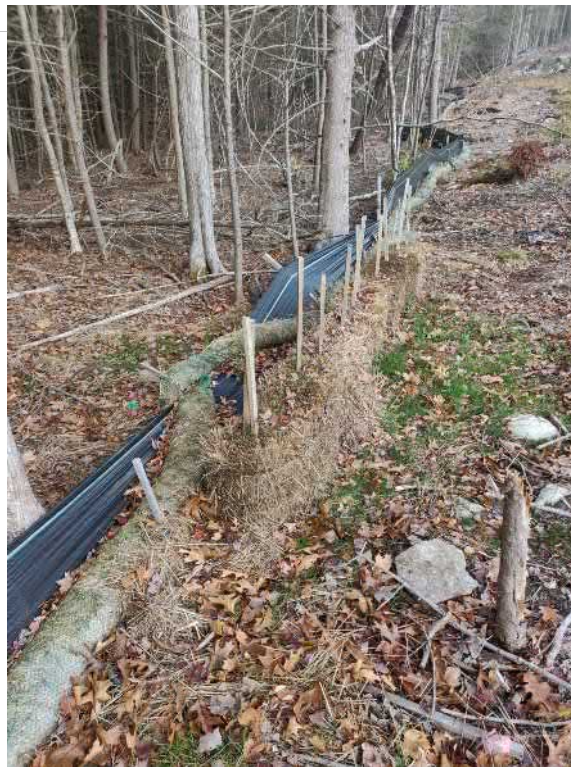
Photo 2

Type/Location of E&S Control	Maintenance Needed?*			
1. Silt Fence and Straw Wattles	Yes (As of 9/2/2021)	No	9/2/2021	<p>A breach was observed at Discharge 2. Although the double row of straw bales is intact, silt fence was observed to be knocked over and signs of stormwater flow were detected in the area beyond the fence.</p> <p>A minor tear was identified in a section of silt fence on the southern side of the Site with no erosion observed.</p> <p>Minor degradation of a straw wattle was observed on the southeastern side of the Site; no erosion was observed but pools of water were found to be forming behind the straw wattle.</p>

View of area downgradient of Discharge 2—facing north west.

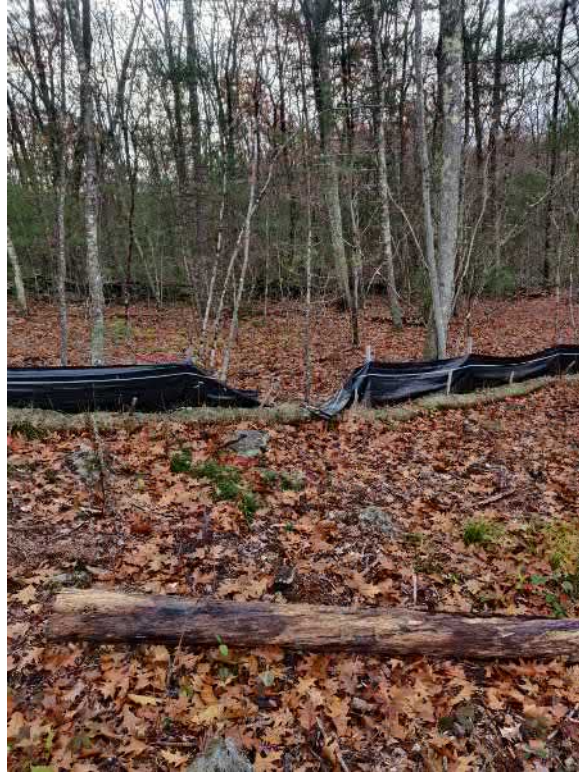
Photo 3

View of the damaged silt fence in southern perimeter of Site —facing south.

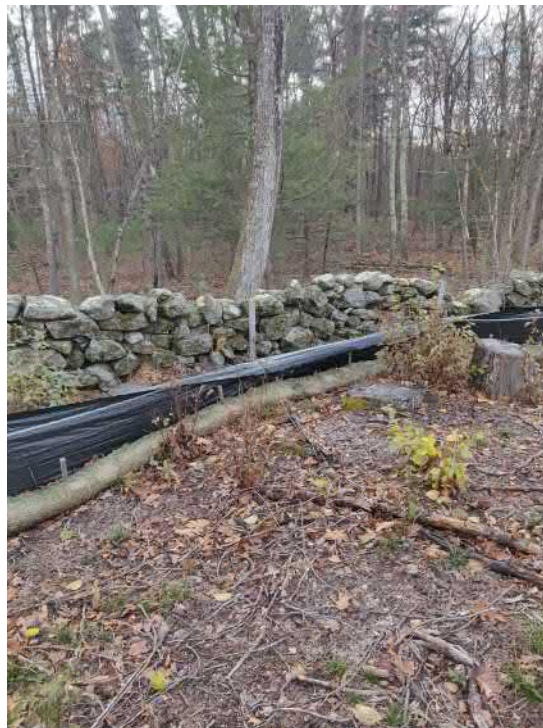
Photo 4

View of damaged silt fence in south west portion of the Site —facing south west

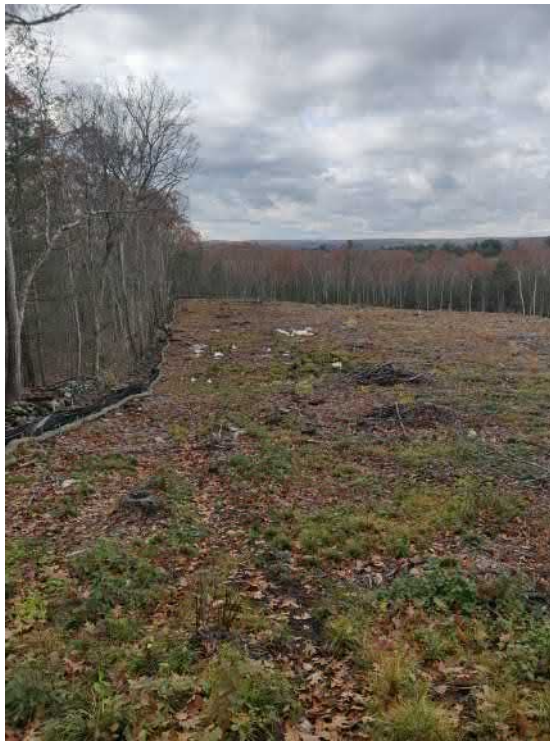
Photo 5

7. Topsoil Re-Use	N/A	N/A	10/05/ 2021	observed within areas of disturbed soils within the limits of work; however, little to no germination was observed within the disturbed area downgradient of the limit of work. Additional seed should be hand-applied in this area.
8. Storm Drain Inlets (North Brookfield Road)	N/A	N/A		The areas downgradient of Discharges 1 and 2 have been stabilized with straw and seed. These areas will be monitored for germination and stabilization.
9. Temporary Drainage Swales (Throughout Site)	N/A	N/A	10/29/ 2021	Seedling growth is observed
10. Temporary Sediment Basins	N/A	N/A		Localized pooling is observed in the eastern portion of the site.

View of the water pooling in eastern perimeter of Site —facing south east.

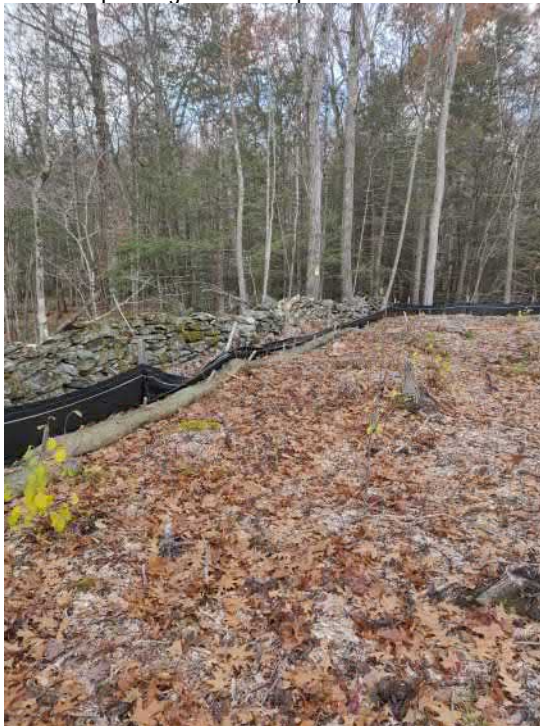
Photo 6

View of damaged silt fence in south west portion of the Site —facing south west

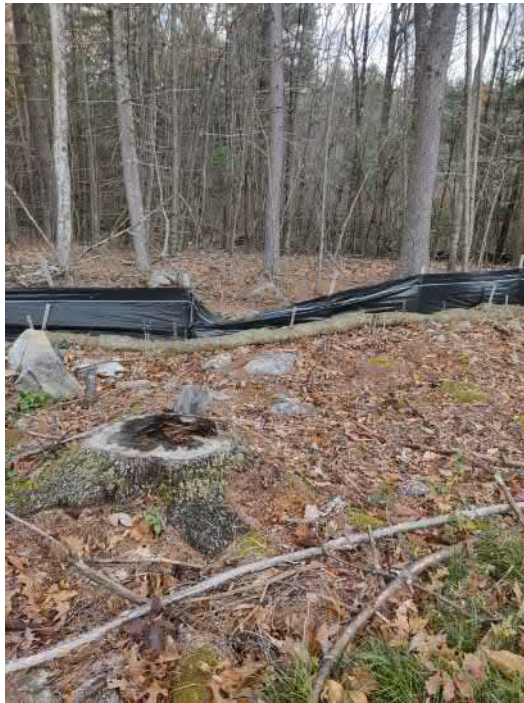
Photo 7

3. Stump and Soil Stockpile Area	No (As of 7/22/2021)	No	10/29/2021	<p>Minor tears were observed in the silt fence along the eastern boundaries of the Site, due to staples becoming dislodged from wooden stakes. The straw wattles are still intact.</p>

View of damaged silt fence in eastern portion of the Site —facing east

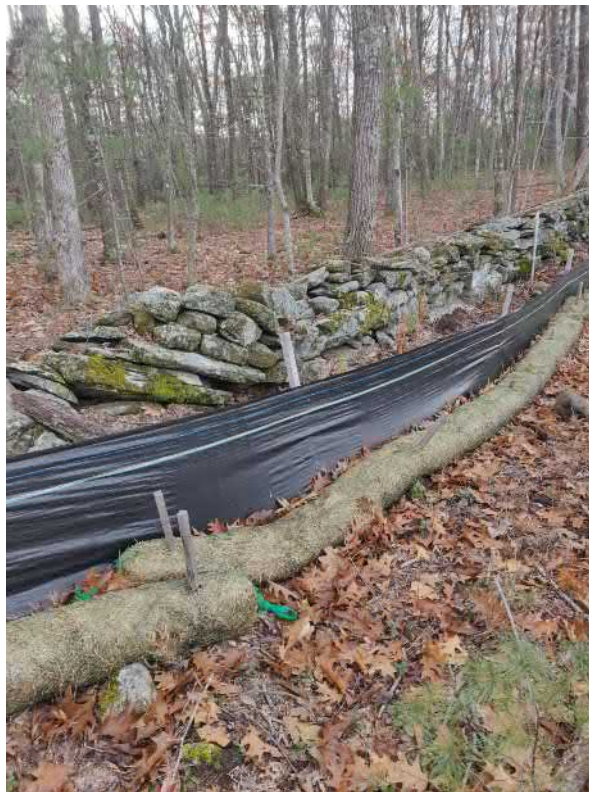
Photo 8

View of damaged silt fence in eastern portion of the Site —facing east

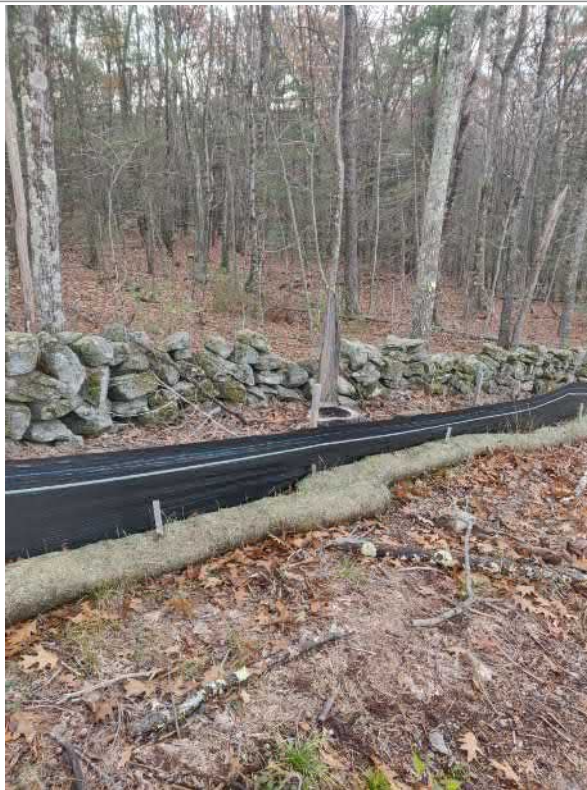
Photo 9

View of damaged silt fence in eastern portion of the Site —facing east

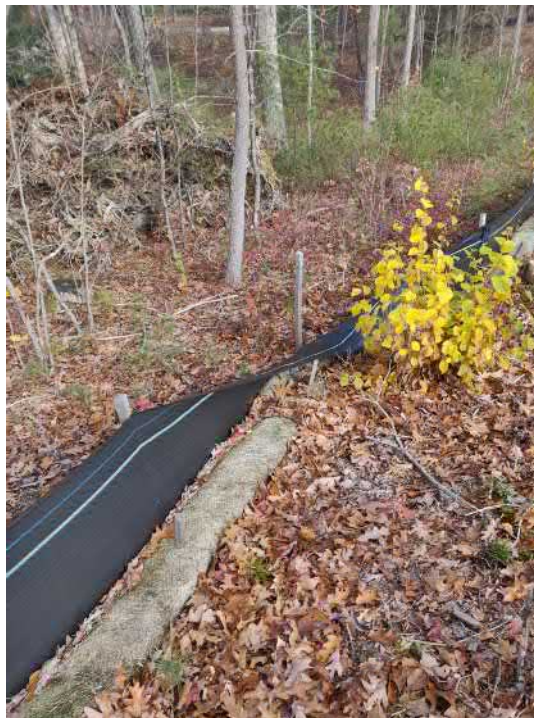
Photo 10

View of damaged silt fence in north western portion of the Site —facing north west
