Inspection Report for North Sturbridge Road Solar Facility

NPDES ID No.: MAR10031G

Inspection Date: 11/19/2021

**FIGURE 1:
SWPPP
INSPECTION
SKETCH
11/19/2021**

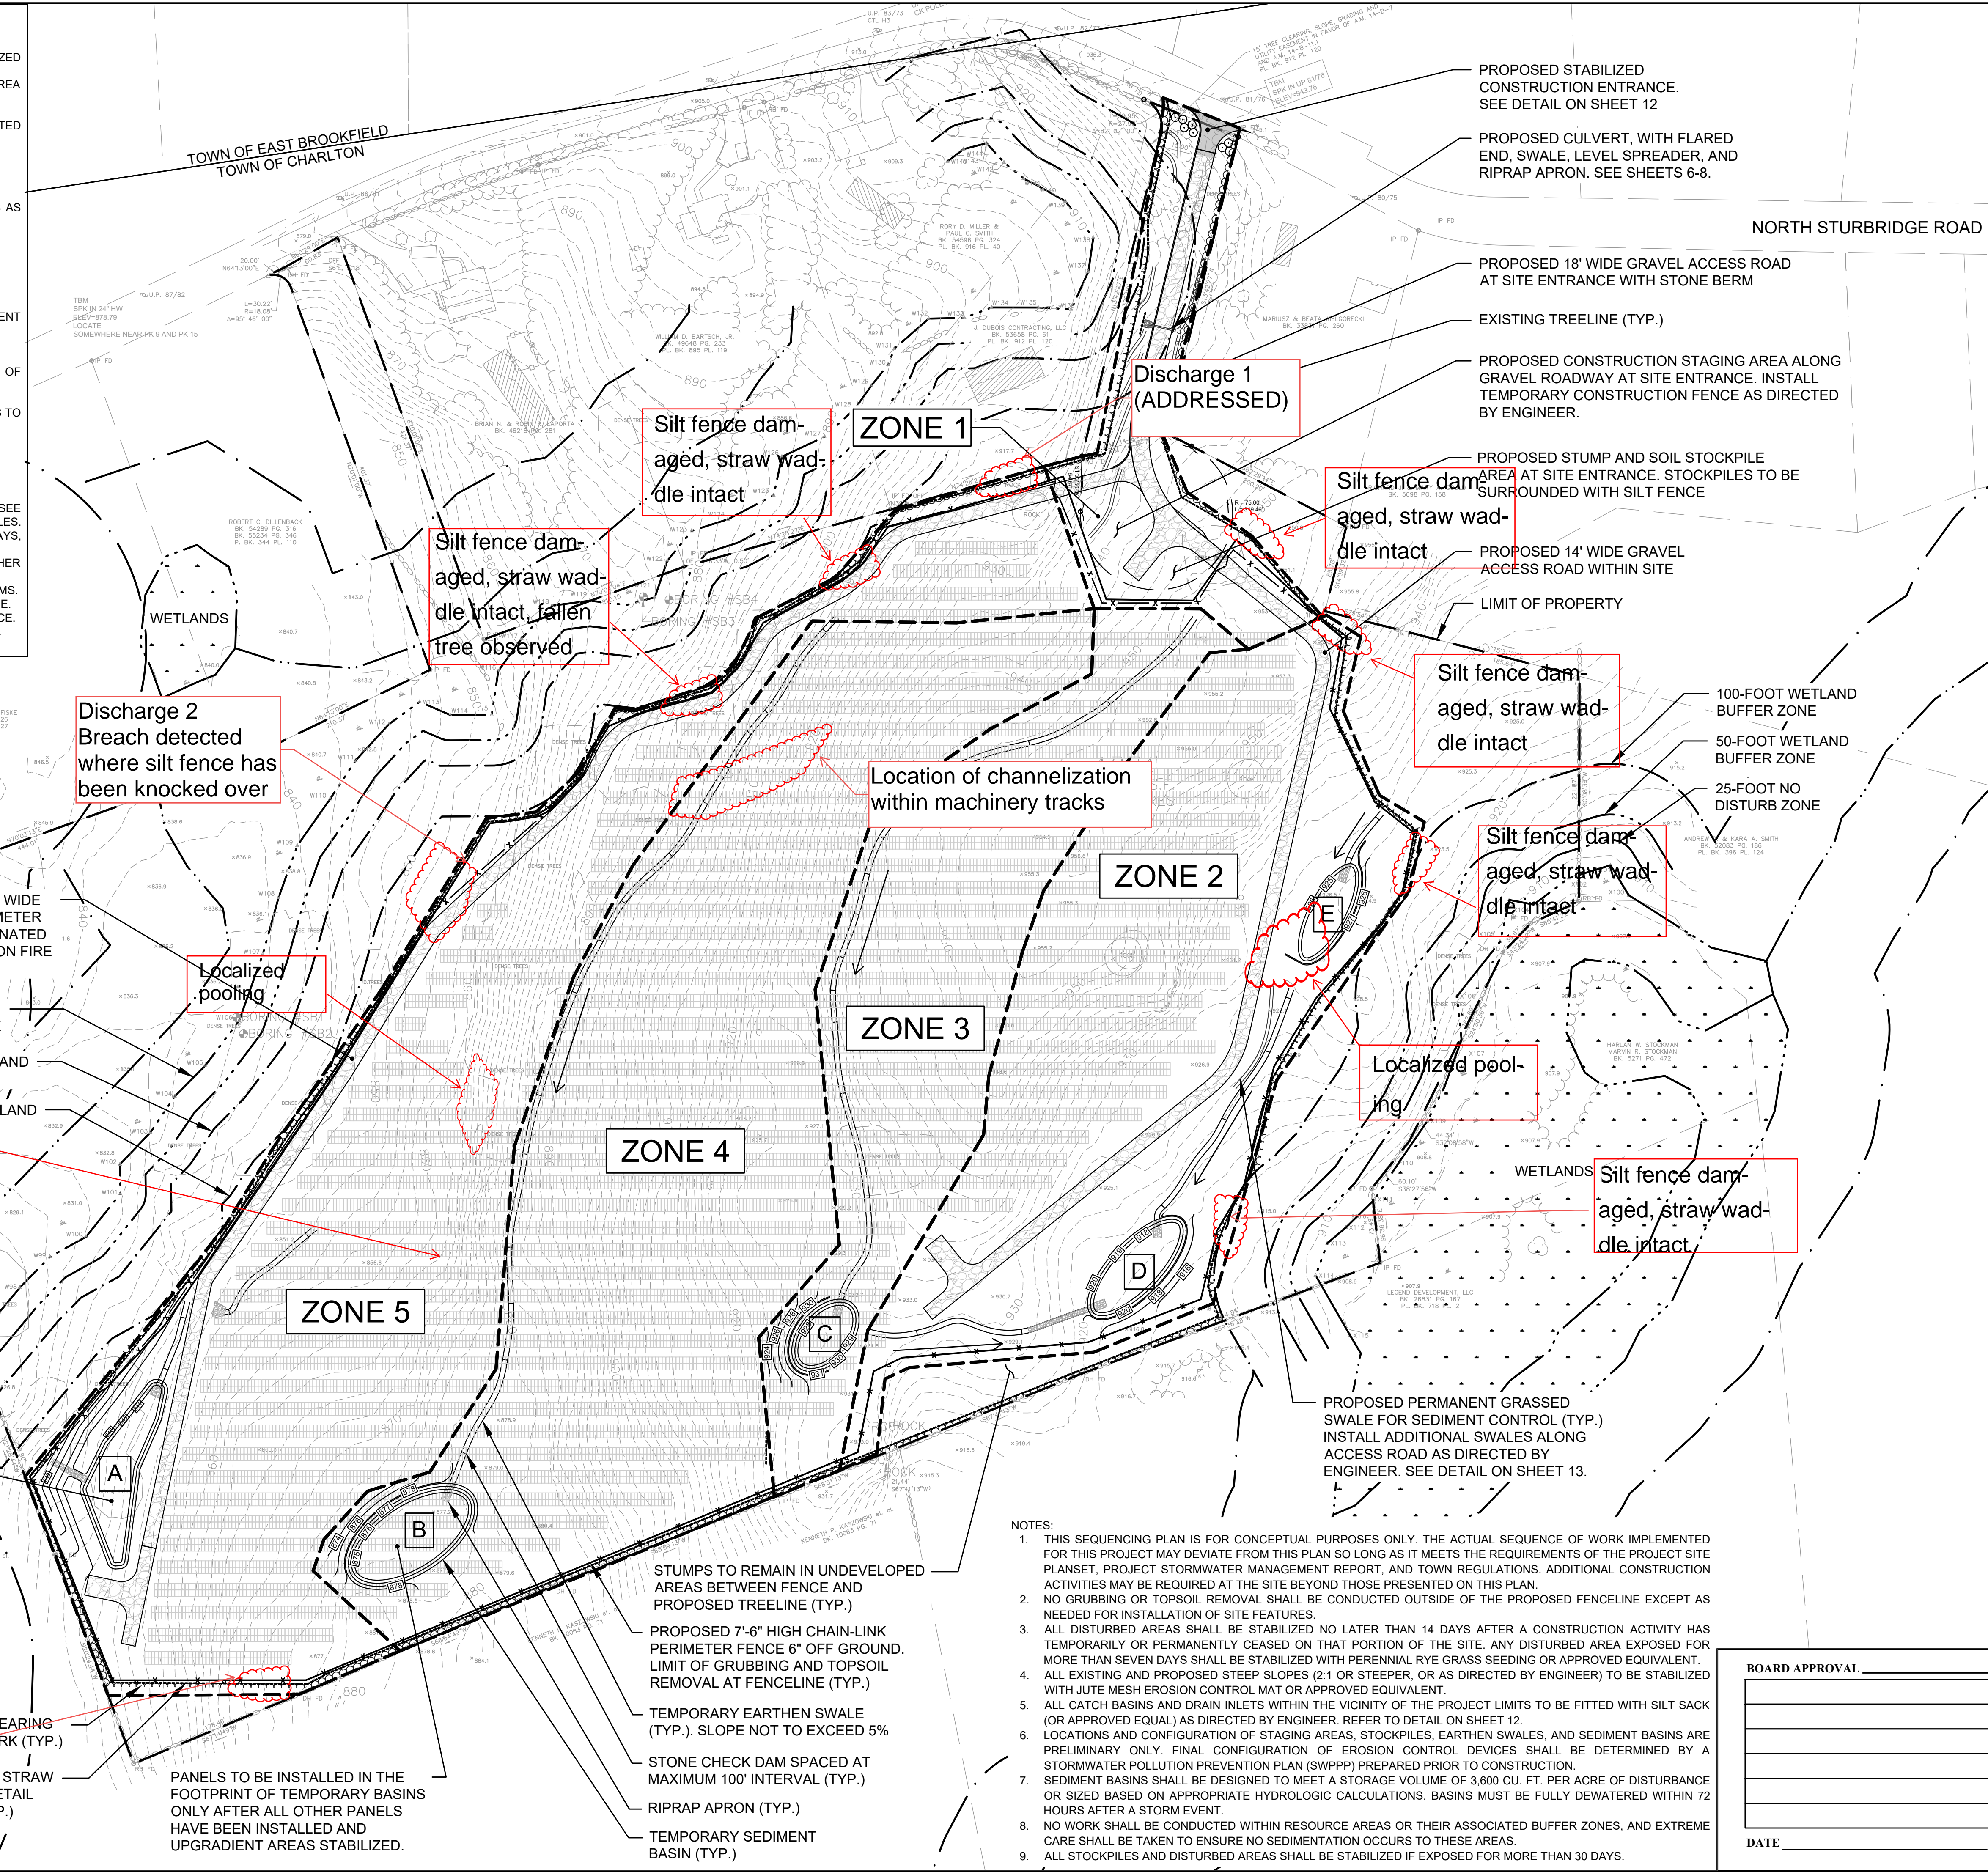
Localized pooling

Silt fence damaged, straw wad-dle intact

Minor tear detected in silt fence

Channelization observed throughout lower portion of Site

Discharge 2 Breach detected where silt fence has been knocked over

Silt fence damaged, straw wad-dle intact, fallen tree observed

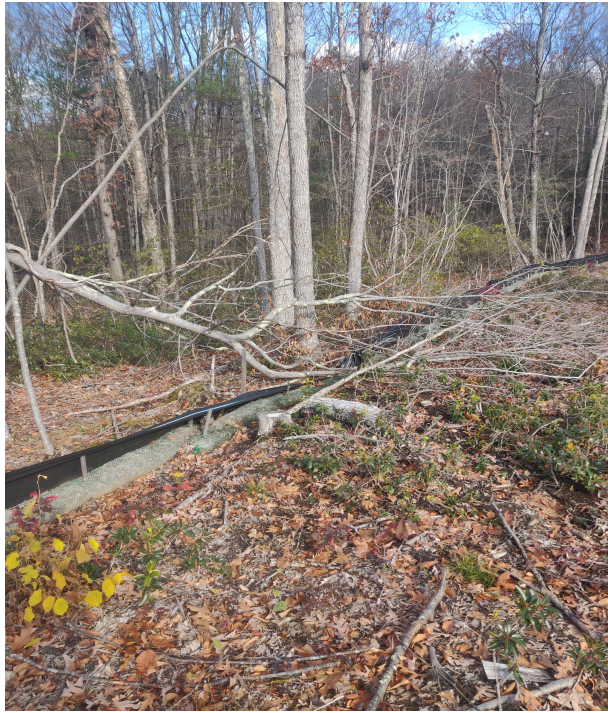
Photo 1

2. Stabilized Construction Entrance (Site Entrance – Access Road)	No (As of 9/2/2021)	No		<p>A tree was knocked over and laying on the silt fence on the on the northwestern portion of the site in Zone 5.</p> <p>Hydroseed was applied to exposed soil in this area and continues to germinate, some grass seedlings are now observed.</p>

View of tree fallen on northwestern portion of Zone 5.

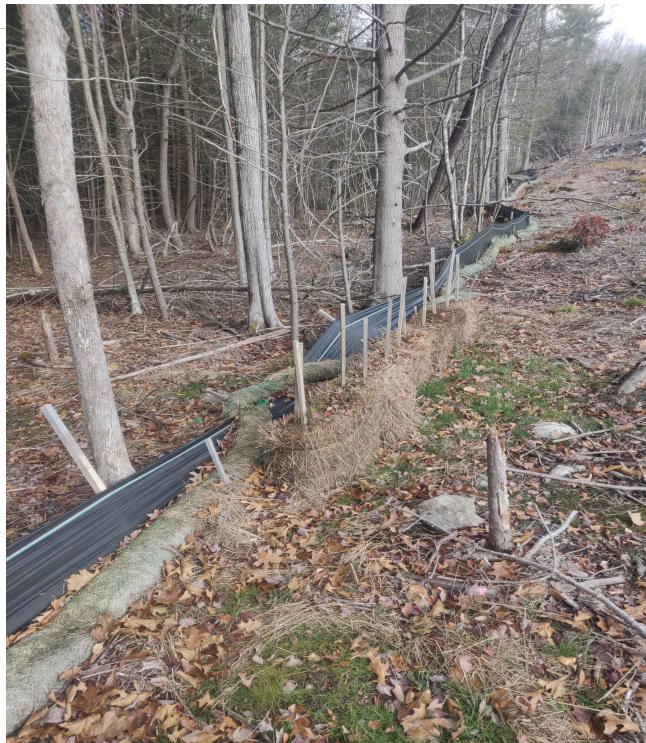
Photo 2

Type/Location of E&S Control	Maintenance Needed?*			
1. Silt Fence and Straw Wattles	Yes (As of 9/2/2021)	No	9/2/2021	<p>A breach was observed at Discharge 2. Although the double row of straw bales is intact, silt fence was observed to be knocked over and signs of stormwater flow were detected in the area beyond the fence.</p> <p>A minor tear was identified in a section of silt fence on the southern side of the Site with no erosion observed.</p> <p>Minor degradation of a straw wattle was observed on the southeastern side of the Site; no erosion was observed but pools of water were found to be forming behind the straw wattle.</p>

View of area downgradient of Discharge 2—facing north west.

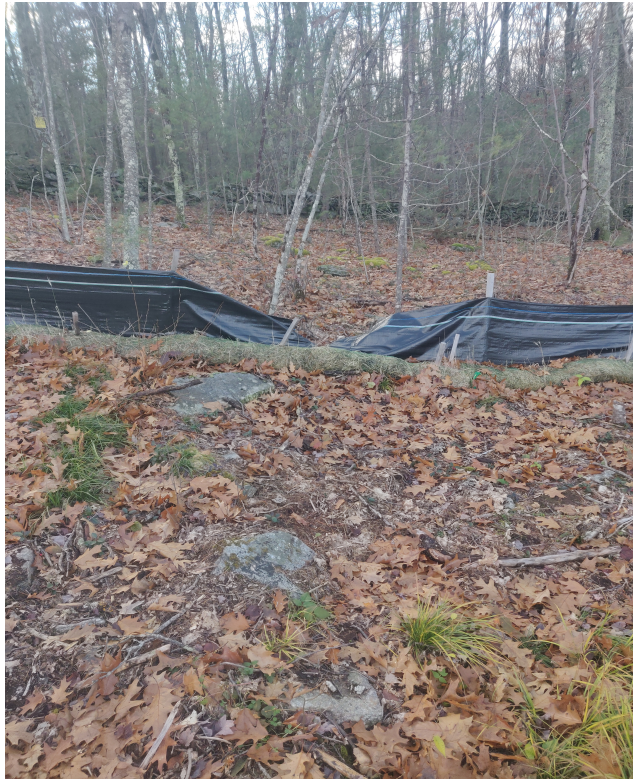
Photo 3

View of the damaged silt fence in southern perimeter of Site —facing south.

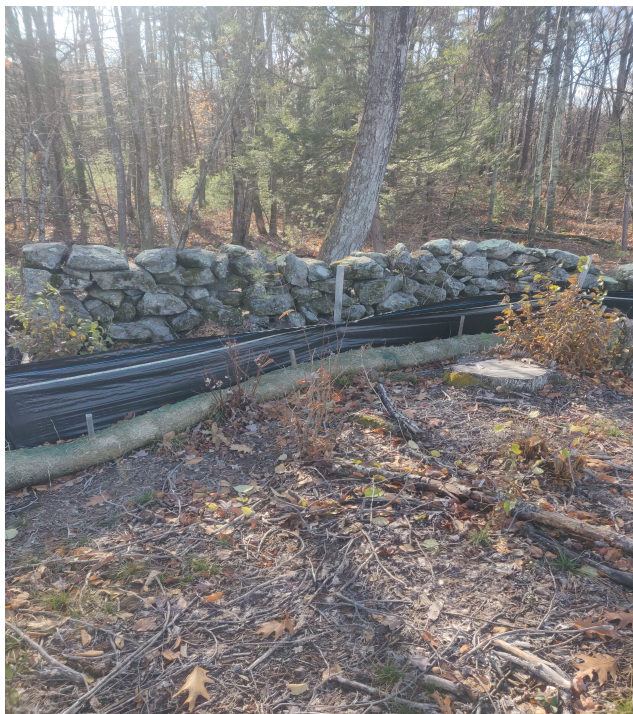
Photo 4

View of damaged silt fence in south west portion of the Site —facing south west

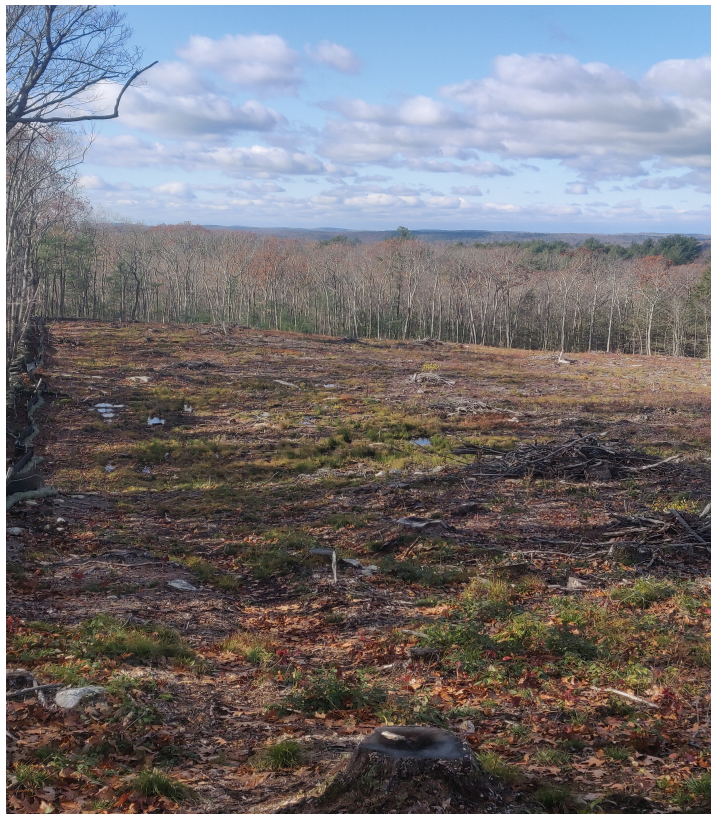
Photo 5

7. Topsoil Re-Use	N/A	N/A	10/05/ 2021	observed within areas of disturbed soils within the limits of work; however, little to no germination was observed within the disturbed area downgradient of the limit of work. Additional seed should be hand-applied in this area.
8. Storm Drain Inlets (North Brookfield Road)	N/A	N/A		The areas downgradient of Discharges 1 and 2 have been stabilized with straw and seed. These areas will be monitored for germination and stabilization.
9. Temporary Drainage Swales (Throughout Site)	N/A	N/A	10/29/ 2021	Seedling growth is observed
10. Temporary Sediment Basins	N/A	N/A		Localized pooling is observed in the eastern portion of the site.

View of the water pooling in eastern perimeter of Site —facing south east.

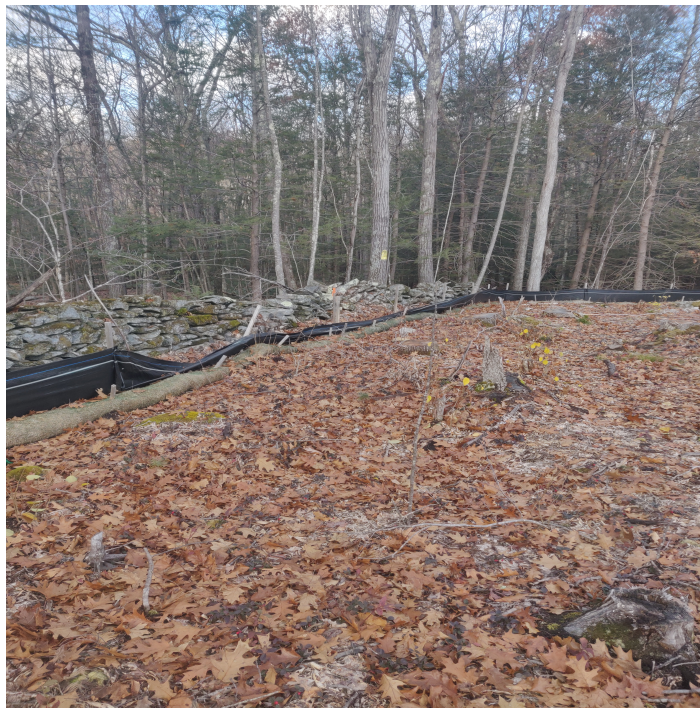
Photo 6

View of damaged silt fence in south west portion of the Site —facing south west

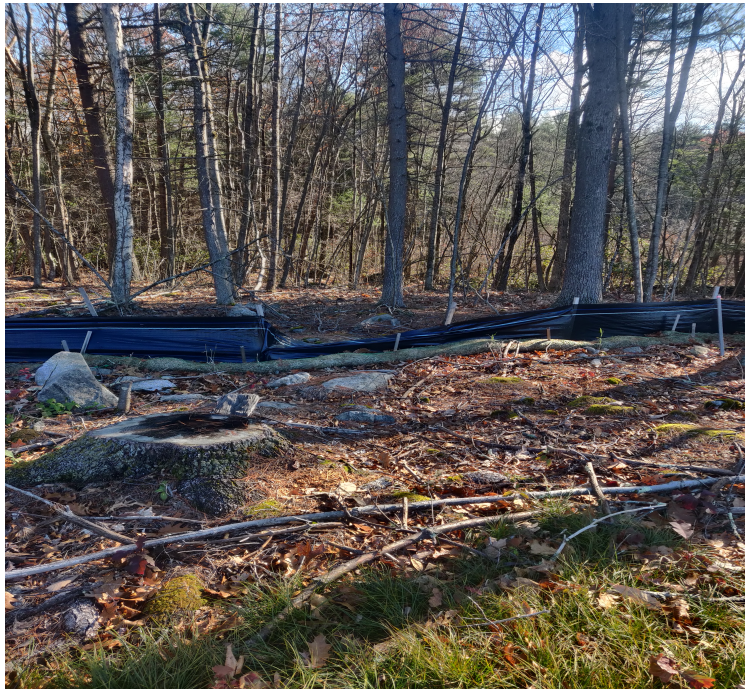
Photo 7

3. Stump and Soil Stockpile Area	No (As of 7/22/2021)	No	10/29/2021	<p>Minor tears were observed in the silt fence along the eastern boundaries of the Site, due to staples becoming dislodged from wooden stakes. The straw wattles are still intact.</p>

View of damaged silt fence in eastern portion of the Site —facing east

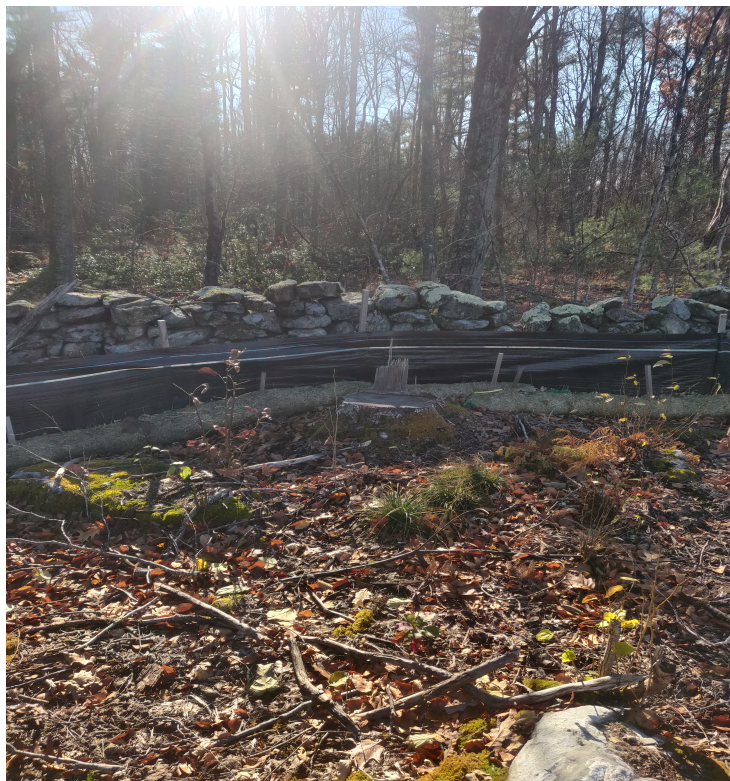
Photo 8

View of damaged silt fence in eastern portion of the Site —facing east

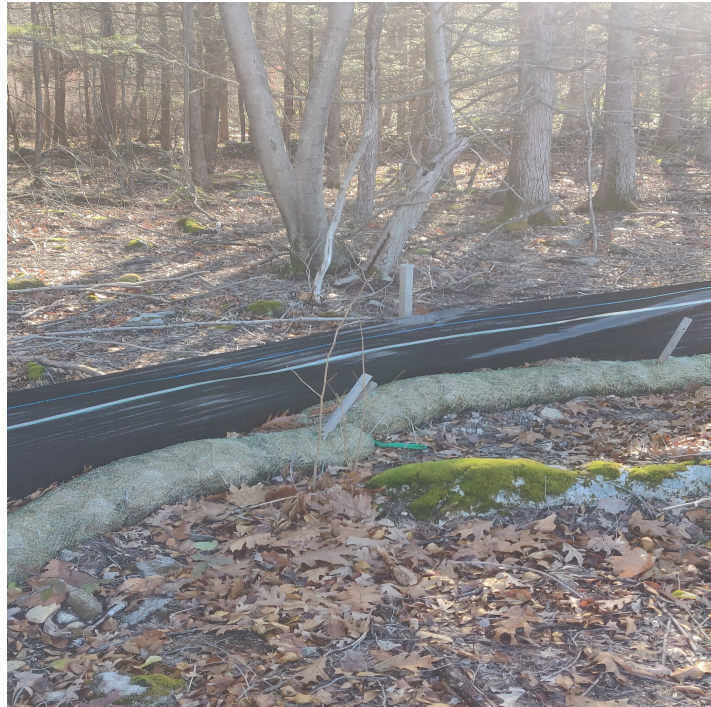
Photo 9

View of damaged silt fence in eastern portion of the Site —facing east

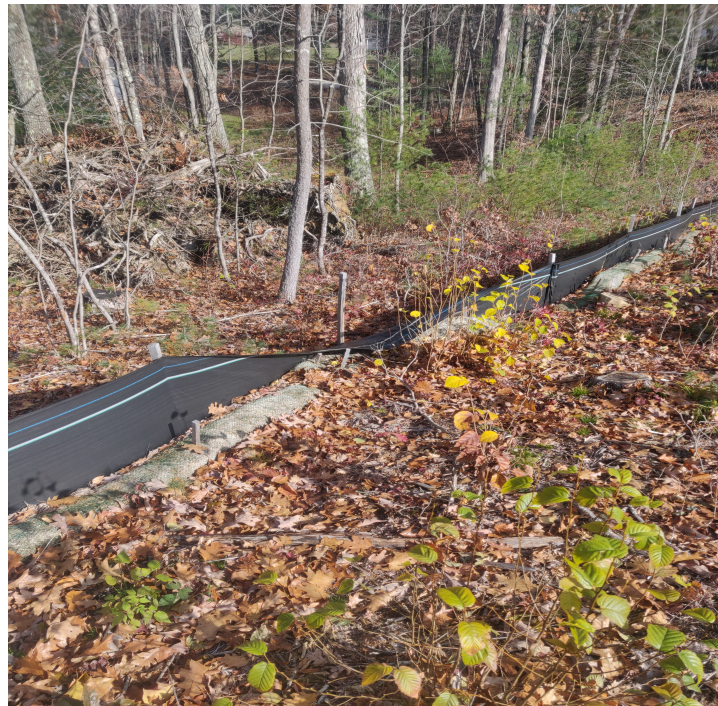
Photo 10

View of damaged silt fence in north western portion of the Site —facing north west
