Inspection Report for North Sturbridge Road Solar Facility

NPDES ID No.: MAR10031G

Inspection Date: 11/19/2021

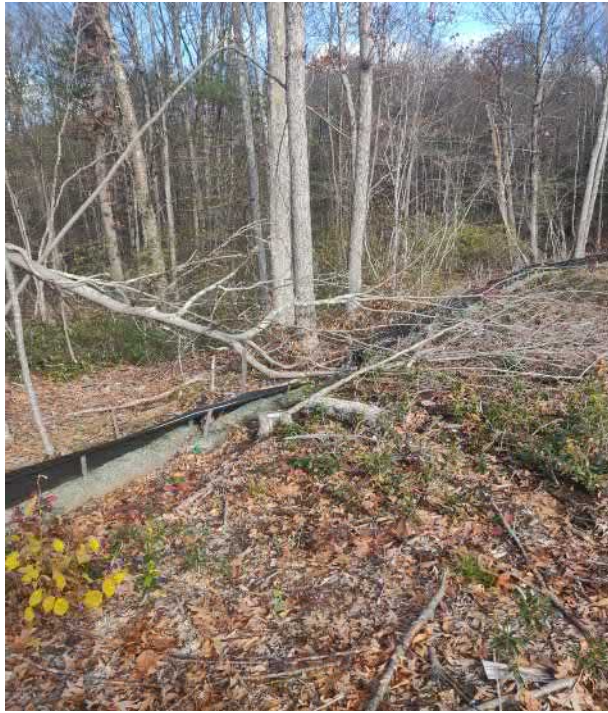
Photo 1

2. Stabilized Construction Entrance (Site Entrance – Access Road)	No (As of 9/2/2021)	No		<p>A tree was knocked over and laying on the silt fence on the on the northwestern portion of the site in Zone 5.</p> <p>Hydroseed was applied to exposed soil in this area and continues to germinate, some grass seedlings are now observed.</p>

View of tree fallen on northwestern portion of Zone 5.

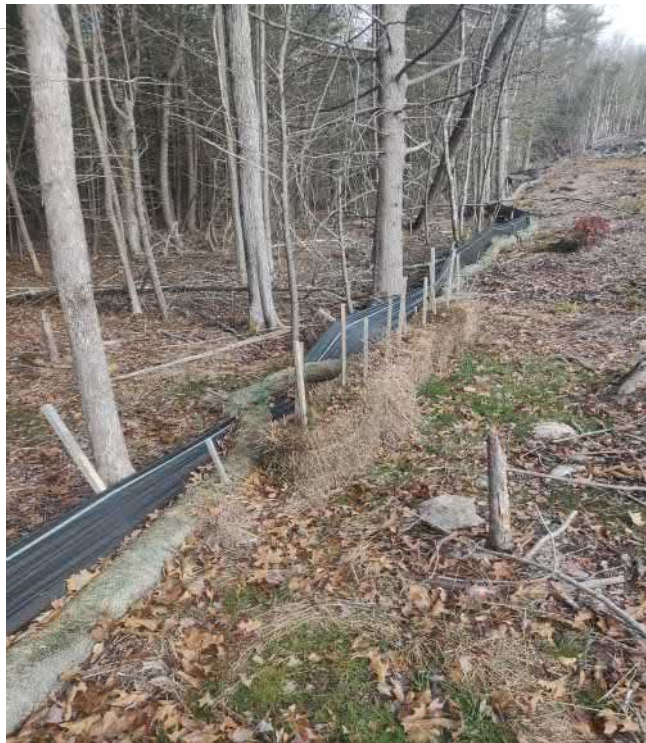
Photo 2

Type/Location of E&S Control	Maintenance Needed?*			
1. Silt Fence and Straw Wattles	Yes (As of 9/2/2021)	No	9/2/2021	<p>A breach was observed at Discharge 2. Although the double row of straw bales is intact, silt fence was observed to be knocked over and signs of stormwater flow were detected in the area beyond the fence.</p> <p>A minor tear was identified in a section of silt fence on the southern side of the Site with no erosion observed.</p> <p>Minor degradation of a straw wattle was observed on the southeastern side of the Site; no erosion was observed but pools of water were found to be forming behind the straw wattle.</p>

View of area downgradient of Discharge 2—facing north west.

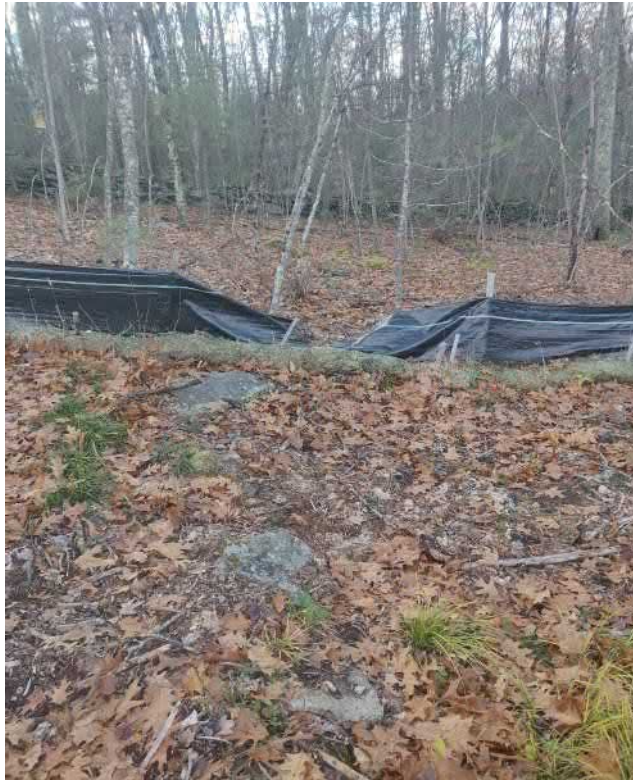
Photo 3

View of the damaged silt fence in southern perimeter of Site —facing south.

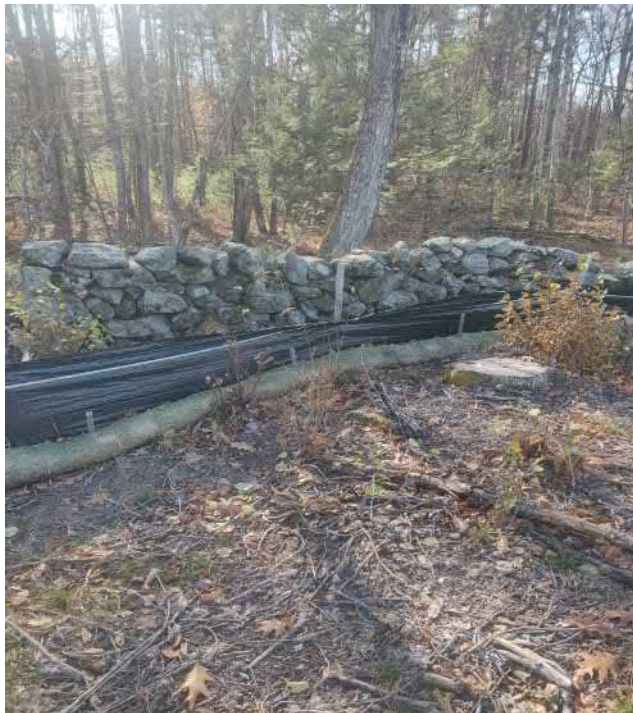
Photo 4

View of damaged silt fence in south west portion of the Site —facing south west

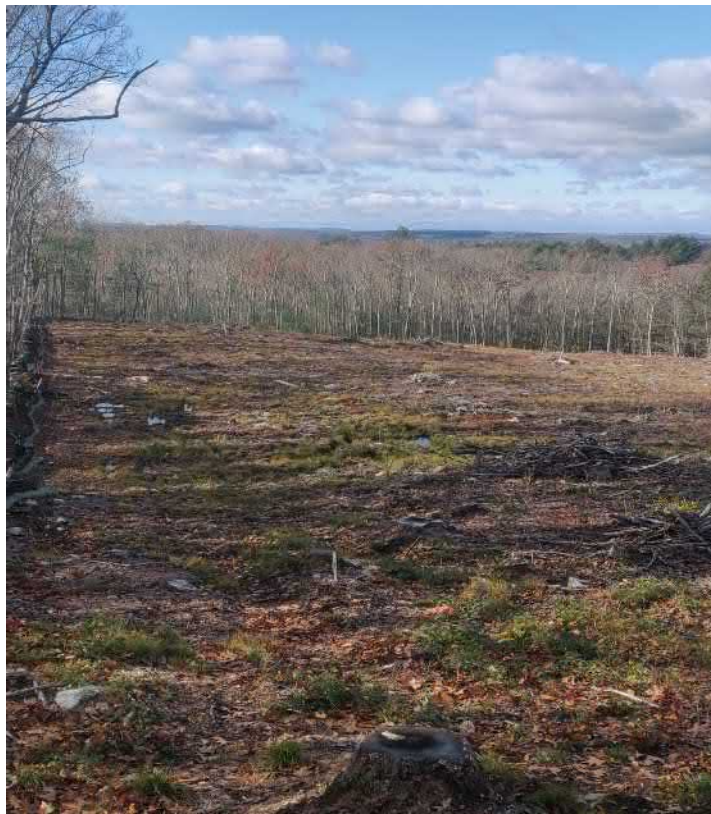
Photo 5

7. Topsoil Re-Use	N/A	N/A	10/05/ 2021	observed within areas of disturbed soils within the limits of work; however, little to no germination was observed within the disturbed area downgradient of the limit of work. Additional seed should be hand-applied in this area.
8. Storm Drain Inlets (North Brookfield Road)	N/A	N/A		The areas downgradient of Discharges 1 and 2 have been stabilized with straw and seed. These areas will be monitored for germination and stabilization.
9. Temporary Drainage Swales (Throughout Site)	N/A	N/A	10/29/ 2021	Seedling growth is observed
10. Temporary Sediment Basins	N/A	N/A		Localized pooling is observed in the eastern portion of the site.

View of the water pooling in eastern perimeter of Site —facing south east.

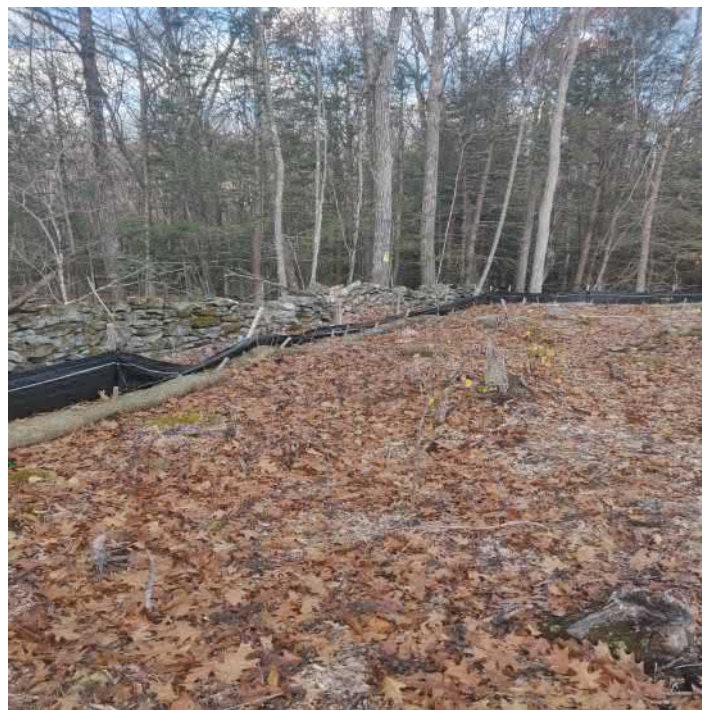
Photo 6

View of damaged silt fence in south west portion of the Site —facing south west

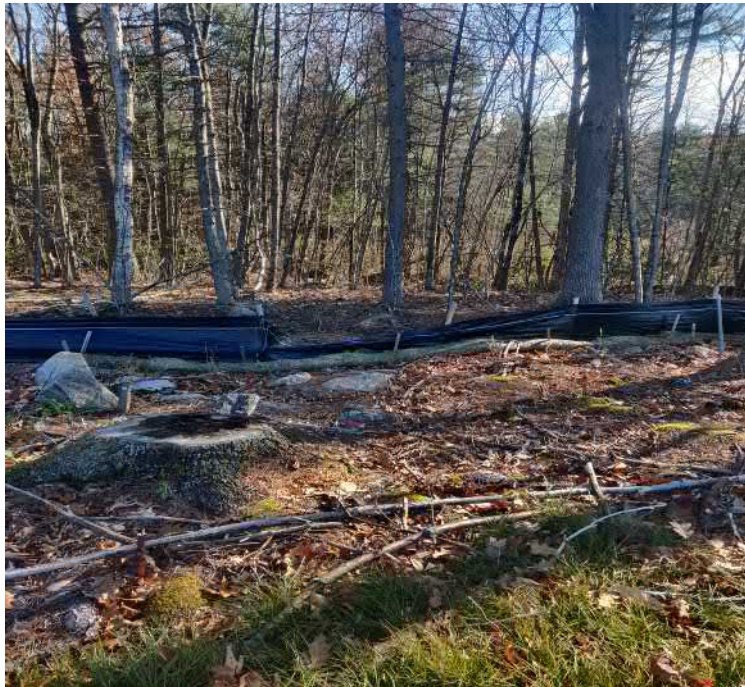
Photo 7

3. Stump and Soil Stockpile Area	No (As of 7/22/2021)	No	10/29/2021	<p>Minor tears were observed in the silt fence along the eastern boundaries of the Site, due to staples becoming dislodged from wooden stakes. The straw wattles are still intact.</p>

View of damaged silt fence in eastern portion of the Site —facing east

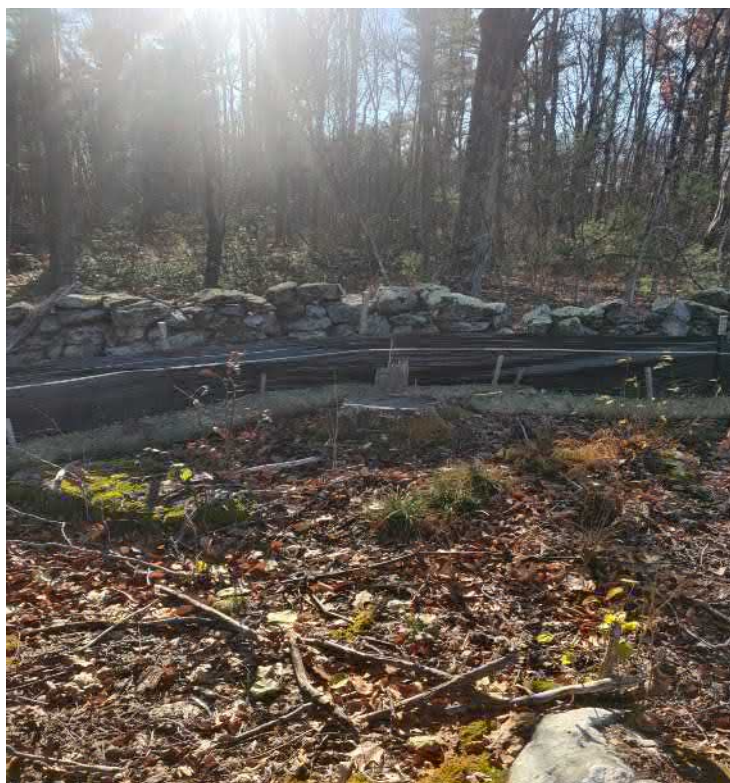
Photo 8

View of damaged silt fence in eastern portion of the Site —facing east

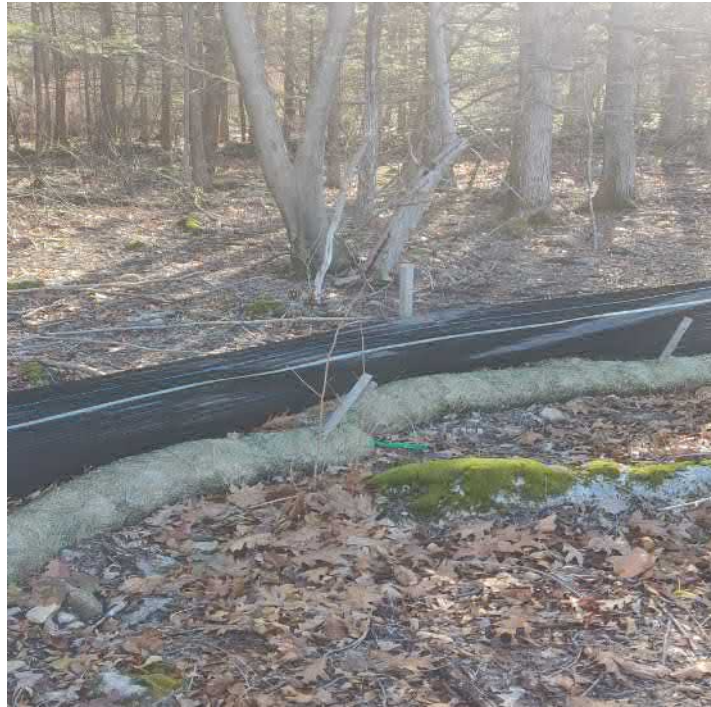
Photo 9

View of damaged silt fence in eastern portion of the Site —facing east

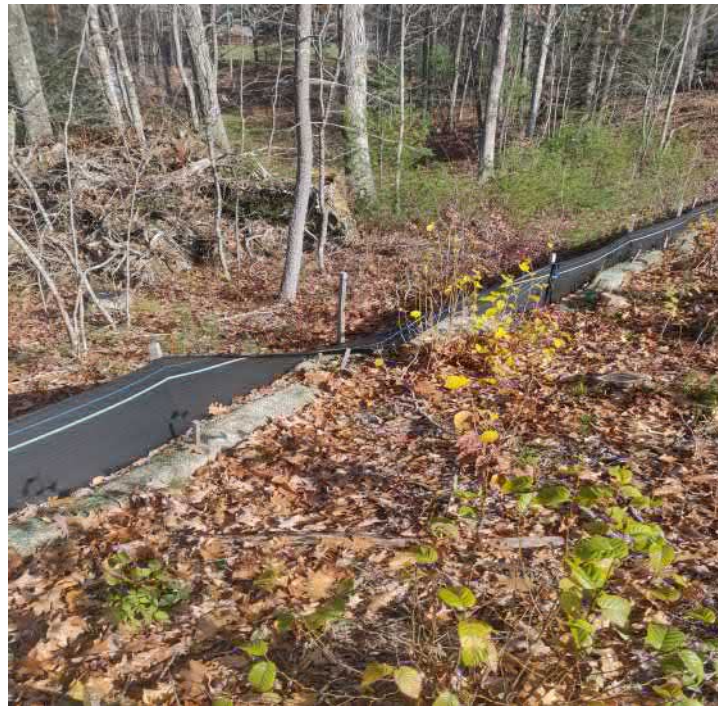
Photo 10

View of damaged silt fence in north western portion of the Site —facing north west
