Inspection Report for North Sturbridge Road Solar Facility

NPDES ID No.: MAR10031G

Inspection Date: 12/27/2021

**FIGURE 1:
SWPPP
INSPECTION
SKETCH
12/27/2021**

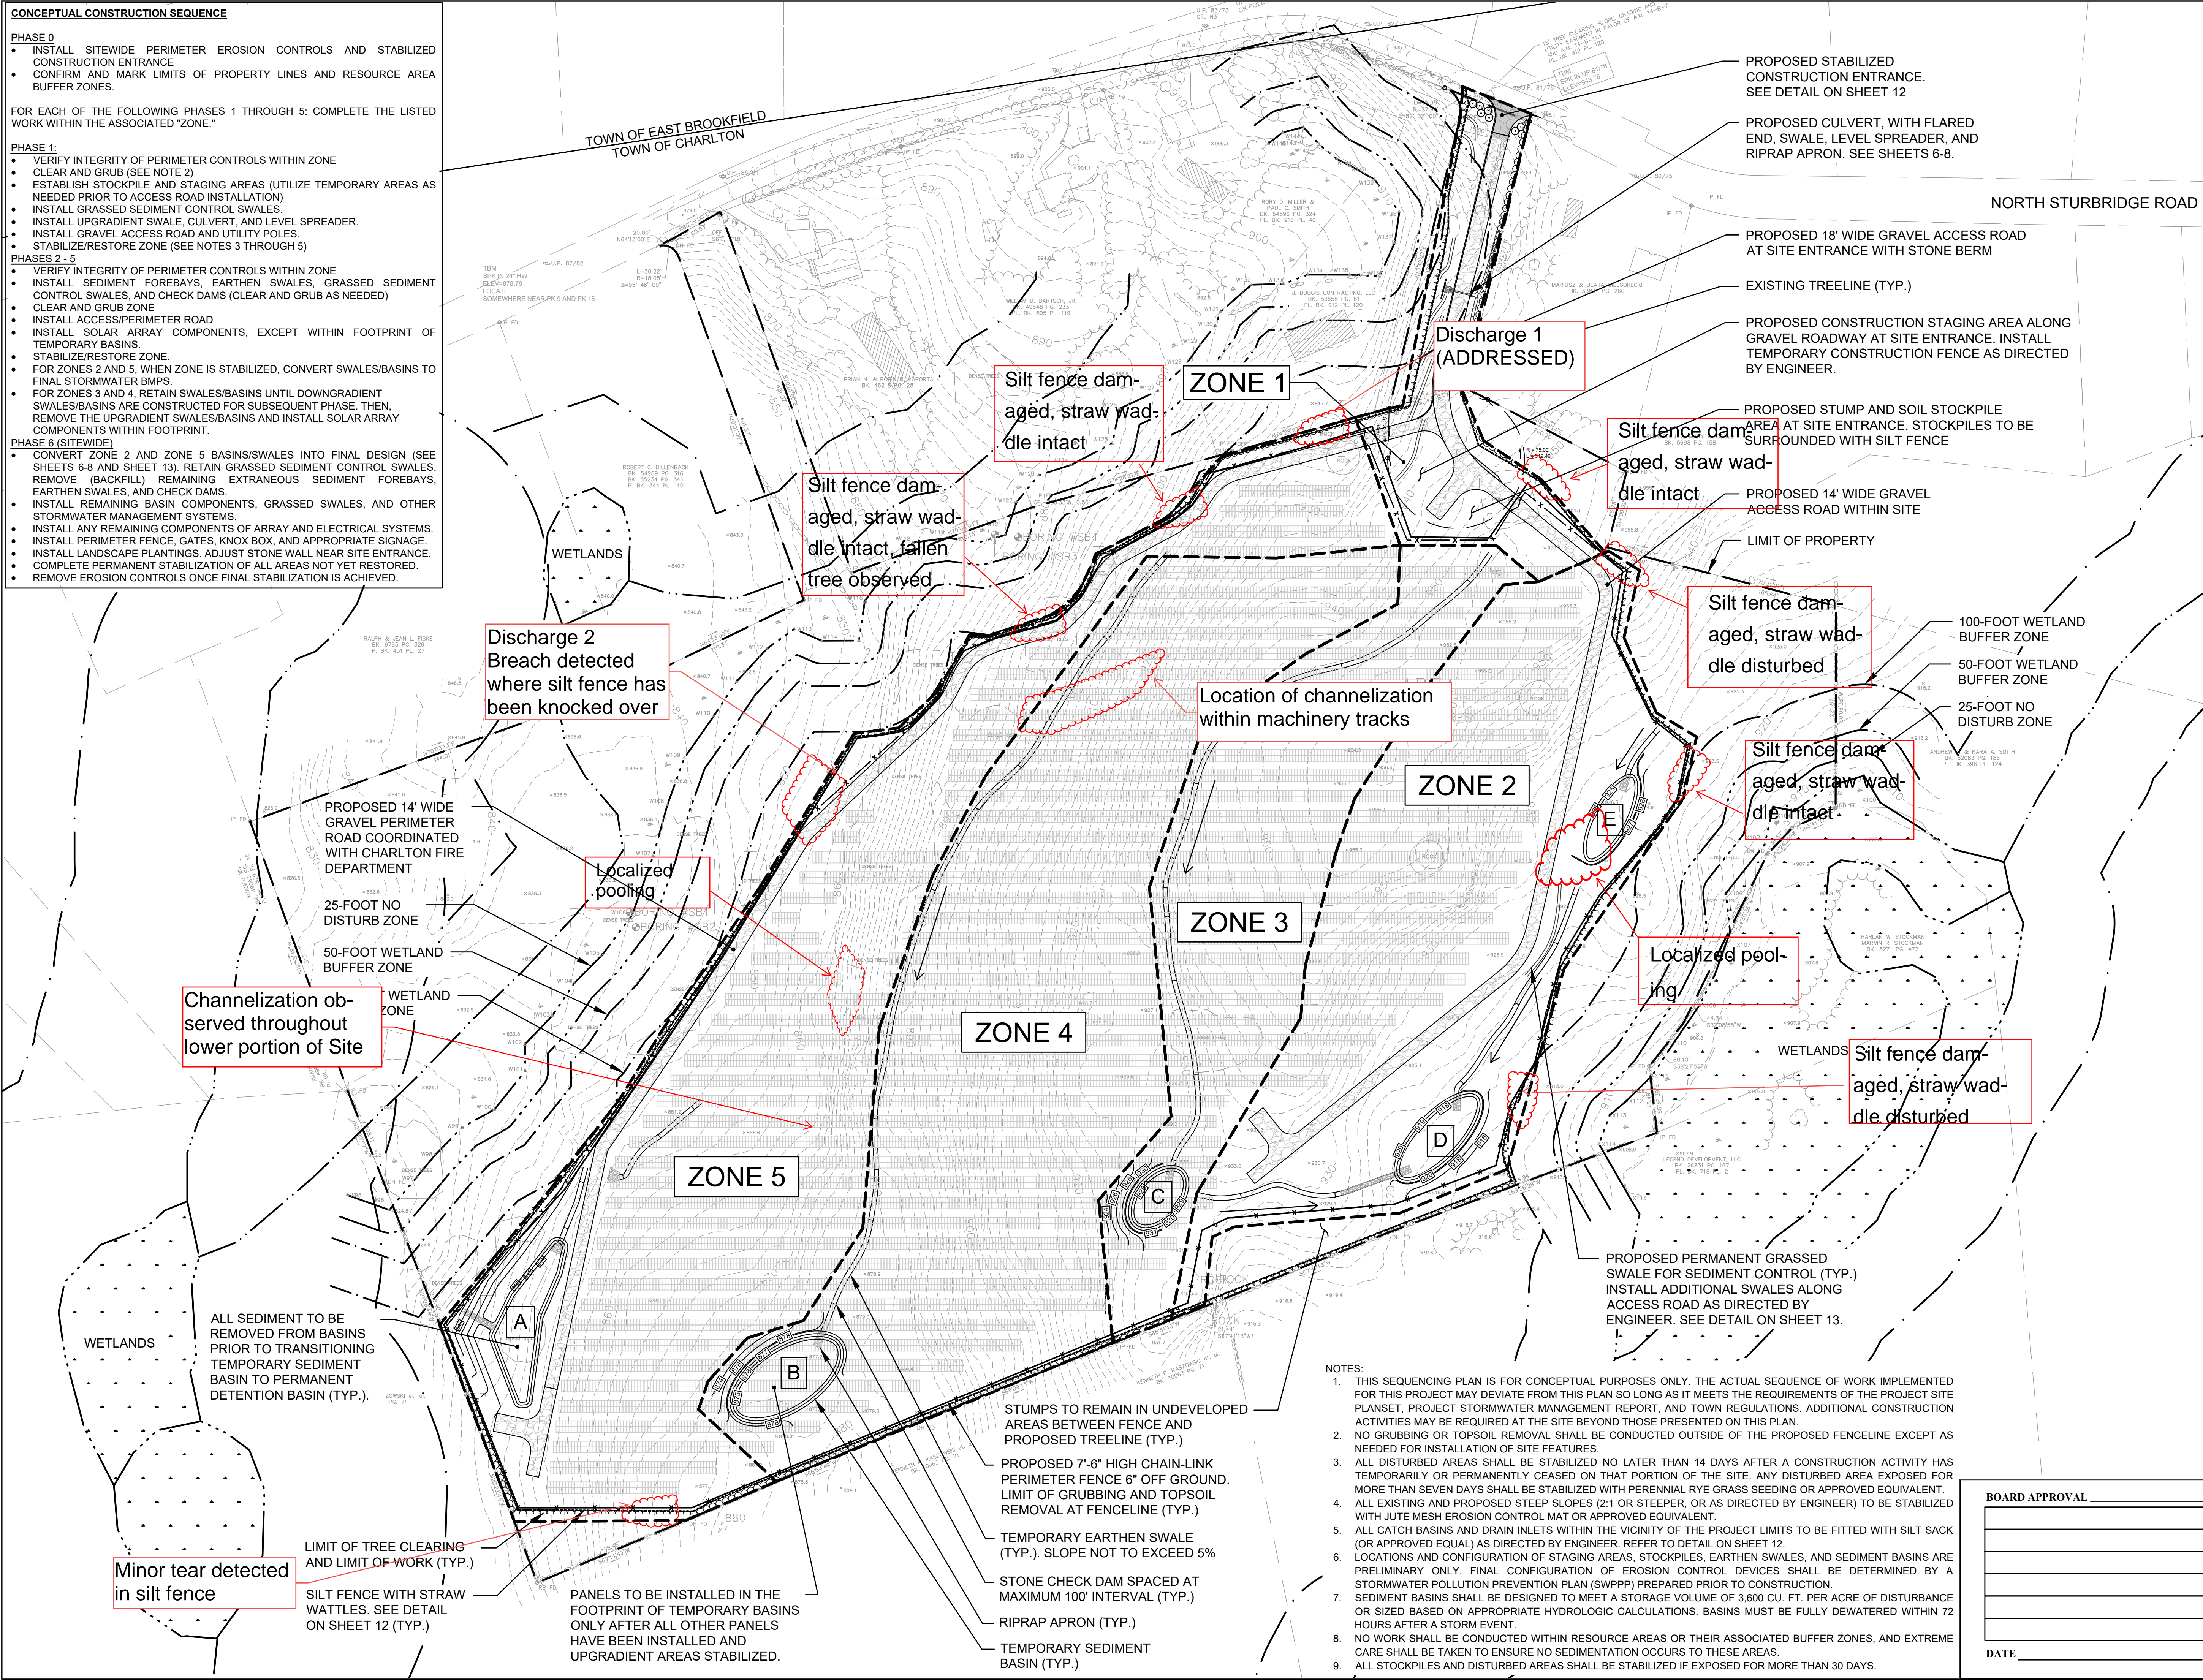
2. Informal access road along northern portion of the Site	Straw mulch or hydroseed	<input type="checkbox"/> Yes [Enter date] <input checked="" type="checkbox"/> No	Erosion channels are beginning to form within upgradient portions of the informal access road (Figure 1). The contractor indicated that stabilization by smoothing out soils and seeding or spreading mulch would occur on 7/30/2021. Stabilization of this area has not been initiated. After inspection of the area on 8/24/2021, it was determined that

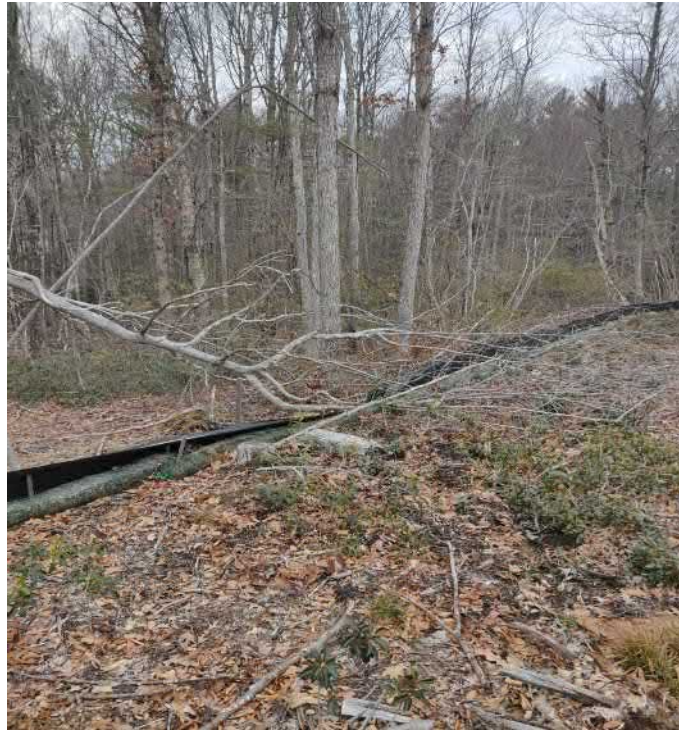
Photo 1

2. Stabilized Construction Entrance (Site Entrance – Access Road)	No (As of 9/2/2021)	No		<p>A tree was knocked over and laying on the silt fence on the on the northwestern portion of the site in Zone 5.</p> <p>Hydroseed was applied to exposed soil in this area and continues to germinate, some grass seedlings are now observed.</p>

View of tree fallen on northwestern portion of Zone 5.

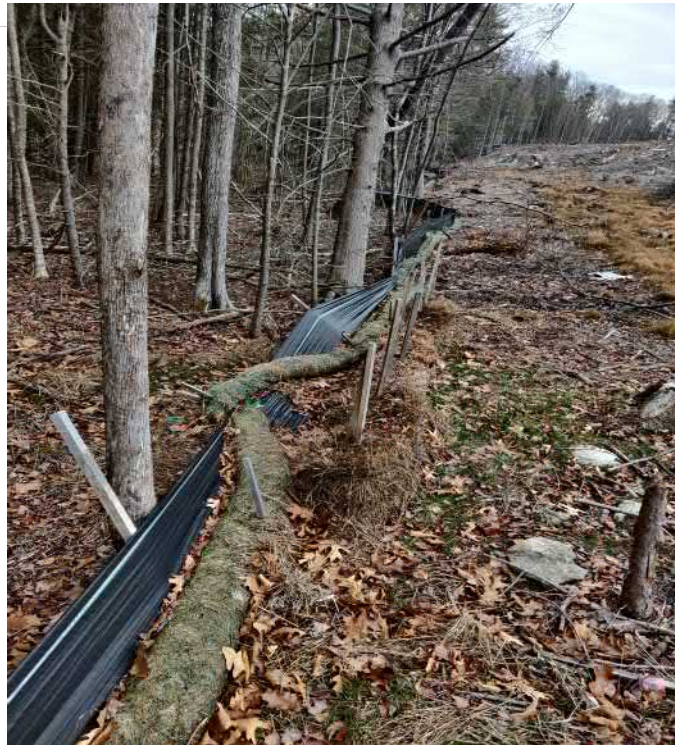
Photo 2

Type/Location of E&S Control	Maintenance Needed?*			
1. Silt Fence and Straw Wattles	Yes (As of 9/2/2021)	No	9/2/2021	<p>A breach was observed at Discharge 2. Although the double row of straw bales is intact, silt fence was observed to be knocked over and signs of stormwater flow were detected in the area beyond the fence.</p> <p>A minor tear was identified in a section of silt fence on the southern side of the Site with no erosion observed.</p> <p>Minor degradation of a straw wattle was observed on the southeastern side of the Site; no erosion was observed but pools of water were found to be forming behind the straw wattle.</p>

View of area downgradient of Discharge 2—facing north west.

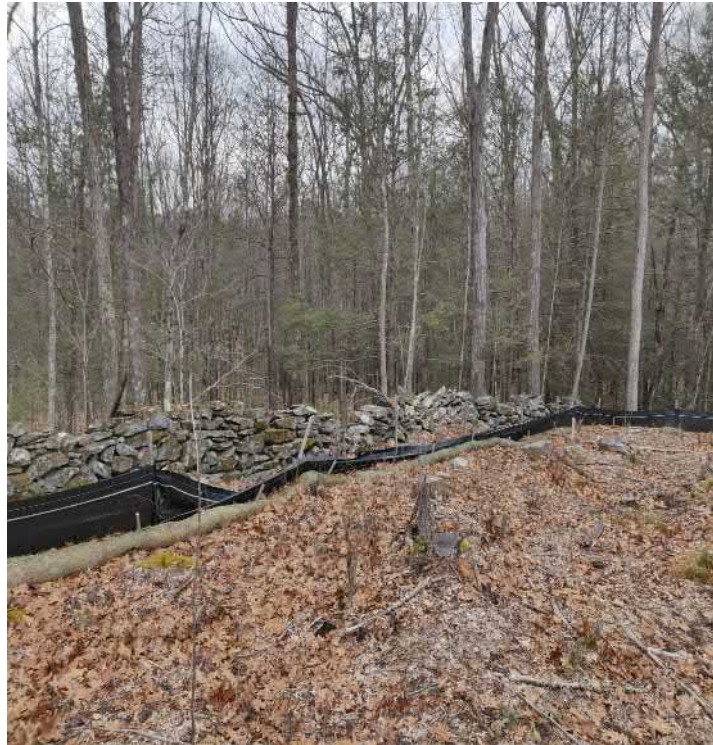
Photo 3

View of the damaged silt fence in southern perimeter of Site —facing south.

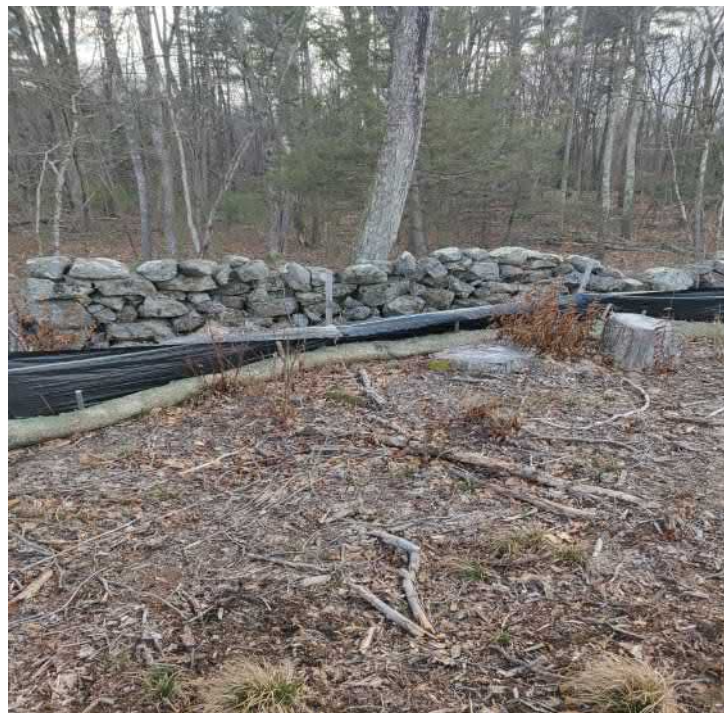
Photo 4

View of damaged silt fence in south west portion of the Site —facing south west

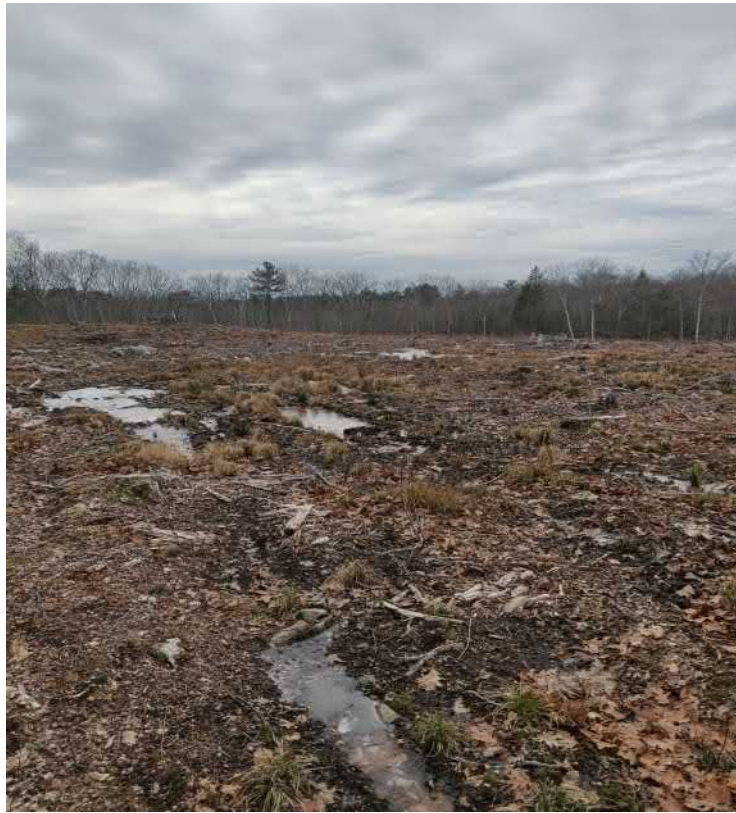
Photo 5

View of the water pooling in eastern perimeter of Site —facing south east.

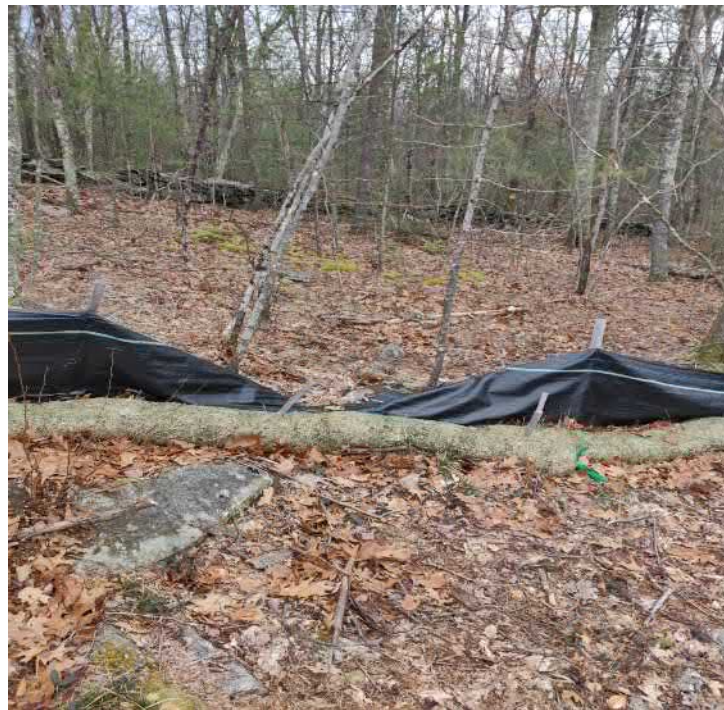
Photo 6

View of damaged silt fence in south east portion of the Site —facing south east

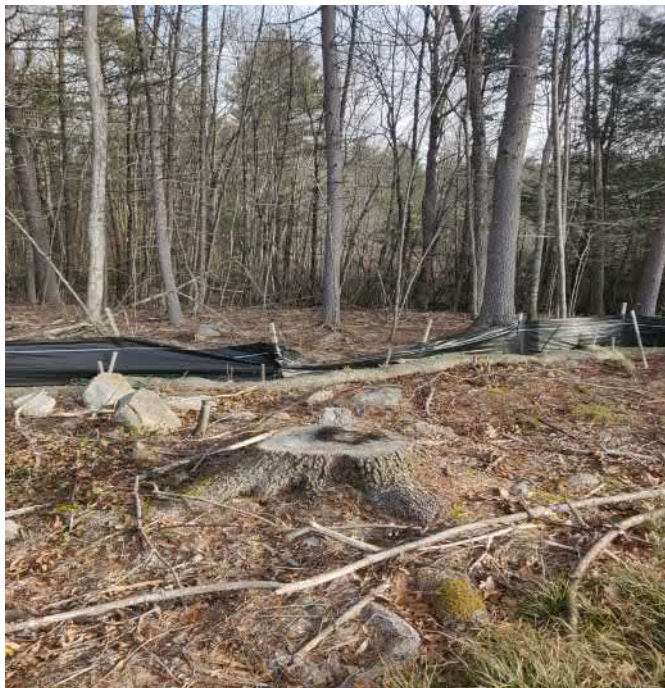
Photo 7

View of damaged silt fence in eastern portion of the Site —facing east

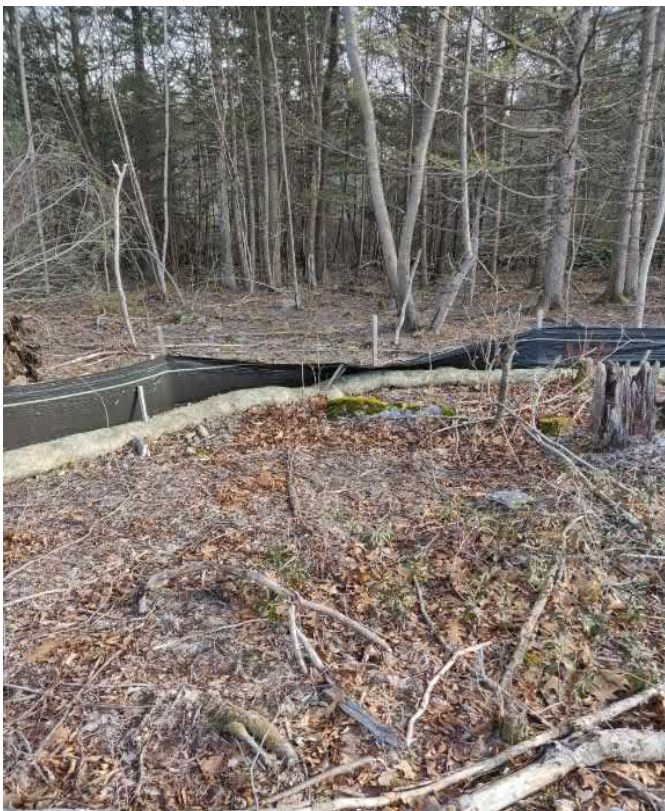
Photo 8

View of damaged silt fence in eastern portion of the Site —facing east

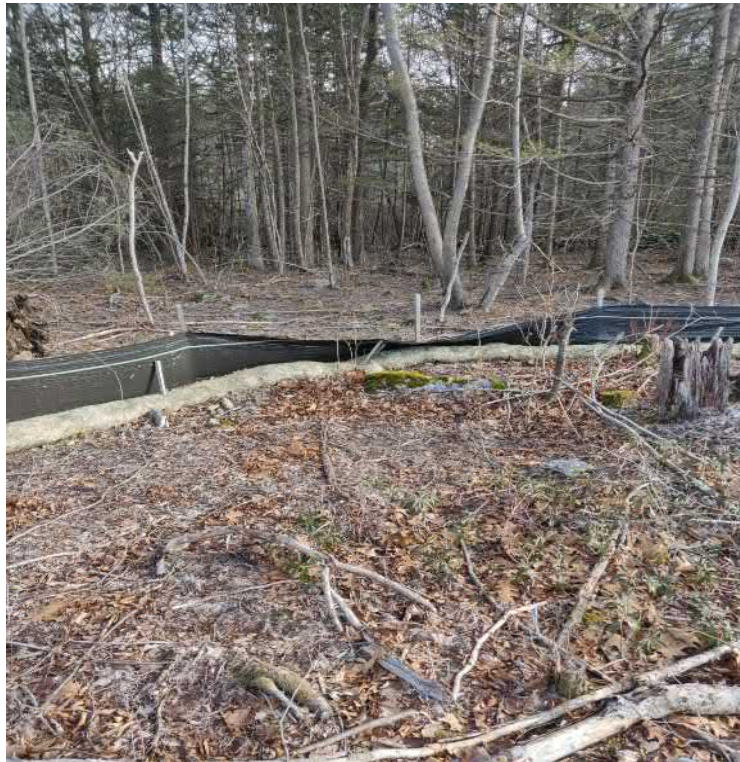
Photo 9

View of damaged silt fence in eastern portion of the Site —facing east

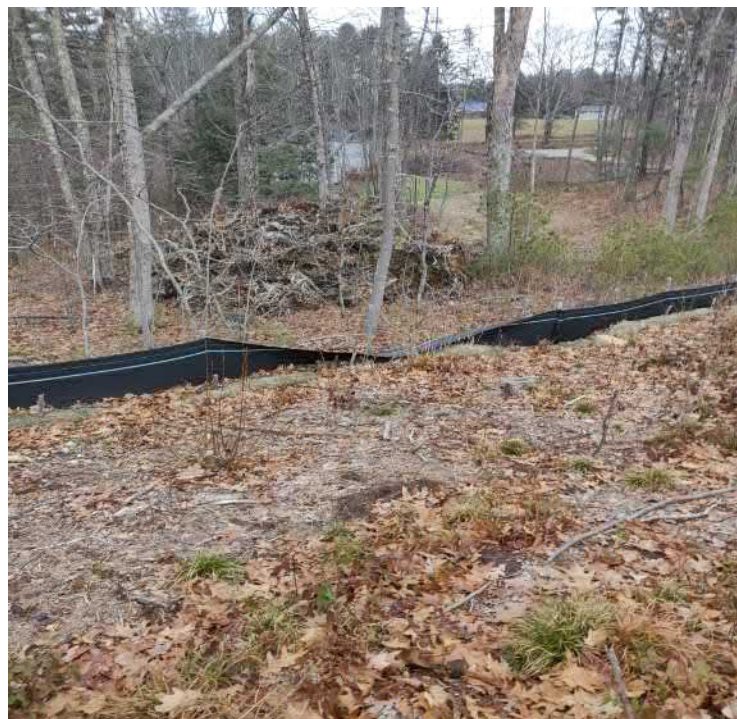
Photo 10

View of damaged silt fence in north western portion of the Site —facing north west

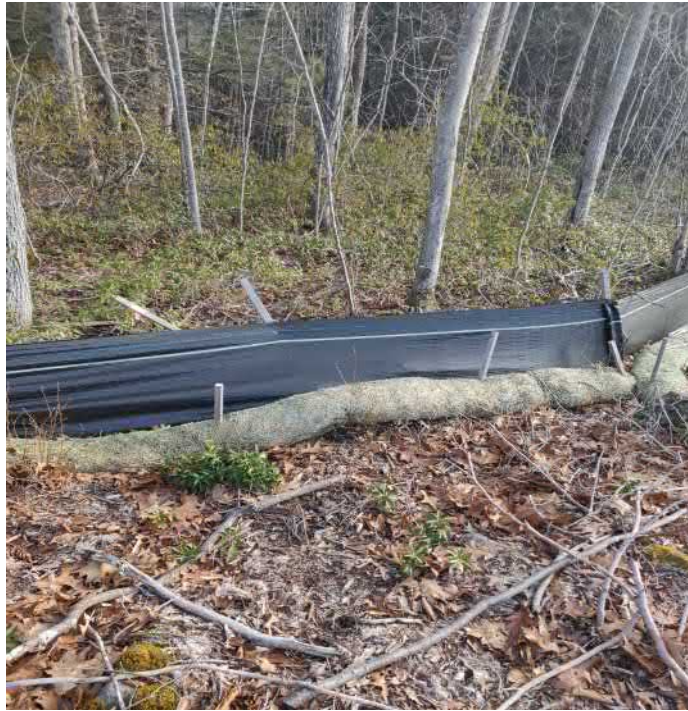
Photo 11

View of damaged silt fence and waddle in eastern portion of the Site —facing north east

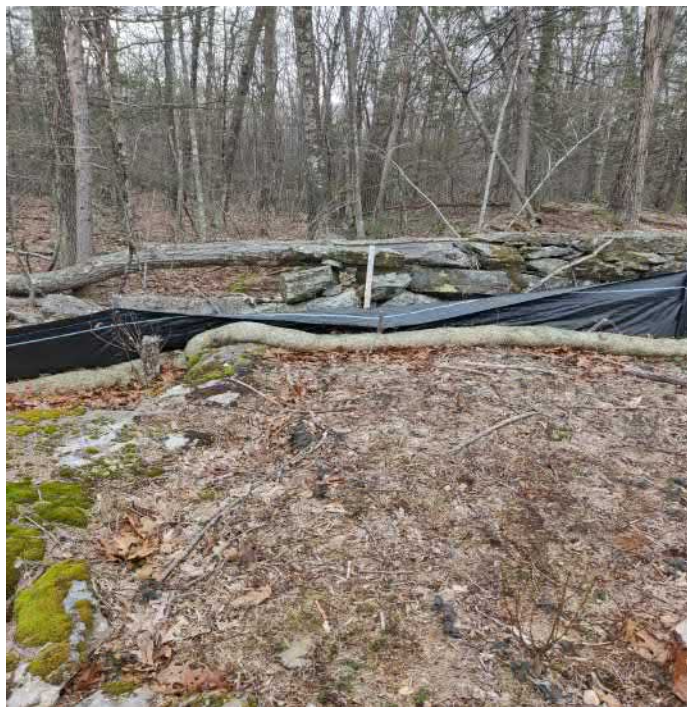
Photo 12

View of damaged silt fence and waddle in south eastern portion of the Site —facing south east
