Inspection Report for North Sturbridge Road Solar Facility

NPDES ID No.: MAR10031G

Inspection Date: 12/27/2021

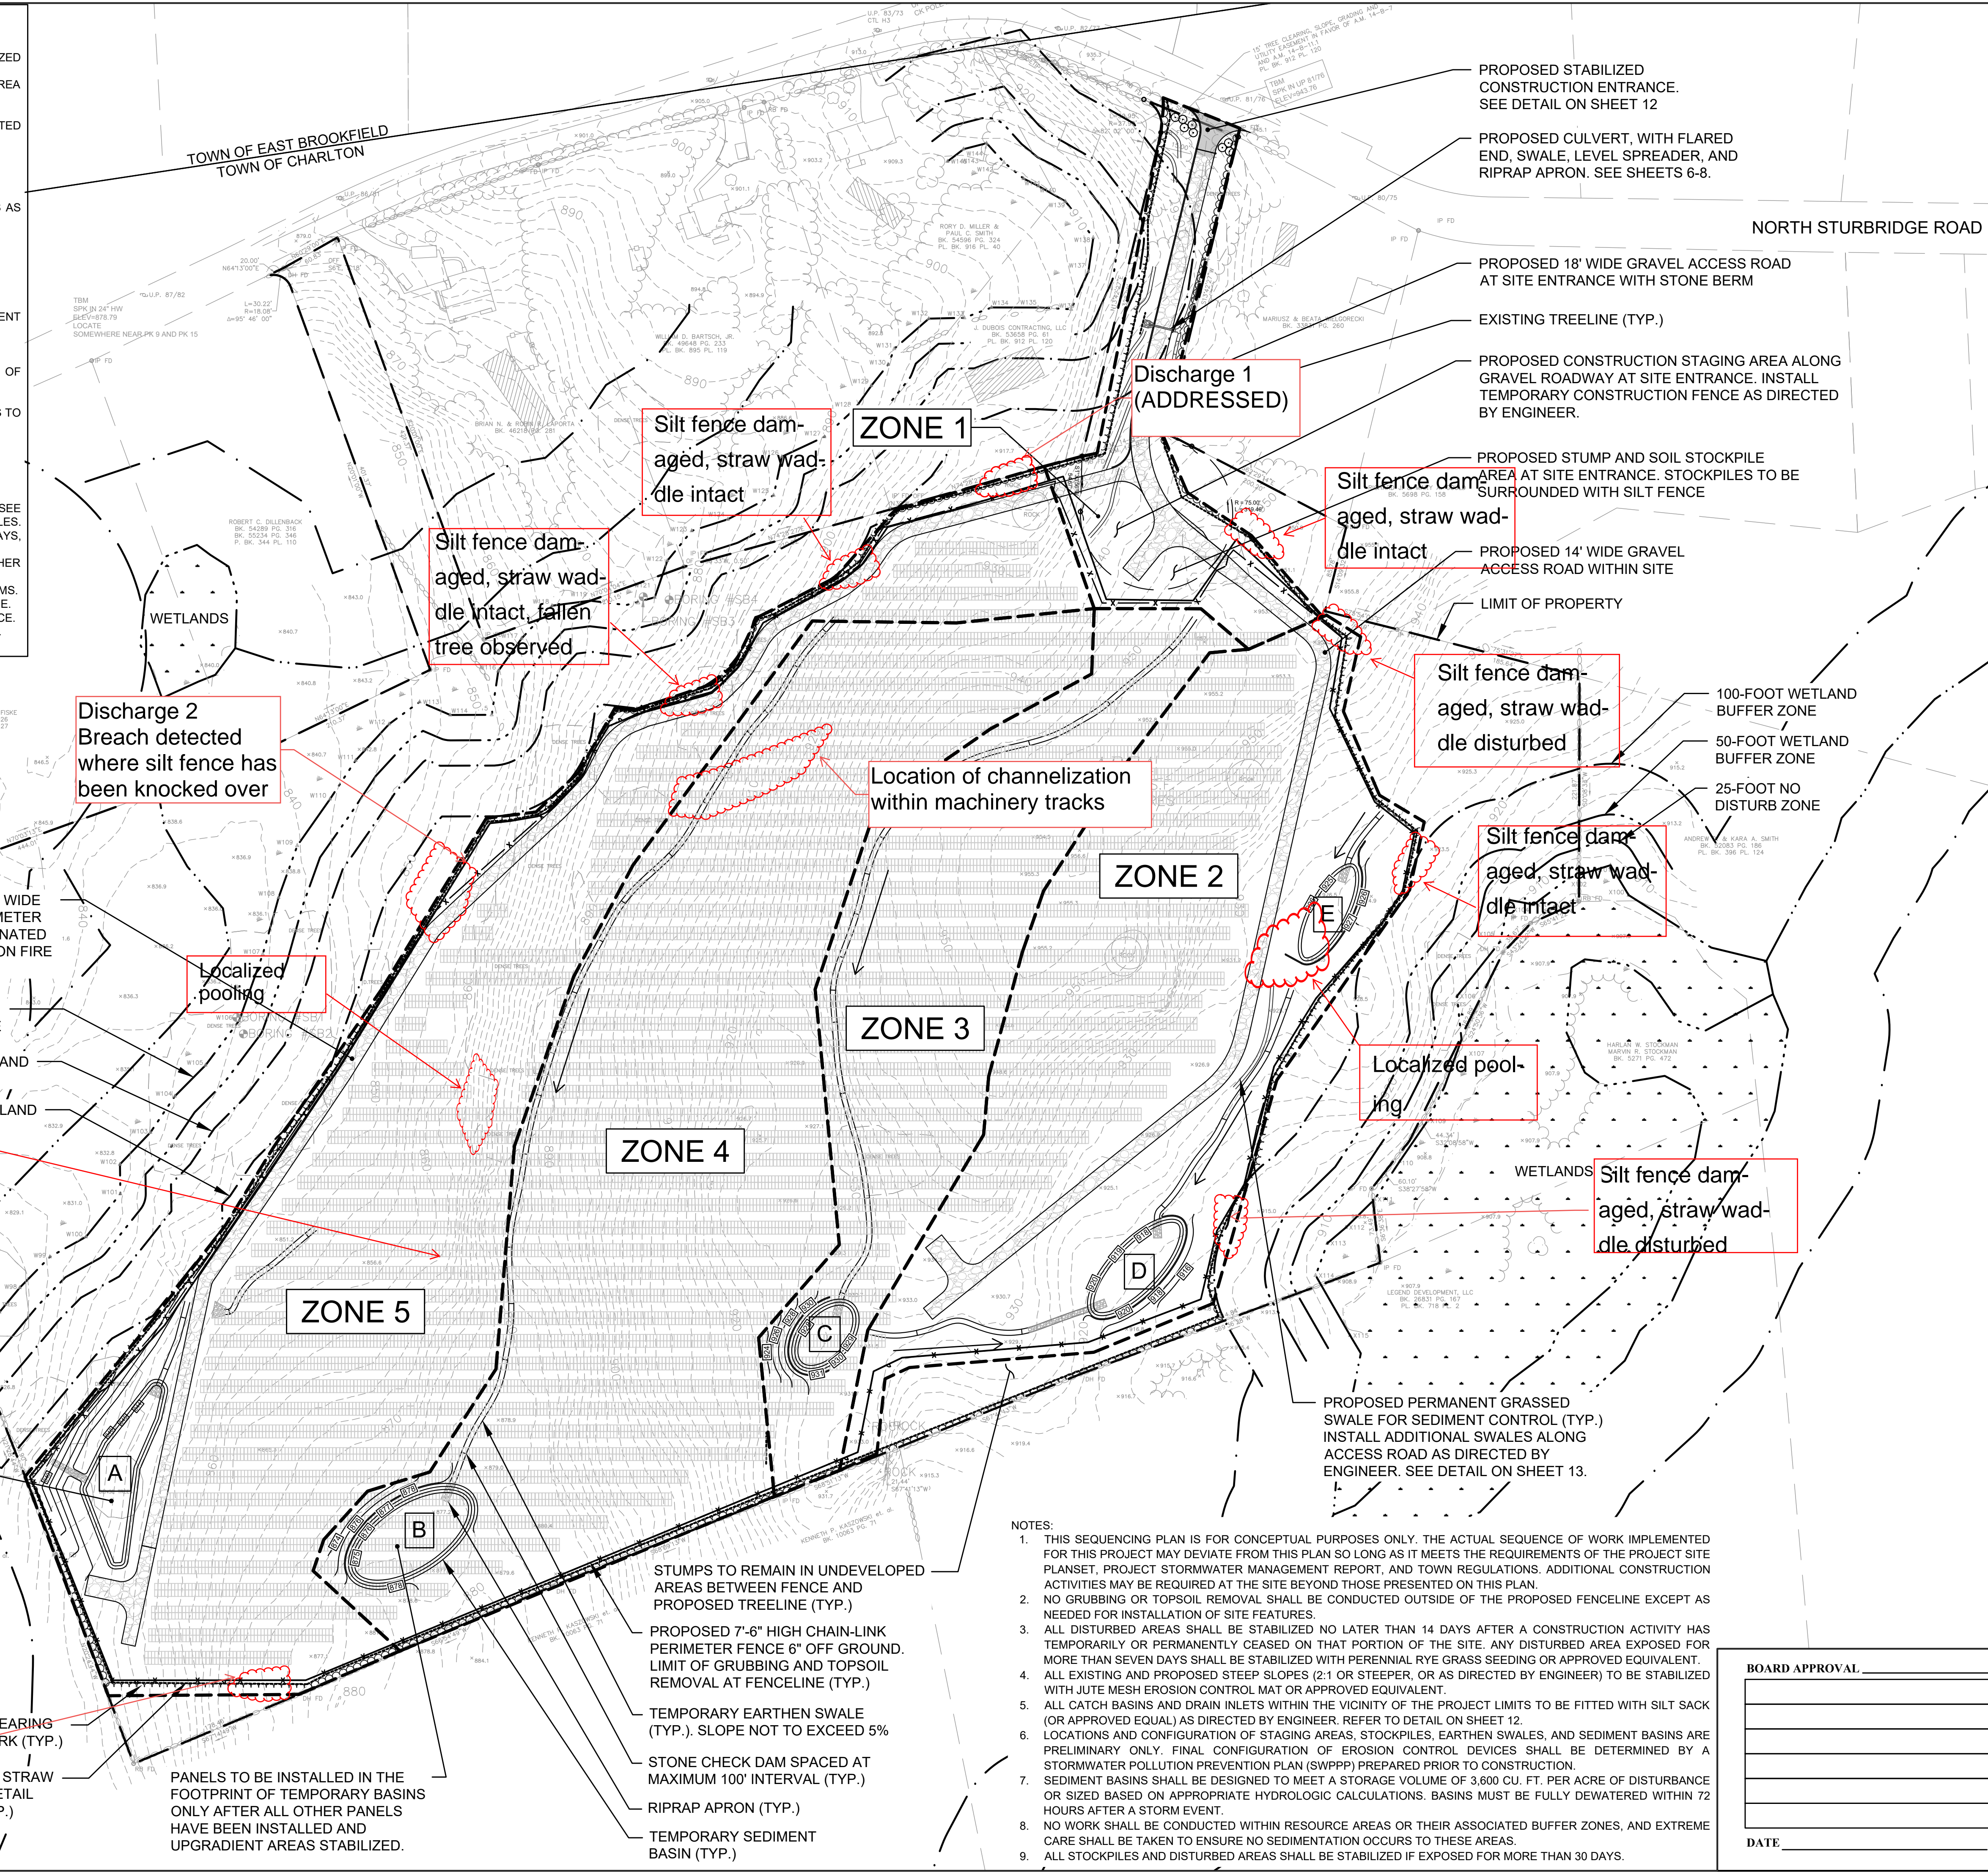
**FIGURE 1:
SWPPP
INSPECTION
SKETCH
12/27/2021**

2. Informal access road along northern portion of the Site	Straw mulch or hydroseed	<input type="checkbox"/> Yes [Enter date] <input checked="" type="checkbox"/> No	Erosion channels are beginning to form within upgradient portions of the informal access road (Figure 1). The contractor indicated that stabilization by smoothing out soils and seeding or spreading mulch would occur on 7/30/2021. Stabilization of this area has not been initiated. After inspection of the area on 8/24/2021, it was determined that

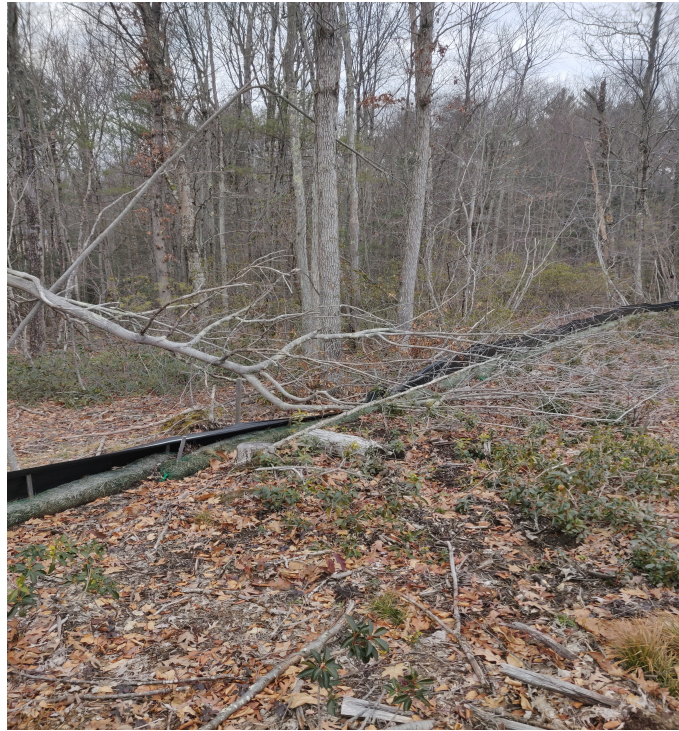
Photo 1

2. Stabilized Construction Entrance (Site Entrance – Access Road)	No (As of 9/2/2021)	No		<p>A tree was knocked over and laying on the silt fence on the on the northwestern portion of the site in Zone 5.</p> <p>Hydroseed was applied to exposed soil in this area and continues to germinate, some grass seedlings are now observed.</p>

View of tree fallen on northwestern portion of Zone 5.

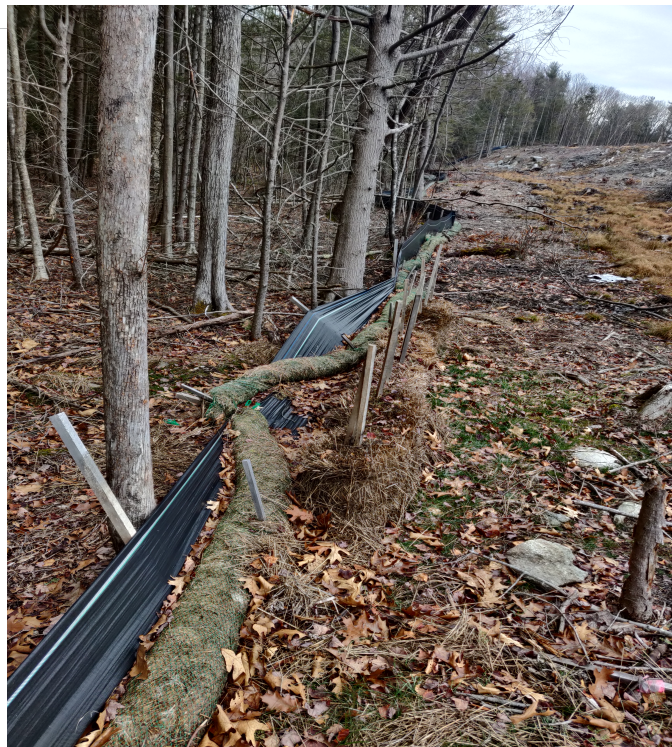
Photo 2

Type/Location of E&S Control	Maintenance Needed?*			
1. Silt Fence and Straw Wattles	Yes (As of 9/2/2021)	No	9/2/2021	<p>A breach was observed at Discharge 2. Although the double row of straw bales is intact, silt fence was observed to be knocked over and signs of stormwater flow were detected in the area beyond the fence.</p> <p>A minor tear was identified in a section of silt fence on the southern side of the Site with no erosion observed.</p> <p>Minor degradation of a straw wattle was observed on the southeastern side of the Site; no erosion was observed but pools of water were found to be forming behind the straw wattle.</p>

View of area downgradient of Discharge 2—facing north west.

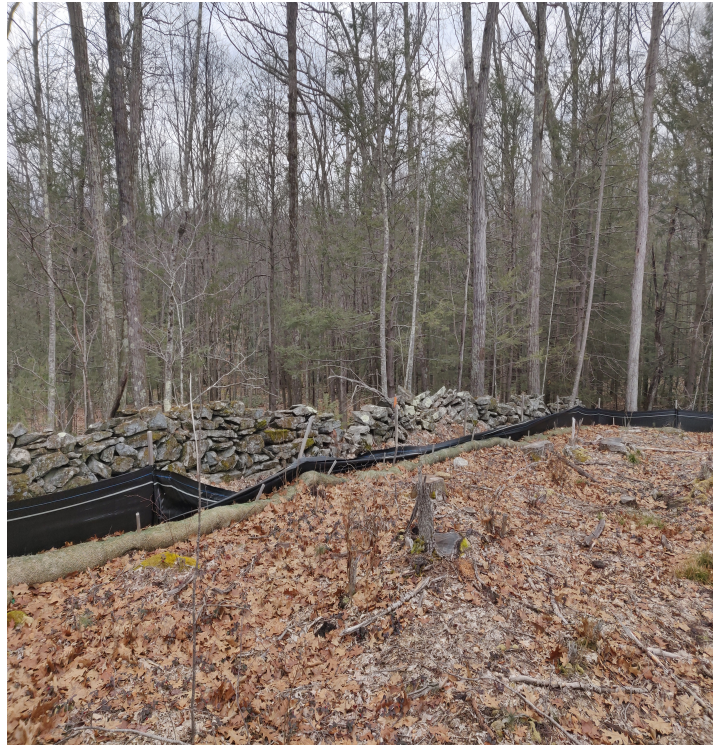
Photo 3

View of the damaged silt fence in southern perimeter of Site —facing south.

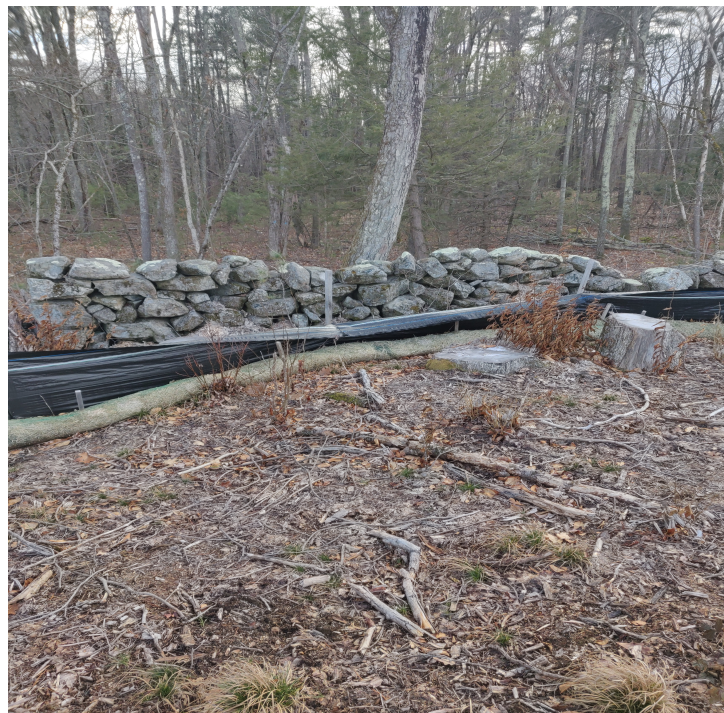
Photo 4

View of damaged silt fence in south west portion of the Site —facing south west

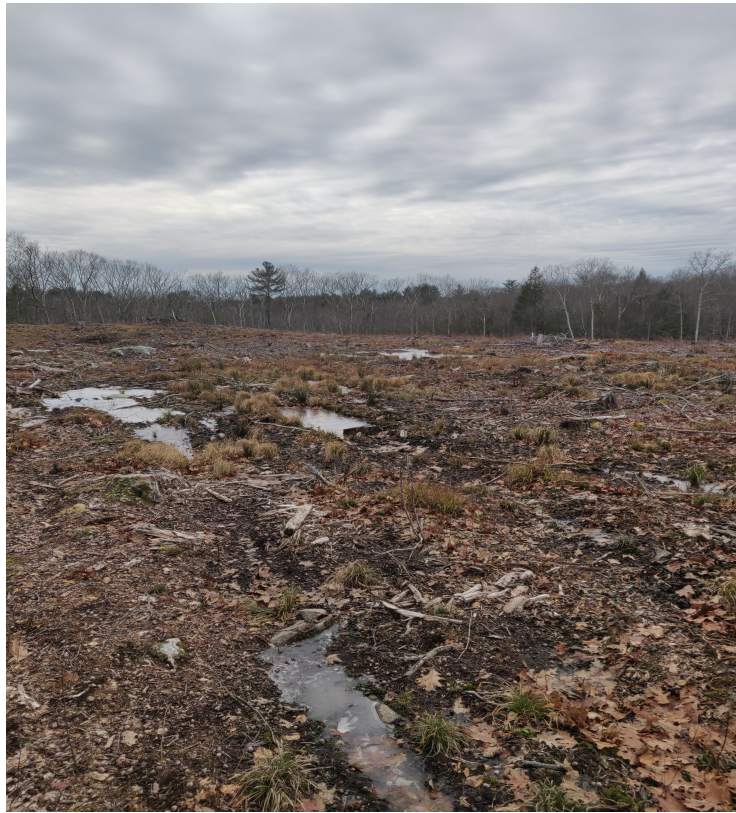
Photo 5

View of the water pooling in eastern perimeter of Site —facing south east.

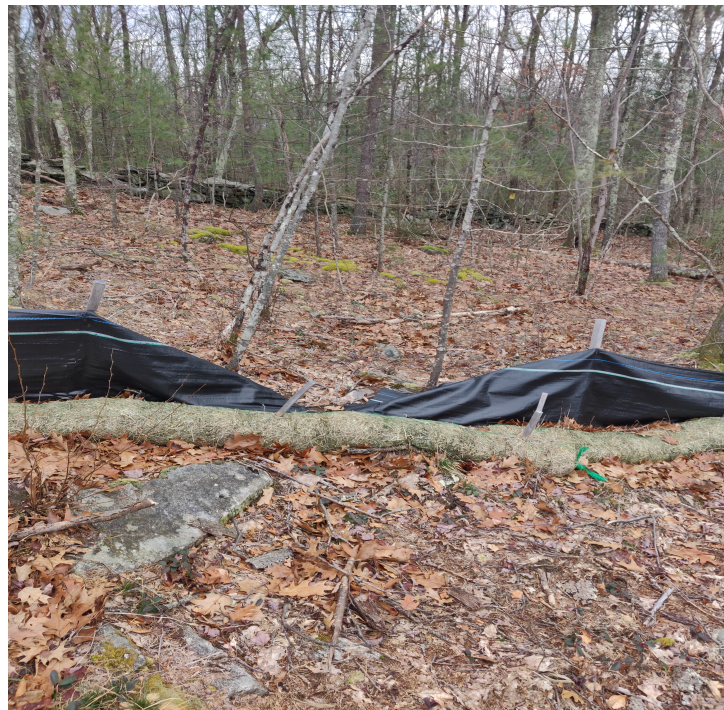
Photo 6

View of damaged silt fence in south east portion of the Site —facing south east

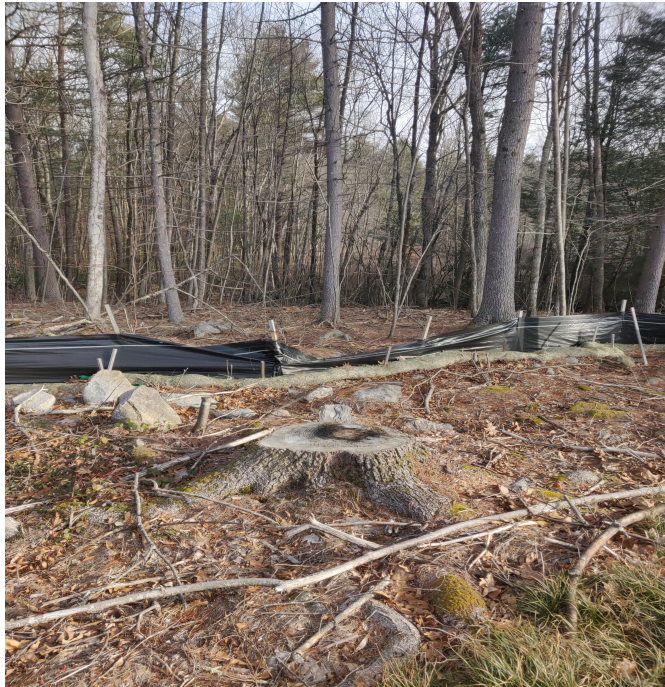
Photo 7

View of damaged silt fence in eastern portion of the Site —facing east

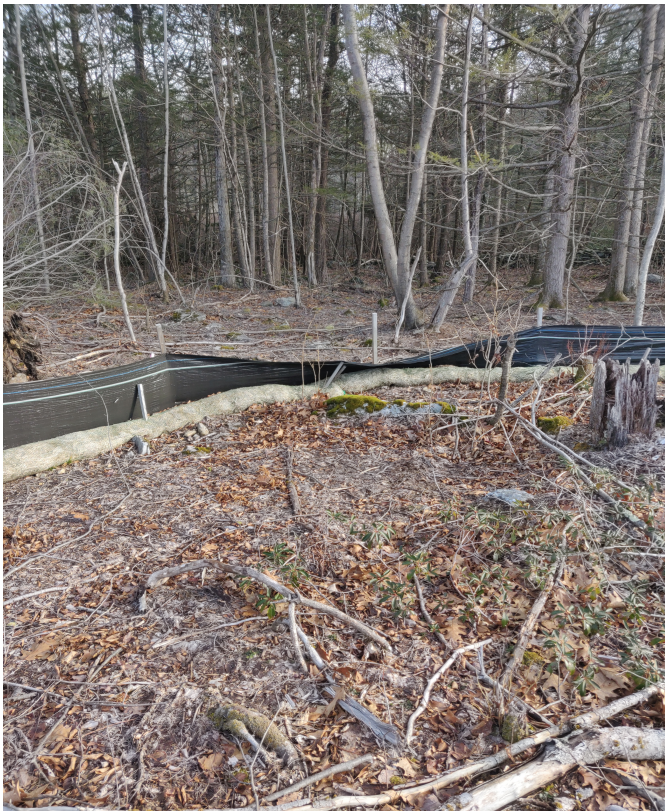
Photo 8

View of damaged silt fence in eastern portion of the Site —facing east

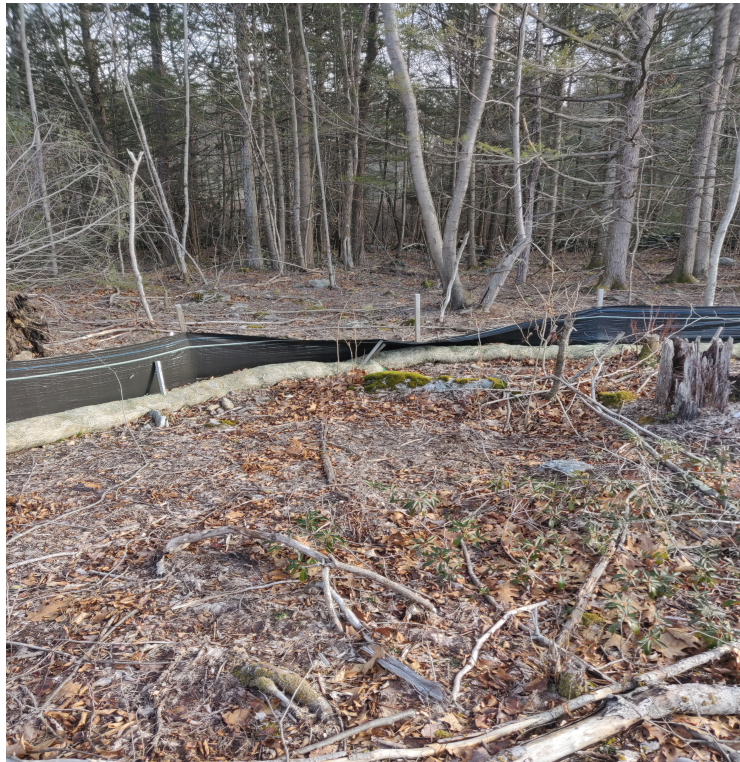
Photo 9

View of damaged silt fence in eastern portion of the Site —facing east

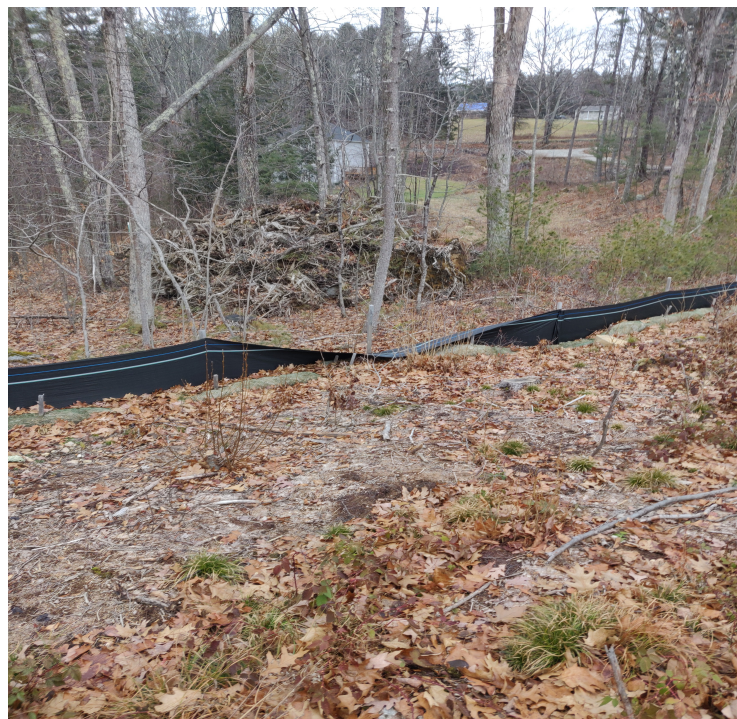
Photo 10

View of damaged silt fence in north western portion of the Site —facing north west

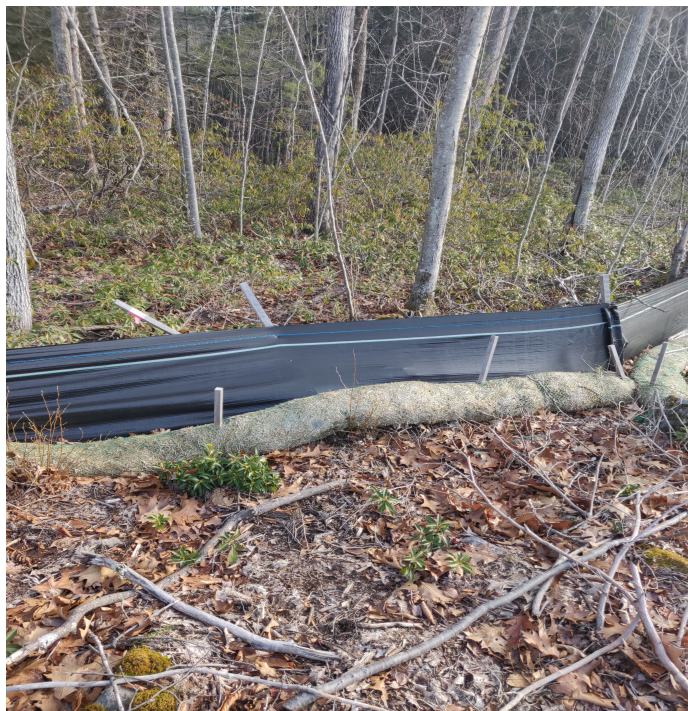
Photo 11

View of damaged silt fence and wattle in eastern portion of the Site —facing north east

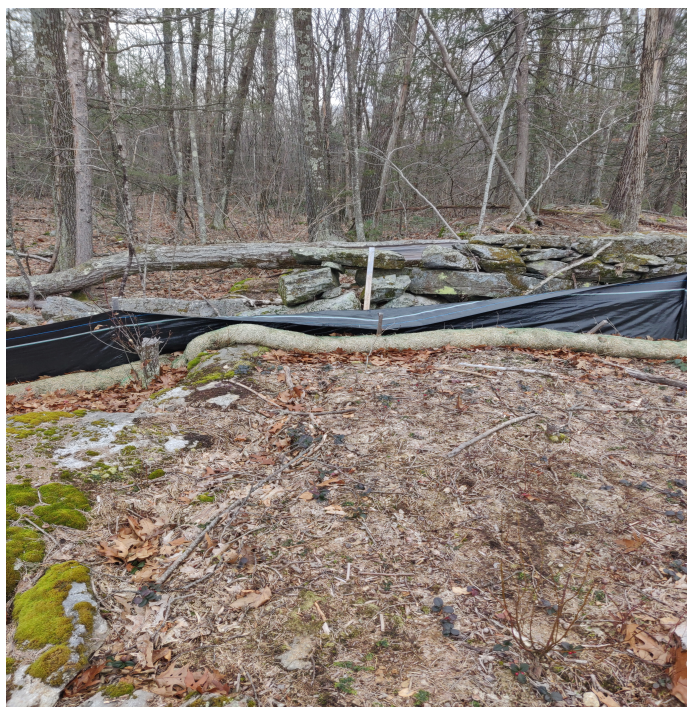
Photo 12

View of damaged silt fence and wattle in south eastern portion of the Site —facing south east
