Inspection Report for North Sturbridge Road Solar Facility

NPDES ID No.: MAR10031G

Inspection Date: 01/03/2022

**FIGURE 1:  
SWPPP  
INSPECTION  
SKETCH  
01/03/2022**

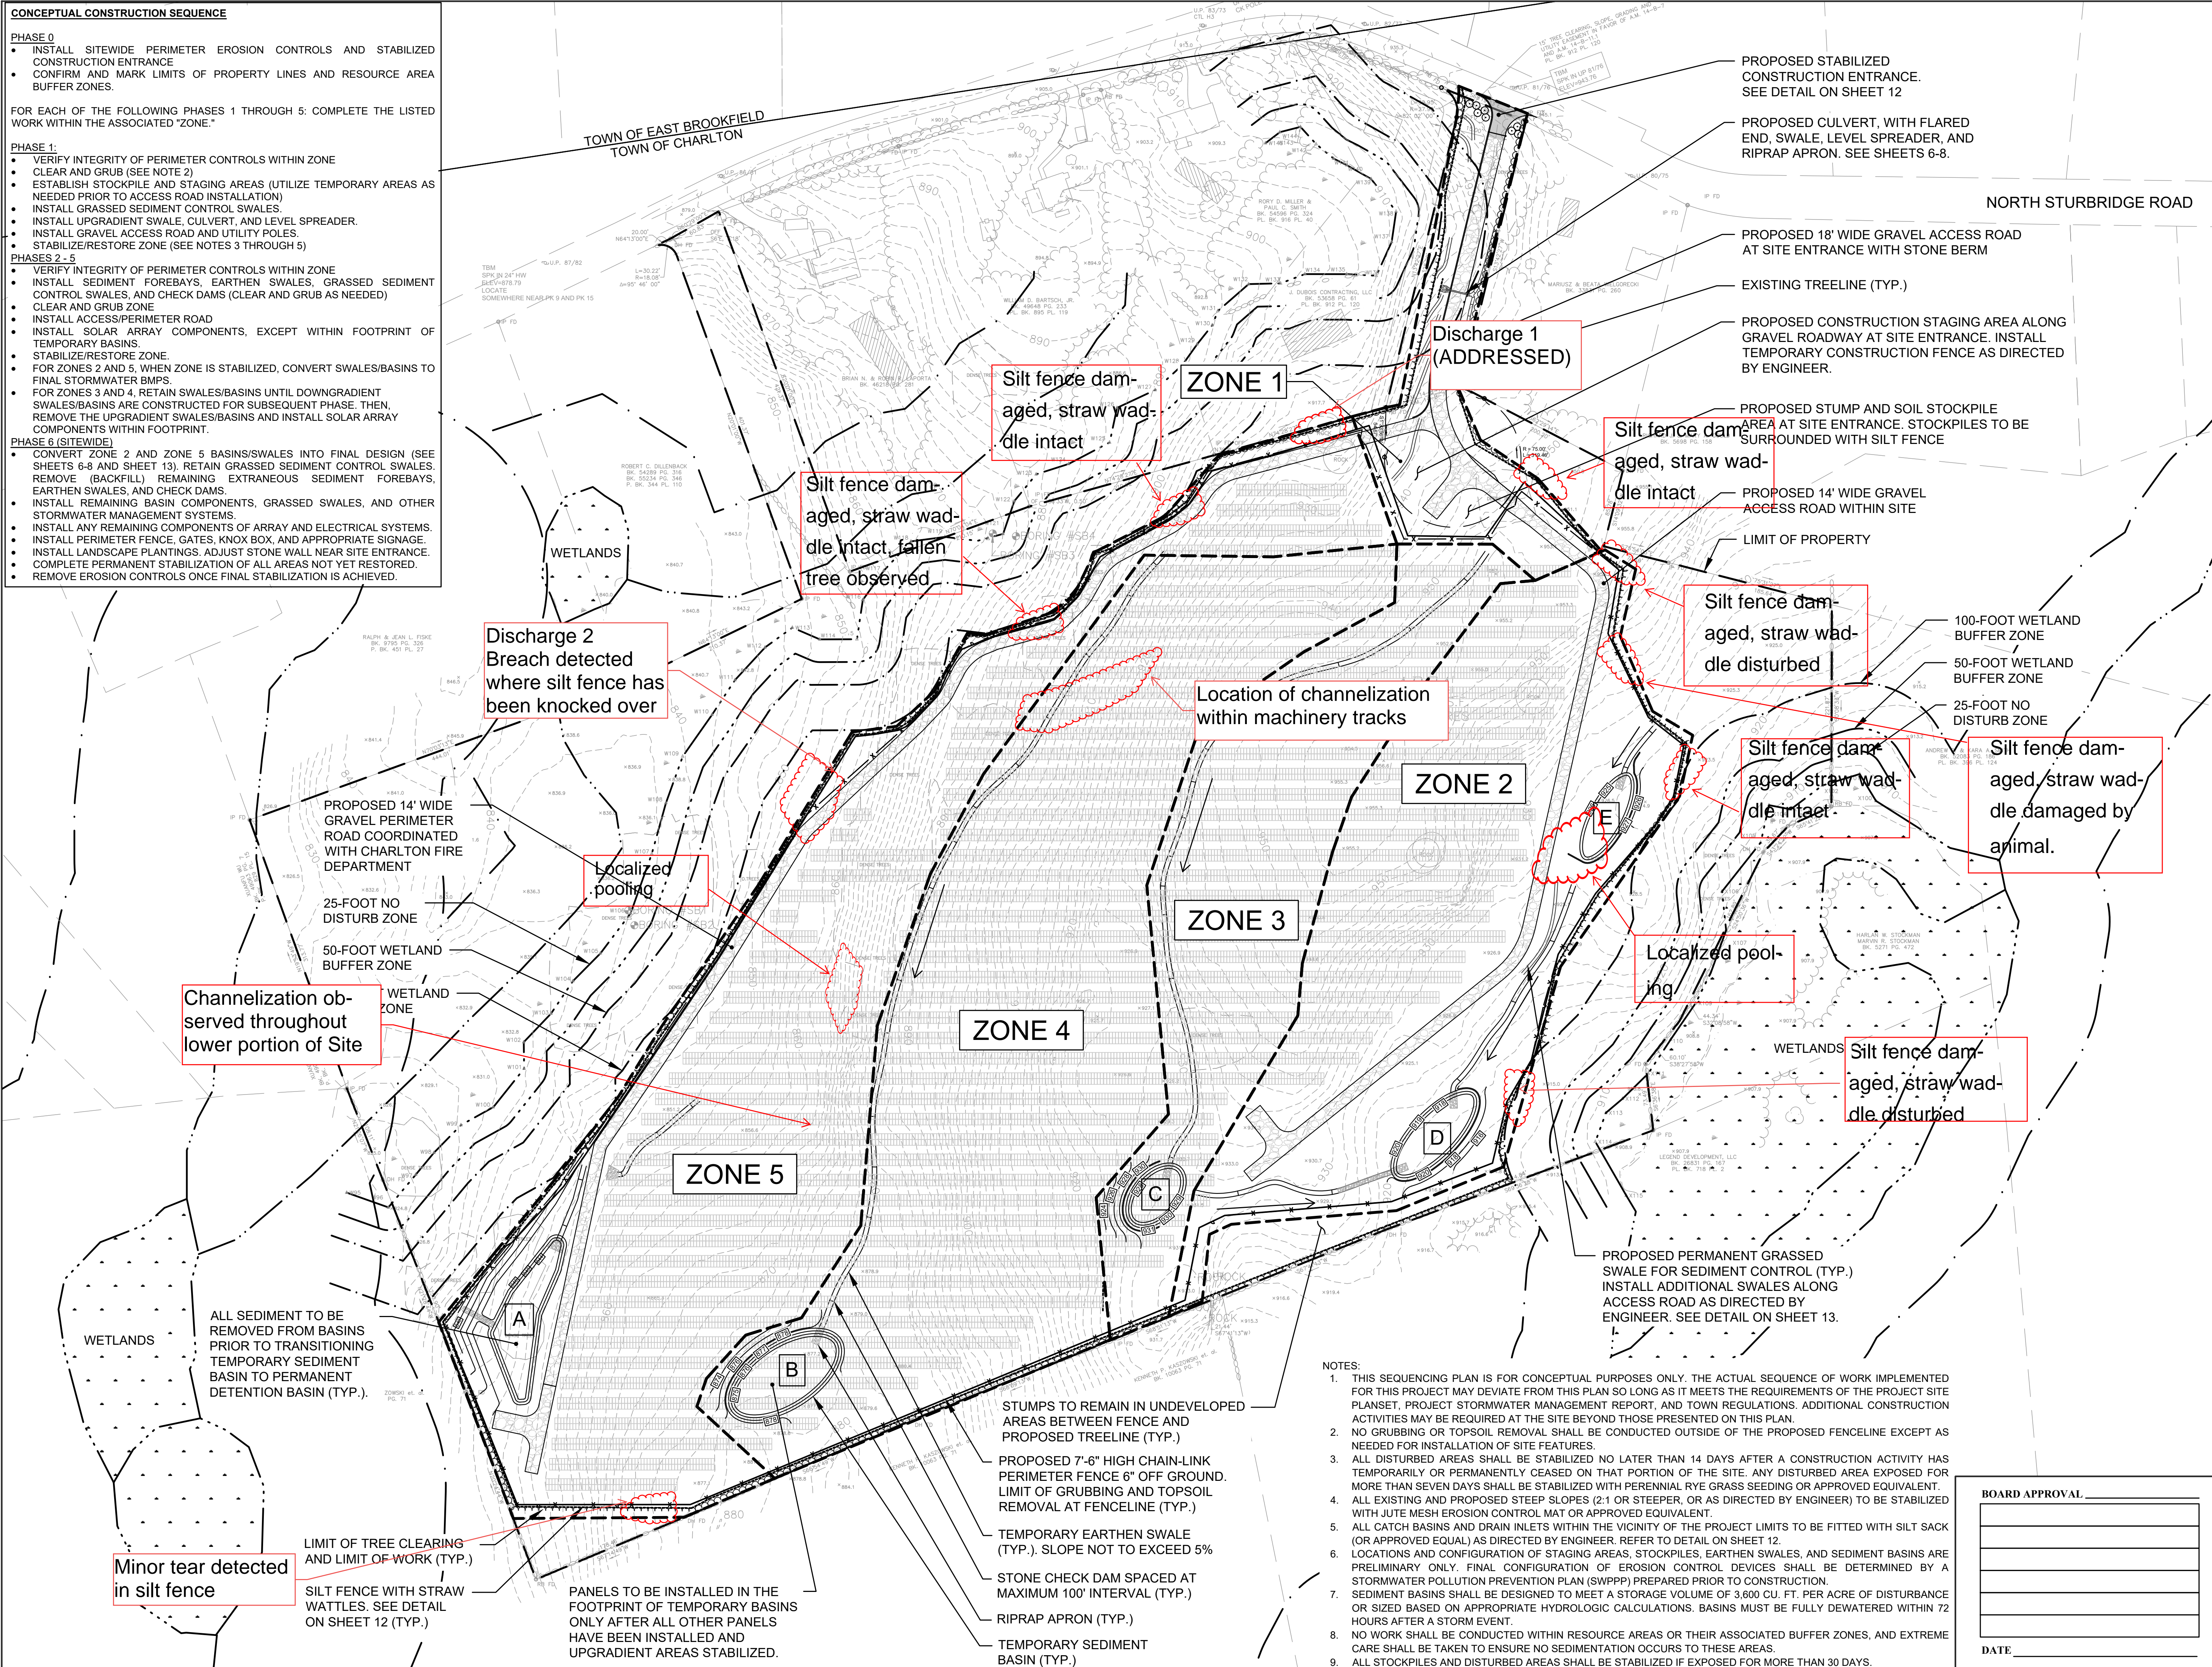
2. Informal access road along northern portion of the Site	Straw mulch or hydroseed	<input type="checkbox"/> Yes [Enter date] <input checked="" type="checkbox"/> No	Erosion channels are beginning to form within upgradient portions of the informal access road (Figure 1). The contractor indicated that stabilization by smoothing out soils and seeding or spreading mulch would occur on 7/30/2021. Stabilization of this area has not been initiated. After inspection of the area on 8/24/2021, it was determined that

Minor tear detected in silt fence

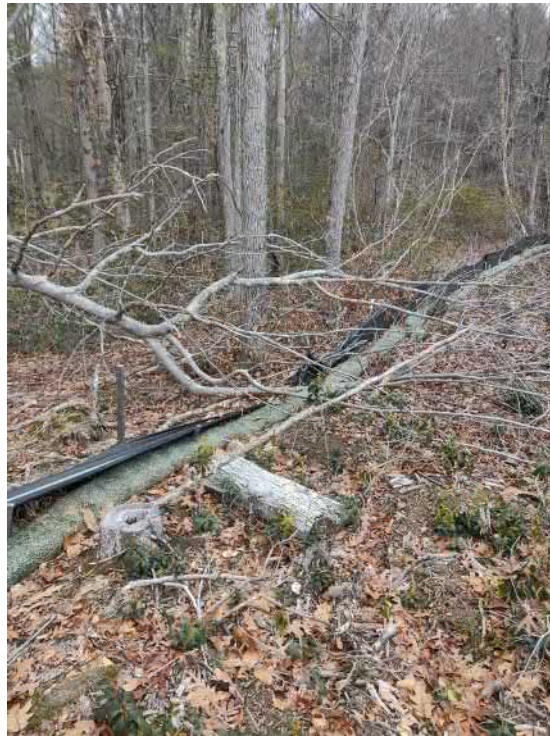
Photo 1

2. Stabilized Construction Entrance (Site Entrance – Access Road)	No (As of 9/2/2021)	No		<p>A tree was knocked over and laying on the silt fence on the on the northwestern portion of the site in Zone 5.</p> <p>Hydroseed was applied to exposed soil in this area and continues to germinate, some grass seedlings are now observed.</p>

View of tree fallen on northwestern portion of Zone 5.

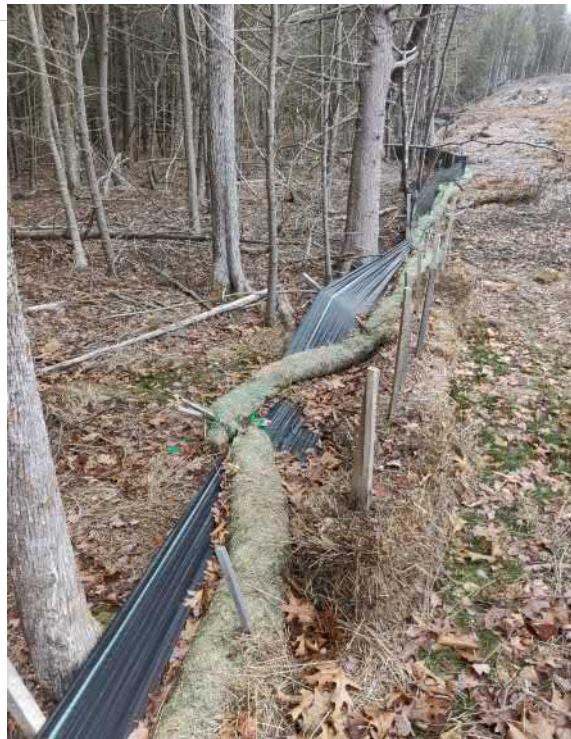
Photo 2

Type/Location of E&S Control	Maintenance Needed?*			
1. Silt Fence and Straw Wattles	Yes (As of 9/2/2021)	No	9/2/2021	<p>A breach was observed at Discharge 2. Although the double row of straw bales is intact, silt fence was observed to be knocked over and signs of stormwater flow were detected in the area beyond the fence.</p> <p>A minor tear was identified in a section of silt fence on the southern side of the Site with no erosion observed.</p> <p>Minor degradation of a straw wattle was observed on the southeastern side of the Site; no erosion was observed but pools of water were found to be forming behind the straw wattle.</p>

View of area downgradient of Discharge 2—facing north west.

Discharge Location	Observations
<p>Discharge 1</p>	<p>Describe the discharge: Breach in silt fence allowed runoff to bypass erosion controls.</p> <p>At points of discharge and the channels and banks of surface waters in the immediate vicinity, are there any visible signs of erosion and/or sediment accumulation that can be attributed to your discharge? <input checked="" type="checkbox"/> Yes <input type="checkbox"/> No</p> <p>If yes, describe what you see, specify the location(s) where these conditions were found, and indicate whether modification, maintenance, or corrective action is needed to resolve the issue: Small areas of bare soil observed in area immediately beyond perimeter controls. Repairs to erosion controls and re-seeding of damaged areas is required.</p>

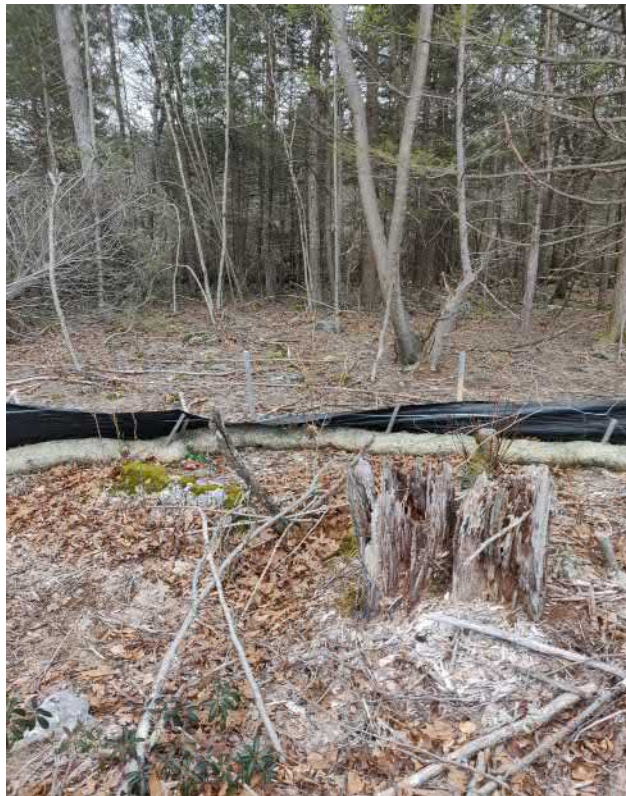
Photo 8

View of damaged silt fence in eastern portion of the Site —facing east

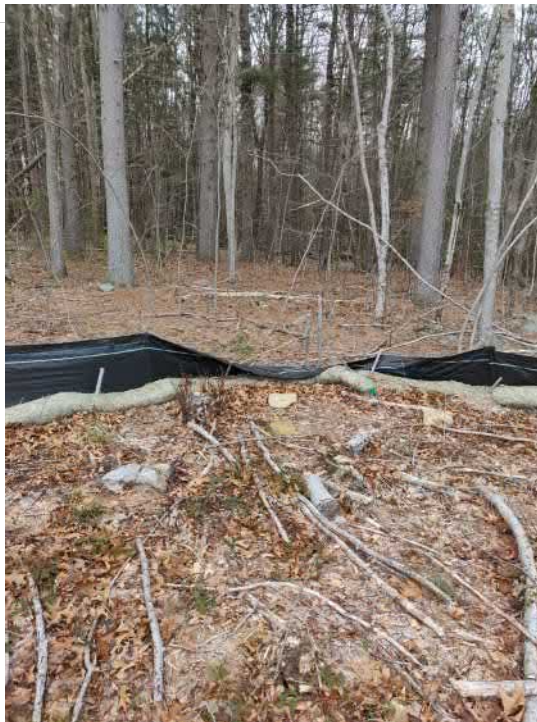
Photo 12

View of damaged silt fence and waddle in south eastern portion of the Site —facing south east
