Inspection Report for North Sturbridge Road Solar Facility

NPDES ID No.: MAR10031G

Inspection Date: 01/03/2022

**FIGURE 1:
SWPPP
INSPECTION
SKETCH
01/03/2022**

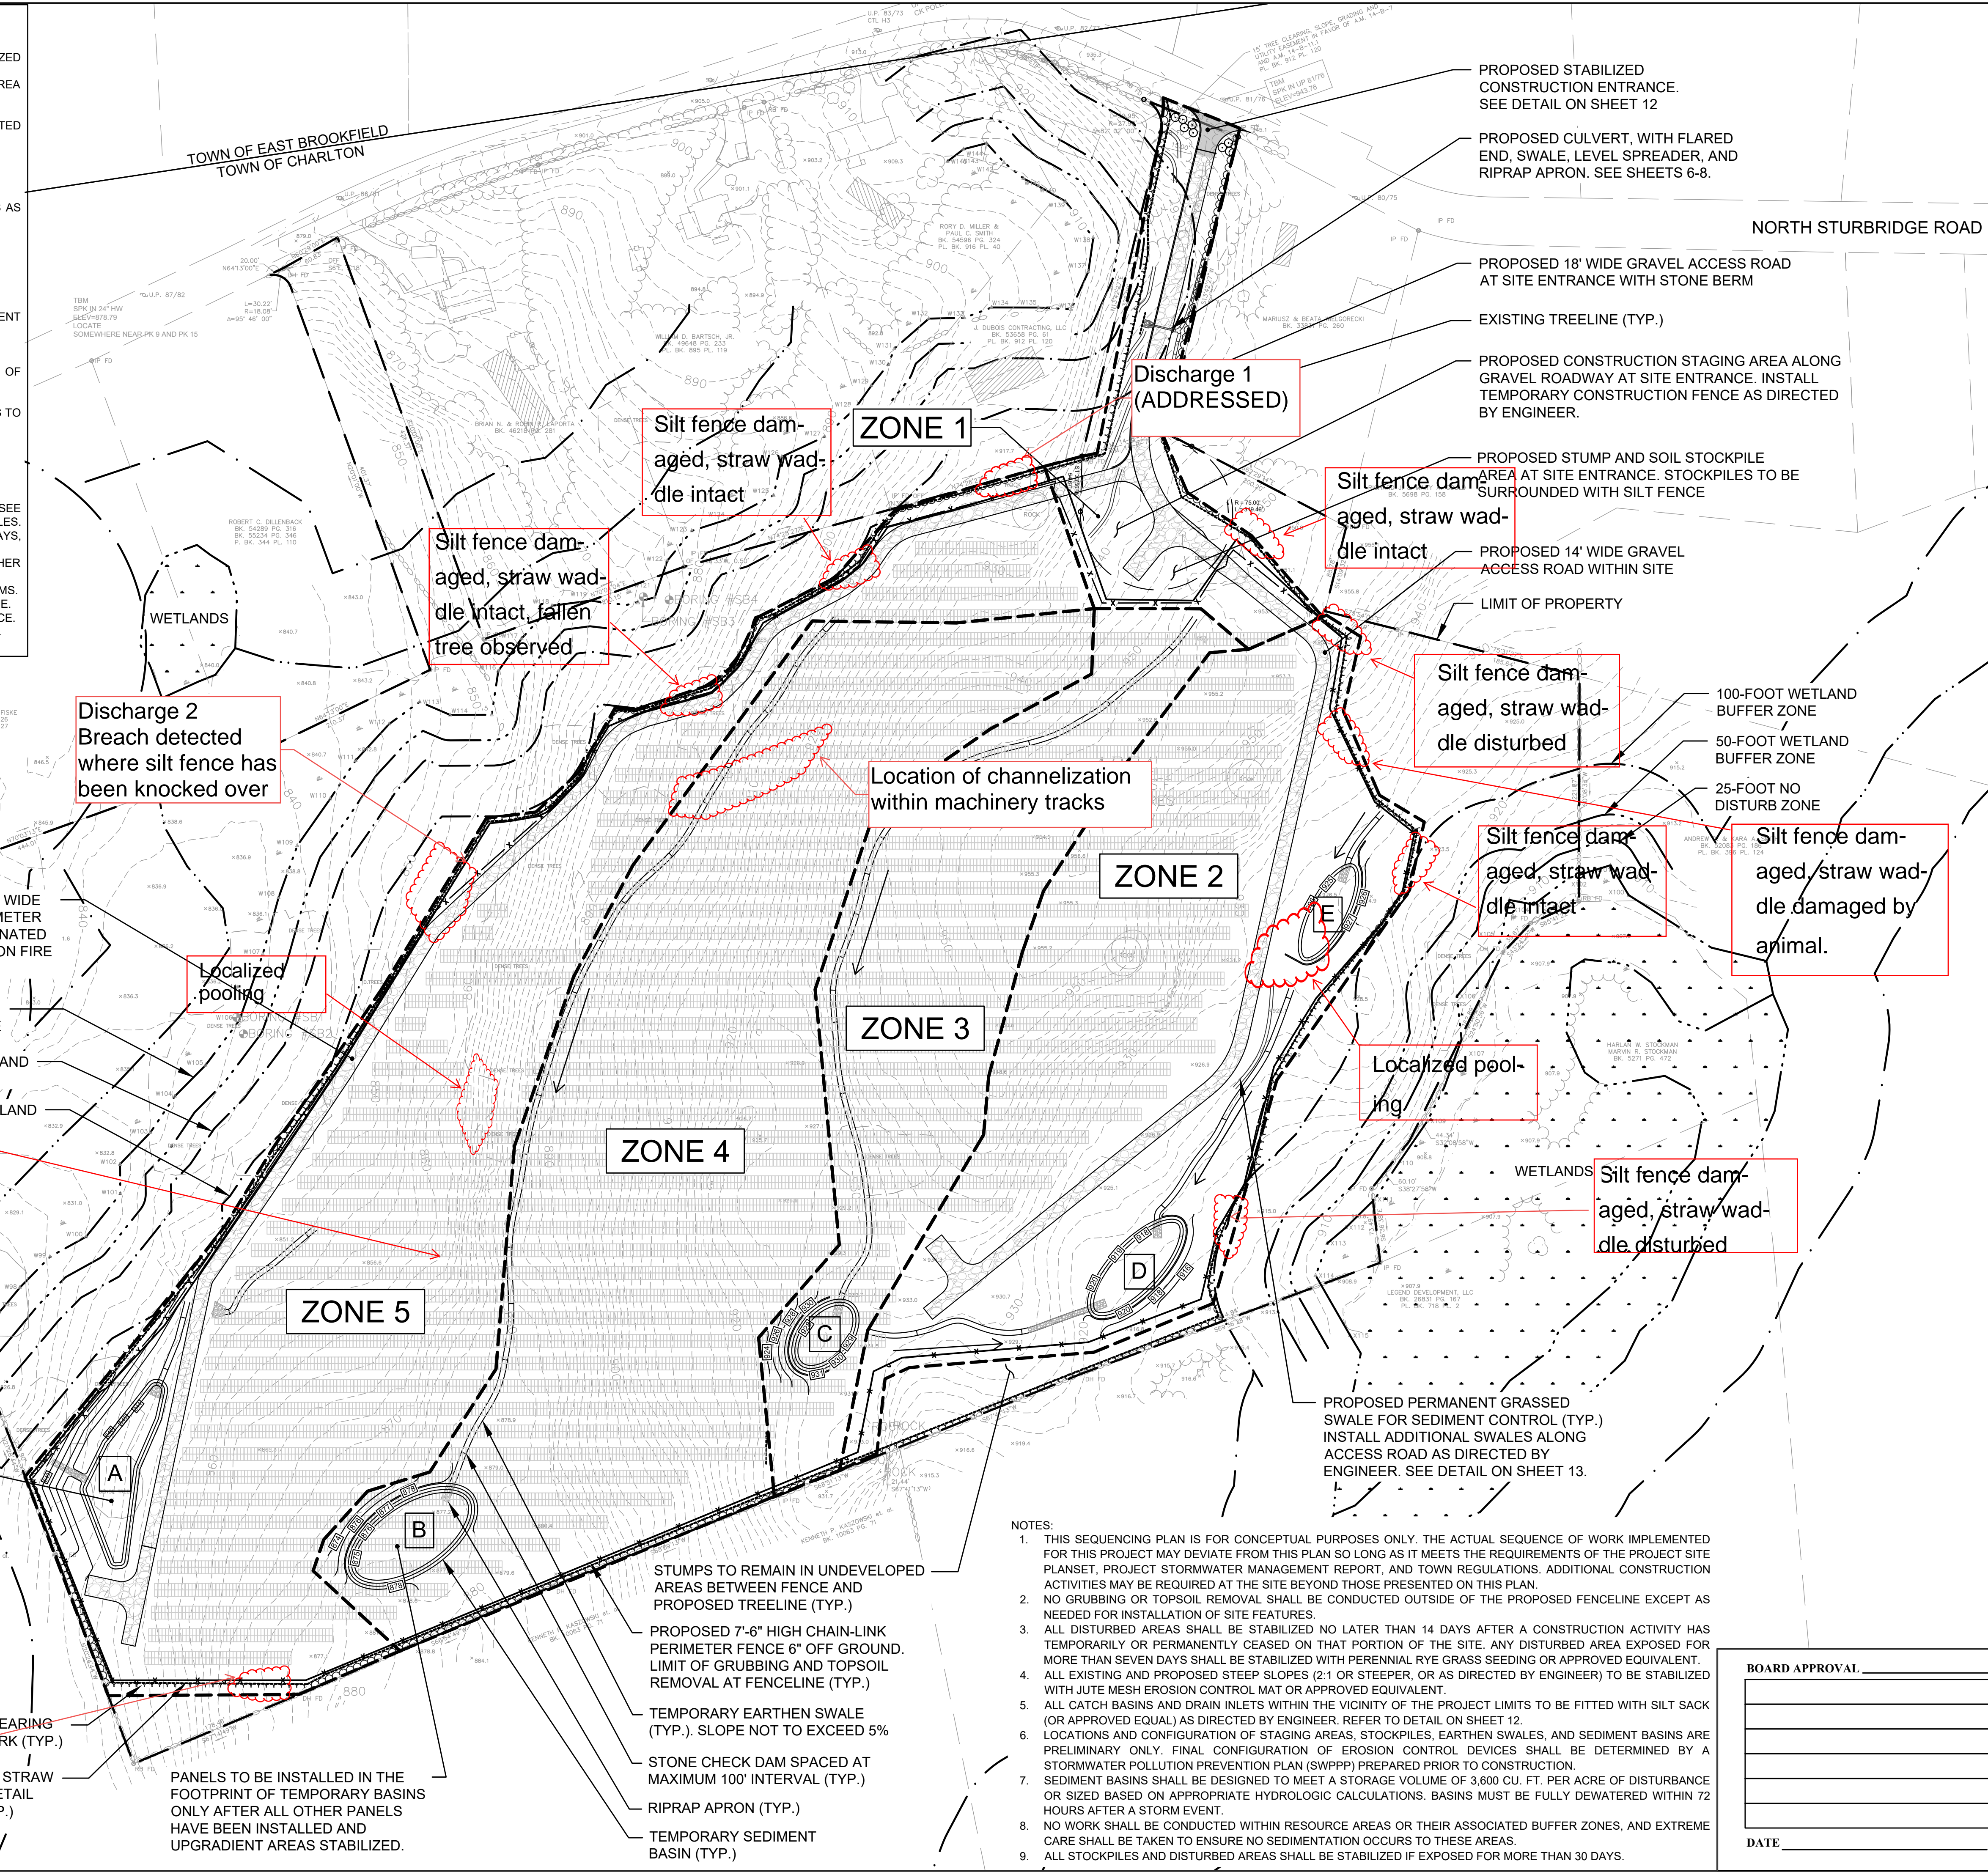
SHEET NO. **4**

2. Informal access road along northern portion of the Site	Straw mulch or hydroseed	<input type="checkbox"/> Yes [Enter date] <input checked="" type="checkbox"/> No	Erosion channels are beginning to form within upgradient portions of the informal access road (Figure 1). The contractor indicated that stabilization by smoothing out soils and seeding or spreading mulch would occur on 7/30/2021. Stabilization of this area has not been initiated. After inspection of the area on 8/24/2021, it was determined that

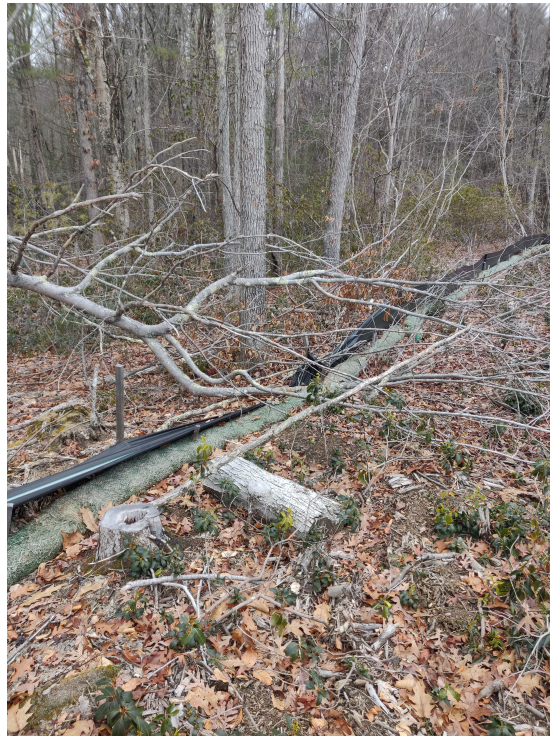
Photo 1

2. Stabilized Construction Entrance (Site Entrance – Access Road)	No (As of 9/2/2021)	No		<p>A tree was knocked over and laying on the silt fence on the on the northwestern portion of the site in Zone 5.</p> <p>Hydroseed was applied to exposed soil in this area and continues to germinate, some grass seedlings are now observed.</p>

View of tree fallen on northwestern portion of Zone 5.

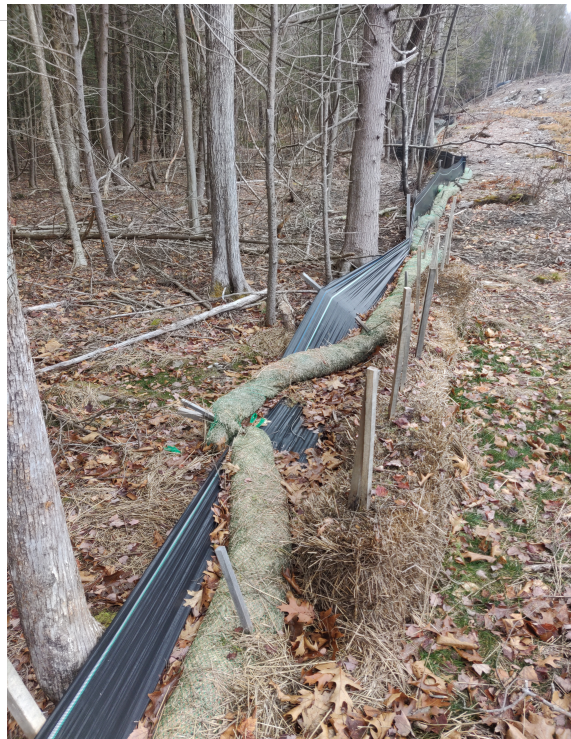
Photo 2

Type/Location of E&S Control	Maintenance Needed?*			
1. Silt Fence and Straw Wattles	Yes (As of 9/2/2021)	No	9/2/2021	<p>A breach was observed at Discharge 2. Although the double row of straw bales is intact, silt fence was observed to be knocked over and signs of stormwater flow were detected in the area beyond the fence.</p> <p>A minor tear was identified in a section of silt fence on the southern side of the Site with no erosion observed.</p> <p>Minor degradation of a straw wattle was observed on the southeastern side of the Site; no erosion was observed but pools of water were found to be forming behind the straw wattle.</p>

View of area downgradient of Discharge 2—facing north west.

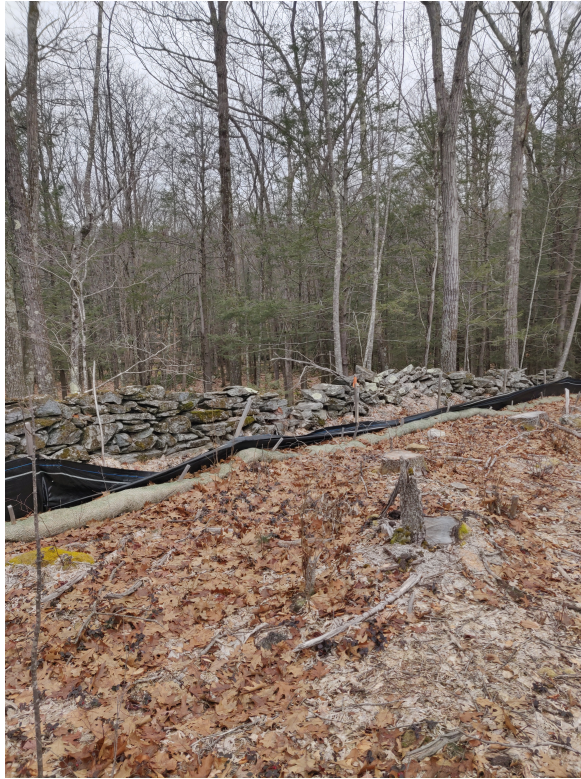
Photo 3

View of the damaged silt fence in southern perimeter of Site —facing south.

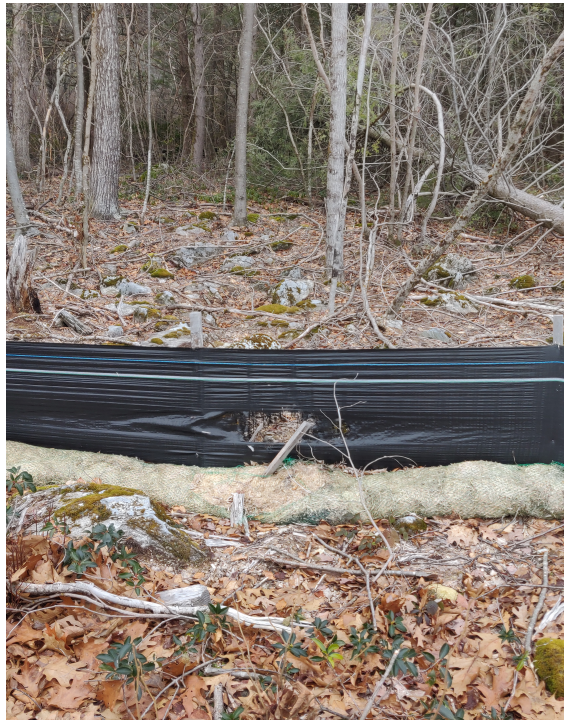
Photo 4

View of damaged silt fence and waddle in eastern portion of the Site —facing east

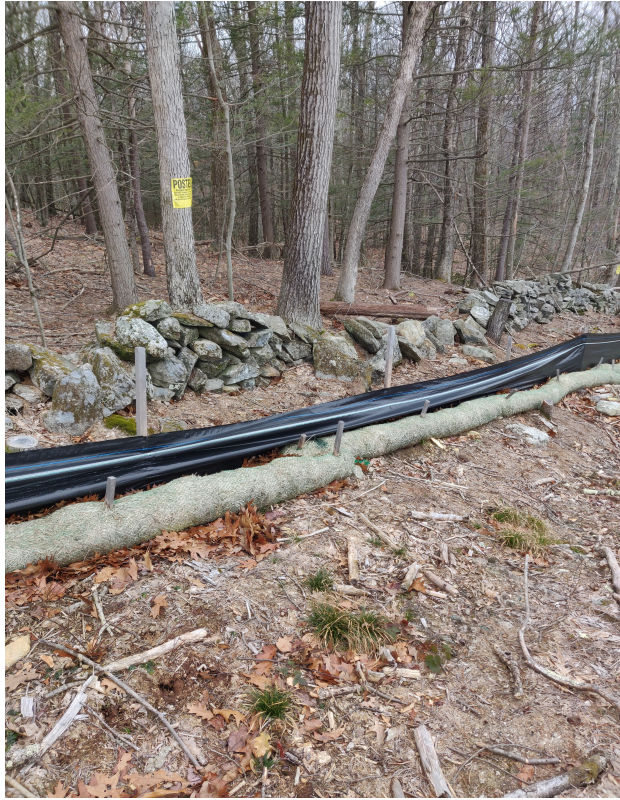
Photo 5

View of the damaged silt fence in eastern portion of Site — facing south east.

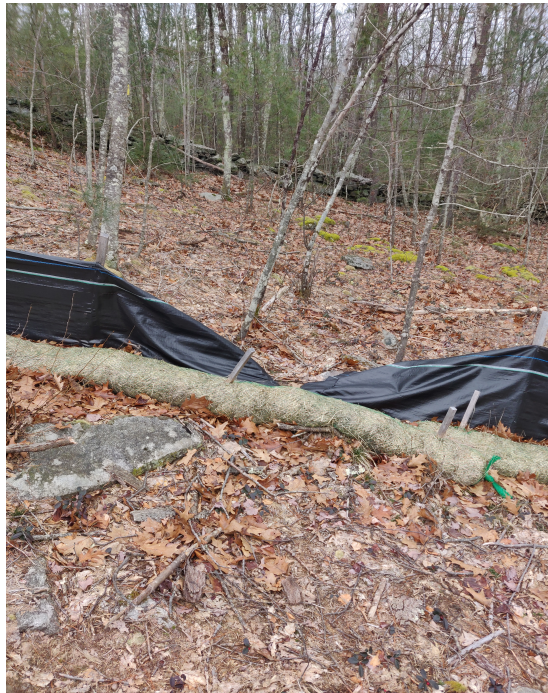
Photo 6

View of damaged silt fence in south east portion of the Site —facing south east

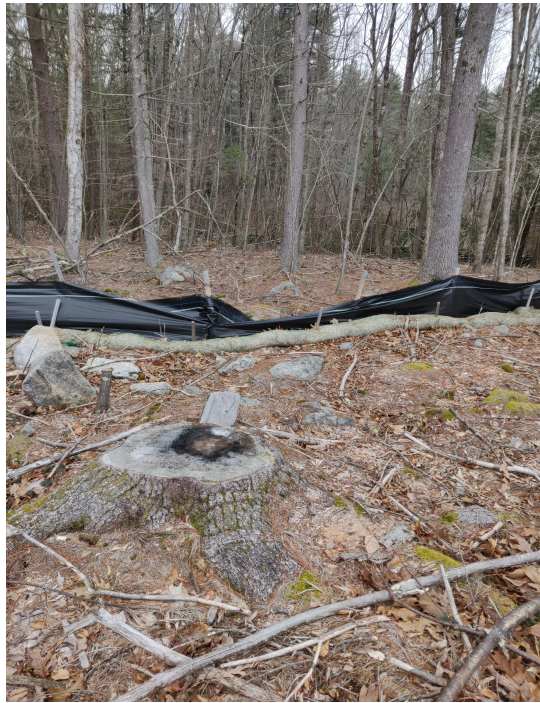
Photo 7

View of damaged silt fence in eastern portion of the Site —facing east

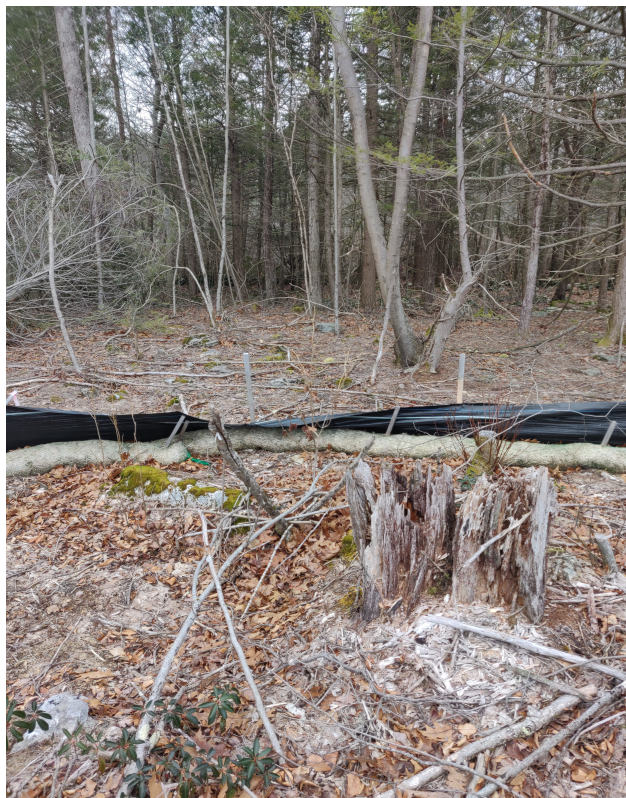
Photo 8

View of damaged silt fence in eastern portion of the Site —facing east

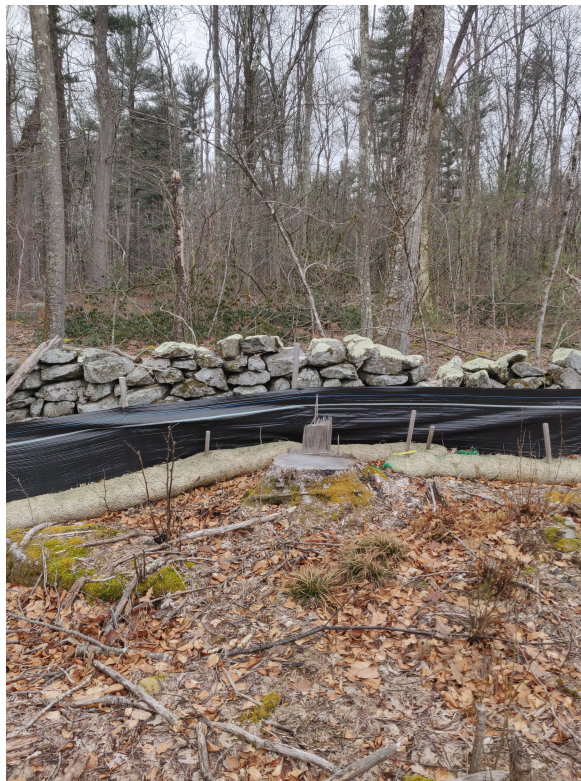
Photo 9

View of damaged silt fence in eastern portion of the Site —facing east

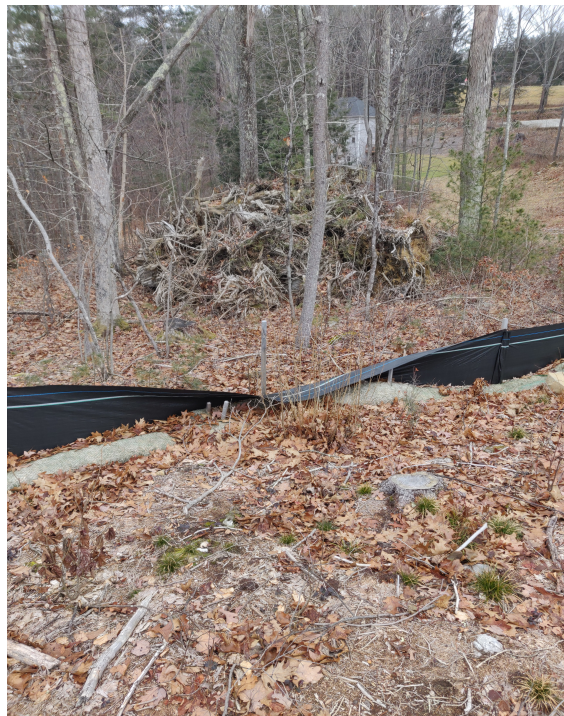
Photo 10

View of damaged silt fence in north western portion of the Site —facing north west

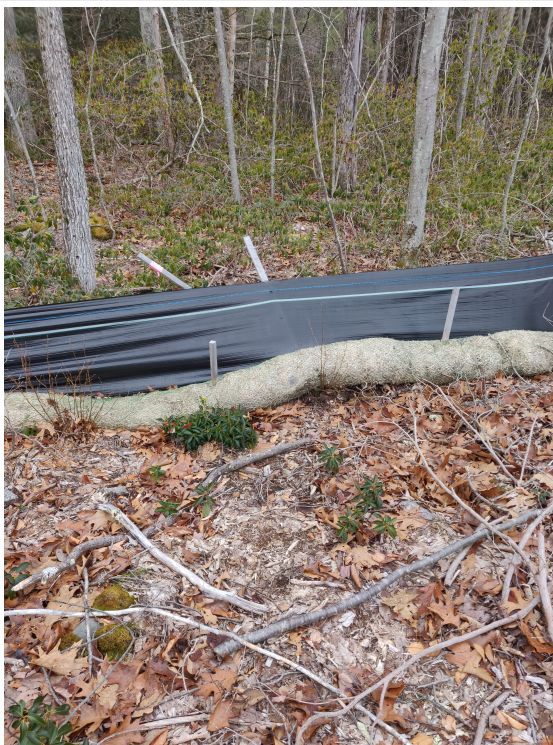
Photo 11

View of damaged silt fence and waddle in eastern portion of the Site —facing north east

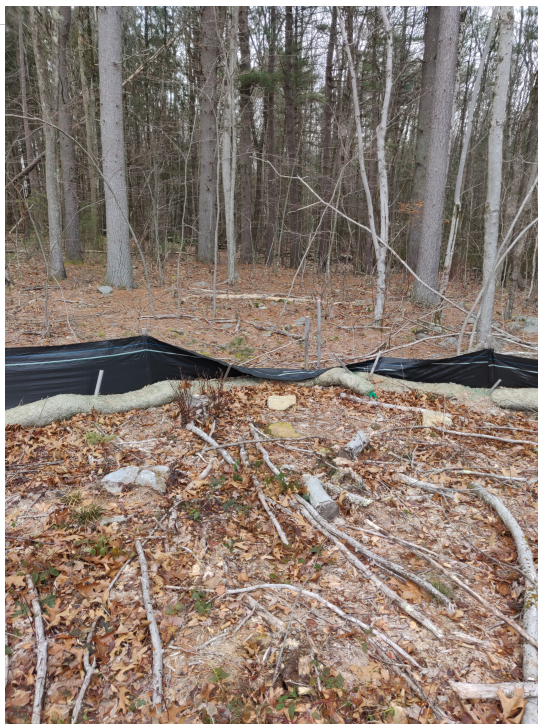
Photo 12

View of damaged silt fence and waddle in south eastern portion of the Site —facing south east
