Inspection Report for North Sturbridge Road Solar Facility NPDES ID No.: MAR10031G

NPDES ID No.: MAR10031G Inspection Date: 02/04/2022

PHOTOGRAPHIC DOCUMENTATION North Sturbridge Road Solar Facility Charlton, Massachusetts Photographs Documented 02.04.2022

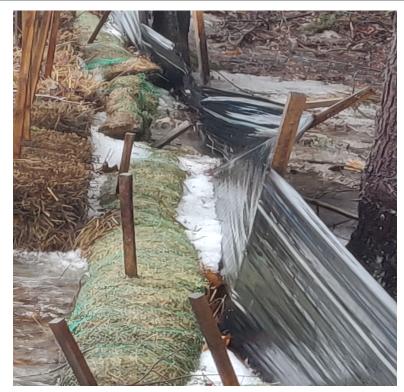
Photo 1

View of area down-gradient of Discharge 2—facing south west.

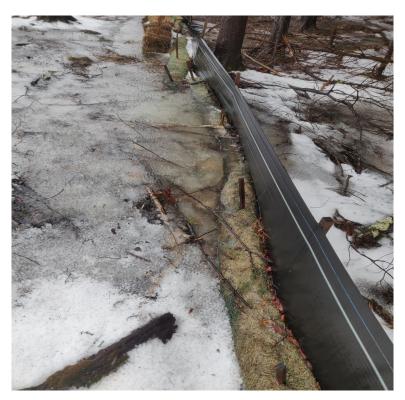
Photo 2

View of area down-gradient of Discharge 2—facing south west.

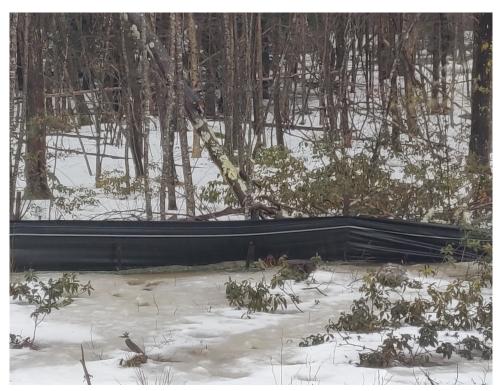
View of the flooded straw waddle and silt fence located up-gradient from Discharge 2 — Facing north west
