Inspection Report for North Sturbridge Road Solar Facility

NPDES ID No.: MAR10031G

Inspection Date: 02/04/2022

FIGURE 1:  
SWPPP  
INSPECTION  
SKETCH  
02/04/2022

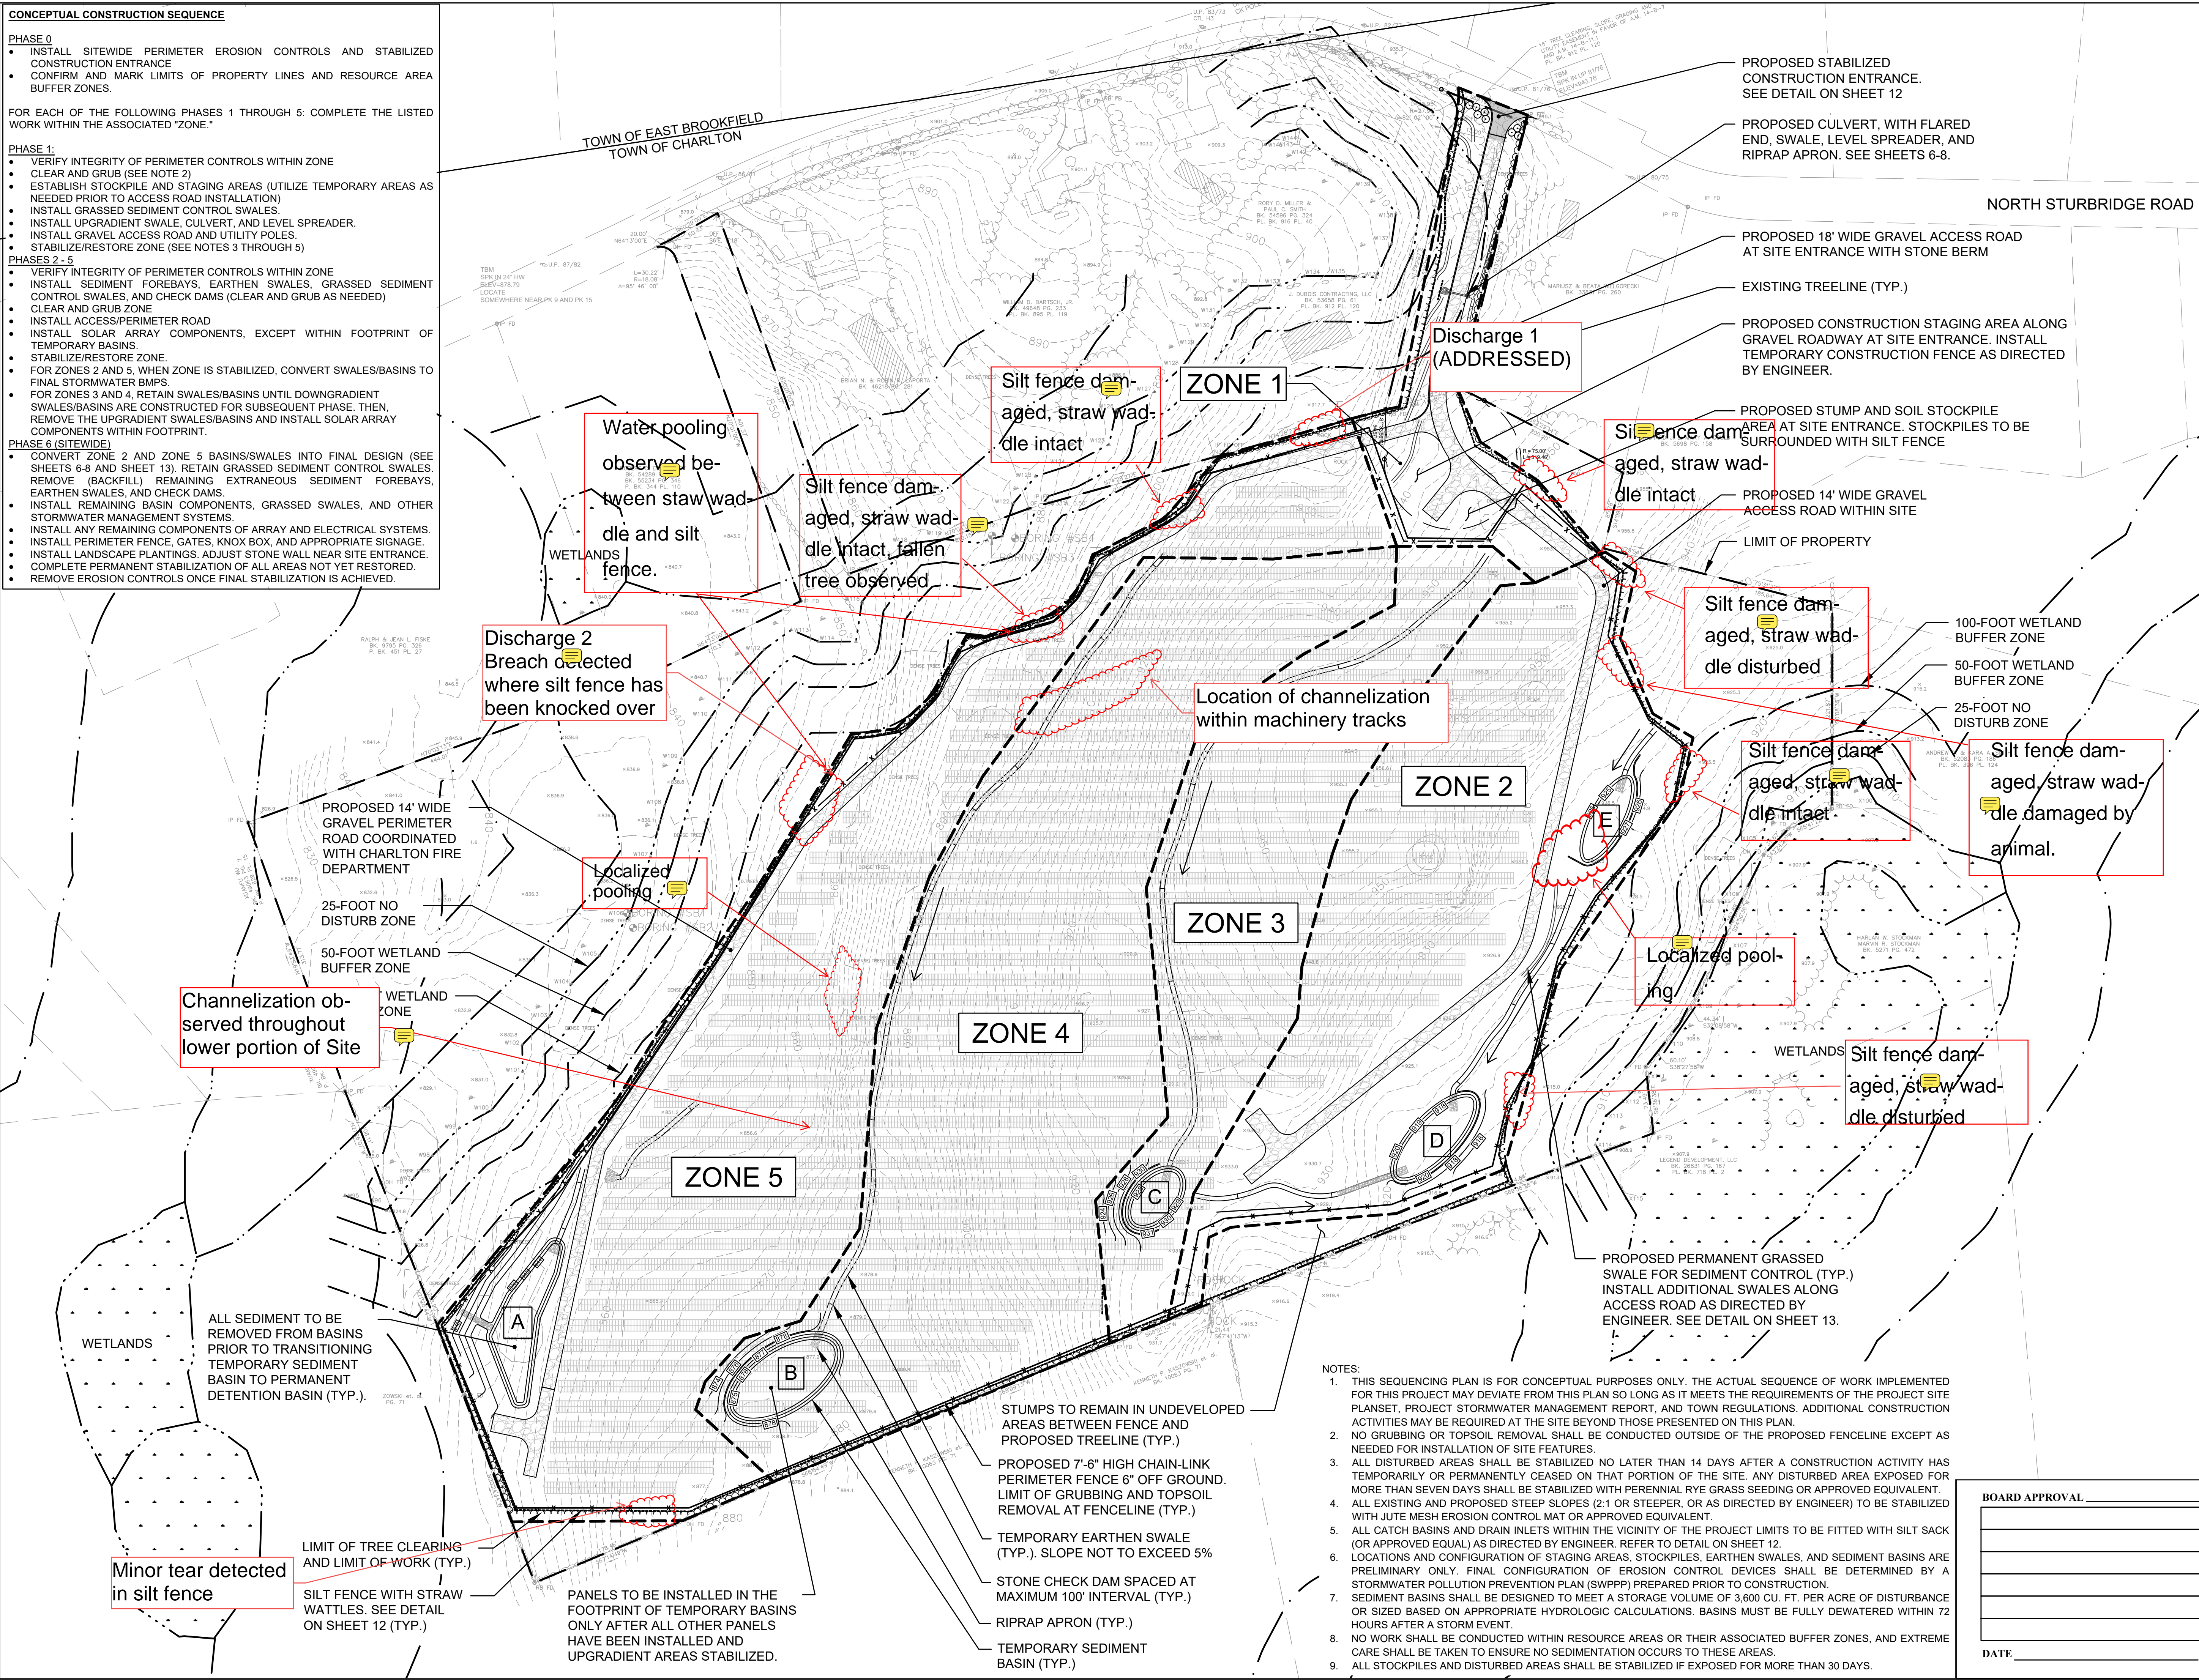
Minor tear detected in silt fence

Water pooling observed between staw wad-dle and silt fence.

Silt fence damaged, straw wad-dle intact, fallen tree observed

Silt fence damaged, straw wad-dle intact

Silt fence damaged, straw wad-dle disturbed

Silt fence damaged, straw wad-dle damaged by animal.

Discharge 2 Breach detected where silt fence has been knocked over

Location of channelization within machinery tracks

Localized pooling

Channelization observed throughout lower portion of Site

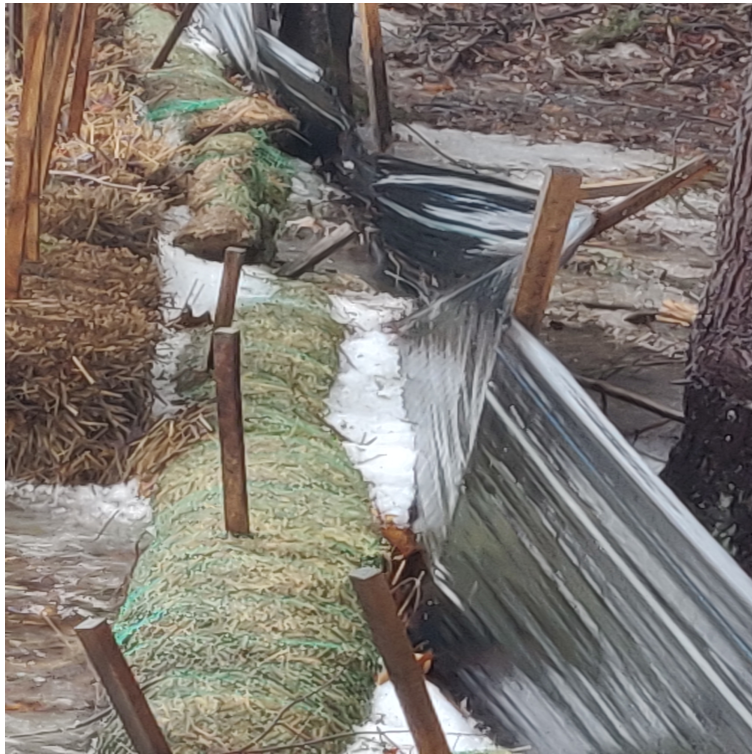
Photo 1

<p>A breach was observed at Discharge 2. Although the double row of straw bales is intact, silt fence was observed to be knocked over and signs of stormwater flow were detected in the area beyond the fence.</p> <p>A minor tear was identified in a section of silt fence on the southern side of the Site with no erosion observed.</p> <p>Minor degradation of a straw wattle was observed on the southeastern side of the Site; no erosion was observed but pools of water were found to be forming behind the straw wattle.</p>

View of area down-gradient of Discharge 2—facing south west.

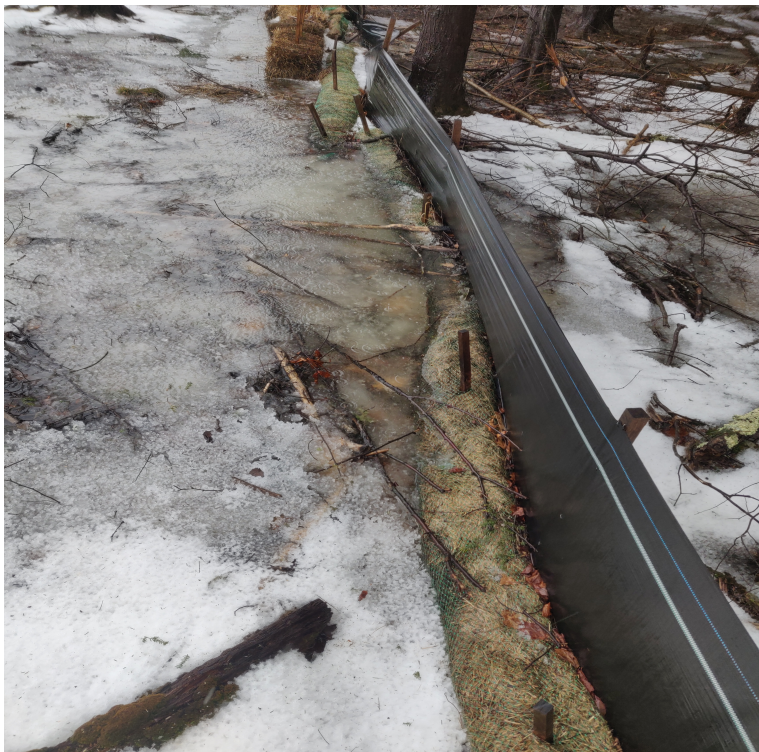
Photo 2

View of area down-gradient of Discharge 2—facing south west.

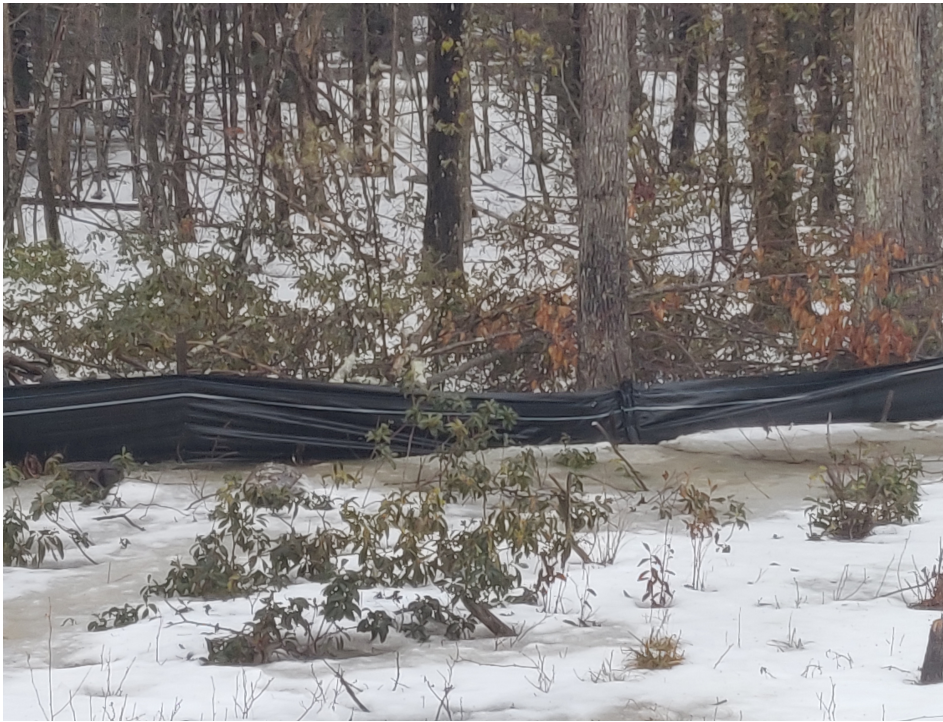
Photo 3

4. Dust Controls	N/A	N/A	10/2/2021	<p>Severe pooling was observed st Discharge 2. Water saturated the straw waddles and has collected between the silt fence.</p>

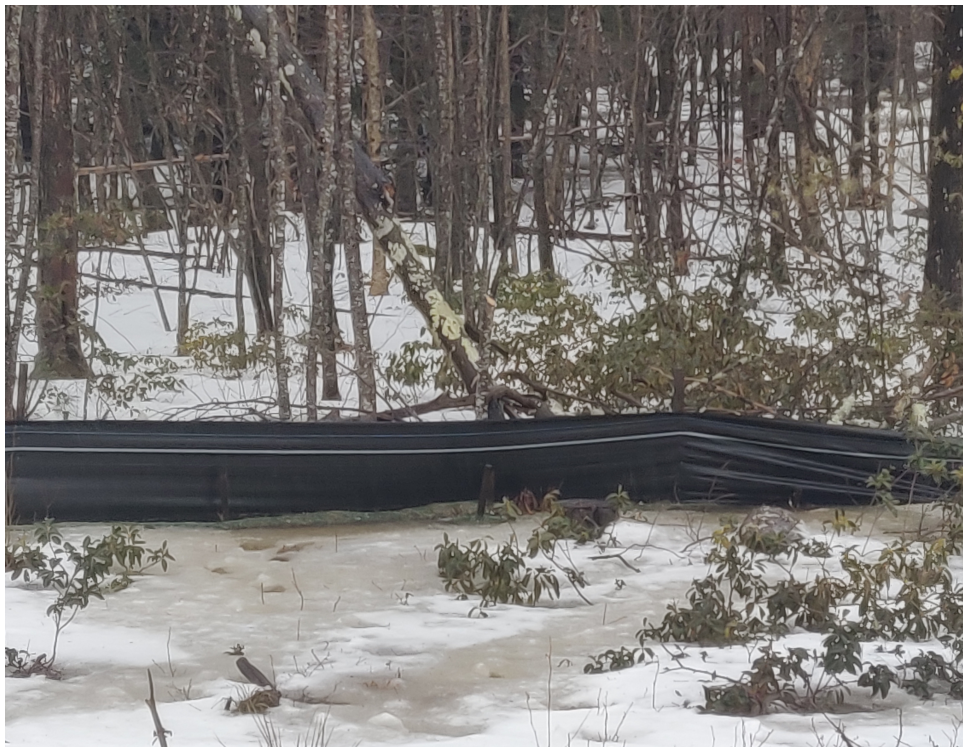
Photo 4 View of the flooded straw wattle and silt fence located up-gradient from Discharge 2 — Facing north west

View of the flooded straw wattle and silt fence located up-gradient from Discharge 2 — Facing north west
