Inspection Report for North Sturbridge Road Solar Facility

NPDES ID No.: MAR10031G

Inspection Date: 02/04/2022

PHOTOGRAPHIC DOCUMENTATION  
North Sturbridge Road Solar Facility  
Charlton, Massachusetts  
Photographs Documented 02.04.2022

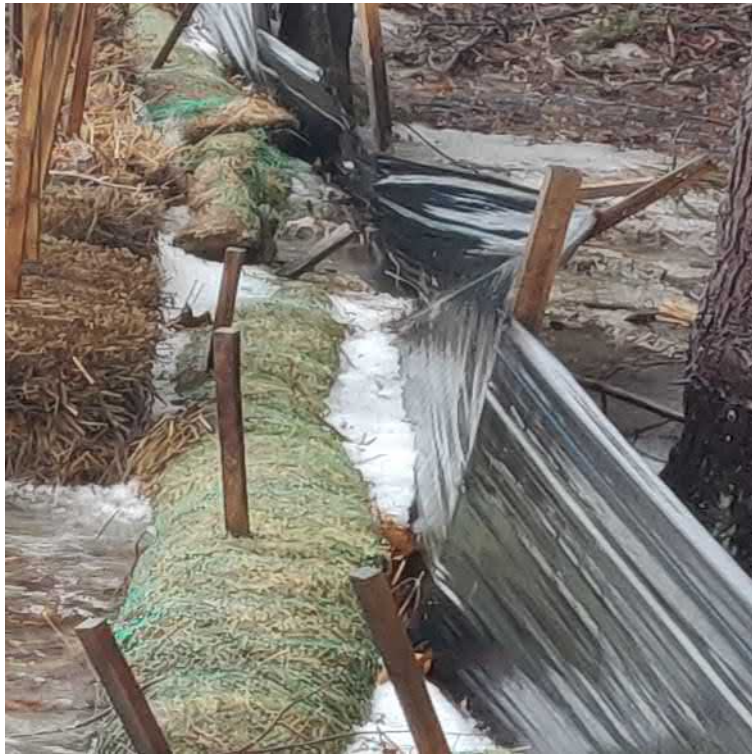
Photo 1

View of area down-gradient of Discharge 2—facing south west.

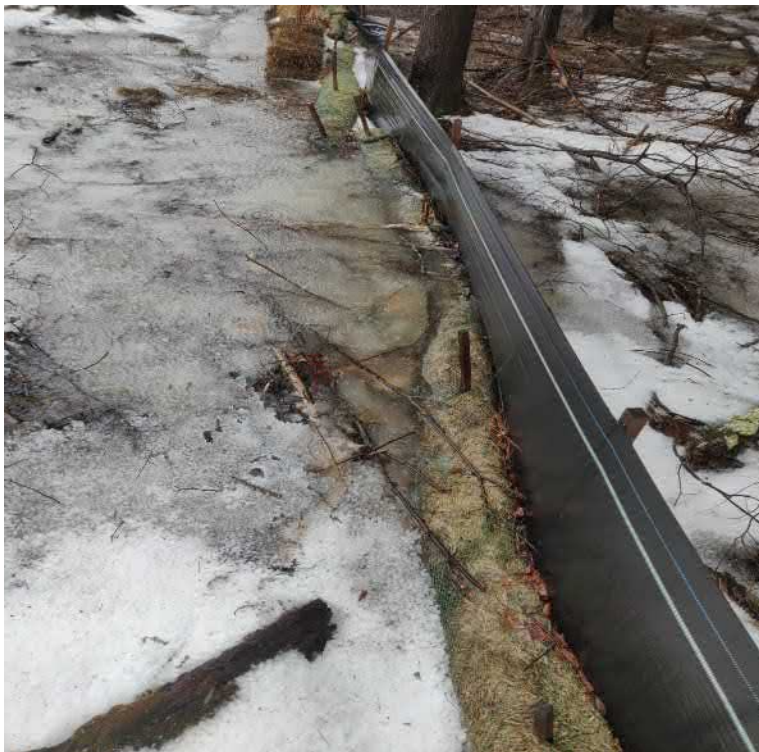
Photo 2

View of area down-gradient of Discharge 2—facing south west.

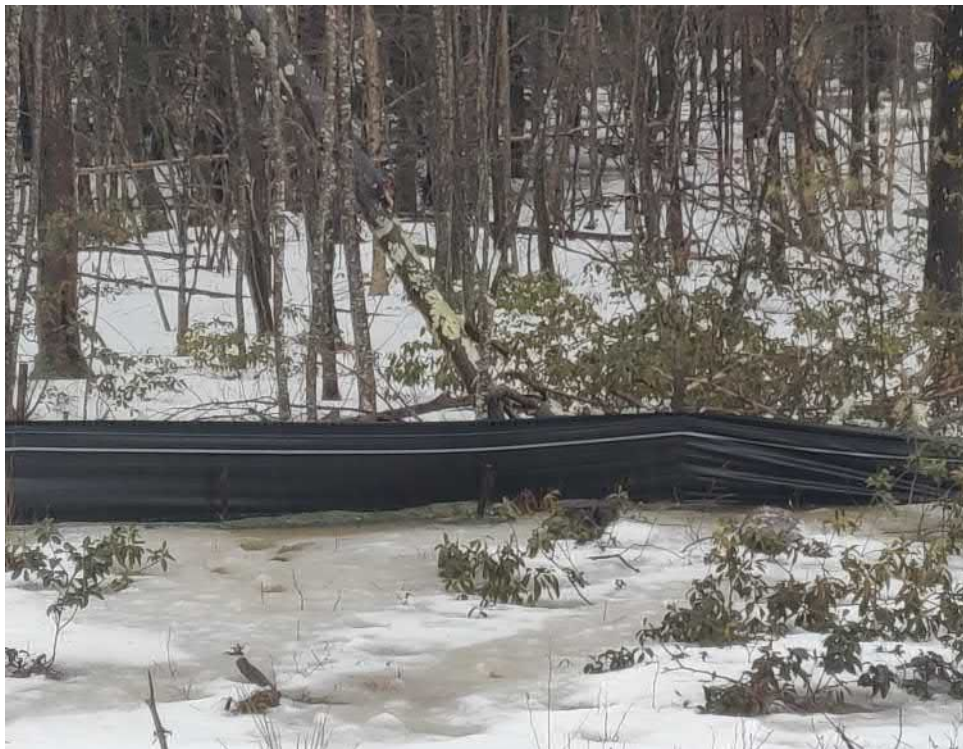
4. Dust Controls	N/A	N/A		
5. Jute Mesh (Steep Slopes)	N/A	N/A	10/2/2021	<p>Severe pooling was observed st Discharge 2. Water saturated the straw waddles and has collected between the silt fence.</p>

Photo 4 View of the flooded straw wattle and silt fence located up-gradient from Discharge 2 — Facing north west

View of the flooded straw wattle and silt fence located up-gradient from Discharge 2 — Facing north west
