## Inspection Report for North Sturbridge Road Solar Facility NPDES ID No.: MAR10031G Inspection Date: 03/15/2022

PHOTOGRAPHIC DOCUMENTATION North Sturbridge Road Solar Facility Charlton, Massachusetts Photographs Documented 03.15.2022

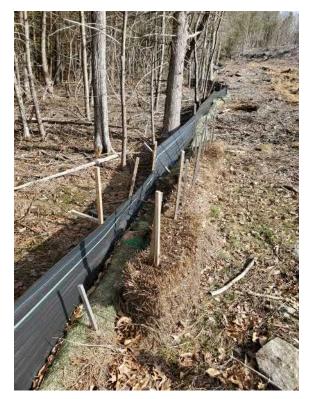
## Photo 1

View of area downgradient of Discharge 2-facing north west.

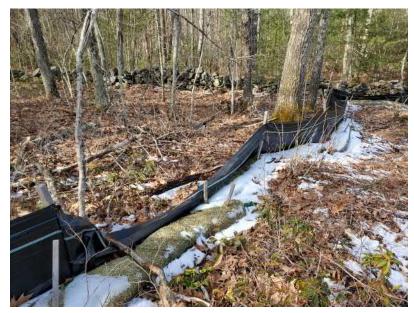
Photo 2

View of damaged silt fence in south east portion of the Site —facing south east
