Inspection Report for North Sturbridge Road Solar Facility

NPDES ID No.: MAR10031G

Inspection Date: 03/15/2022

**FIGURE 1:  
 SWPPP  
 INSPECTION  
 SKETCH  
 03/15/2022**

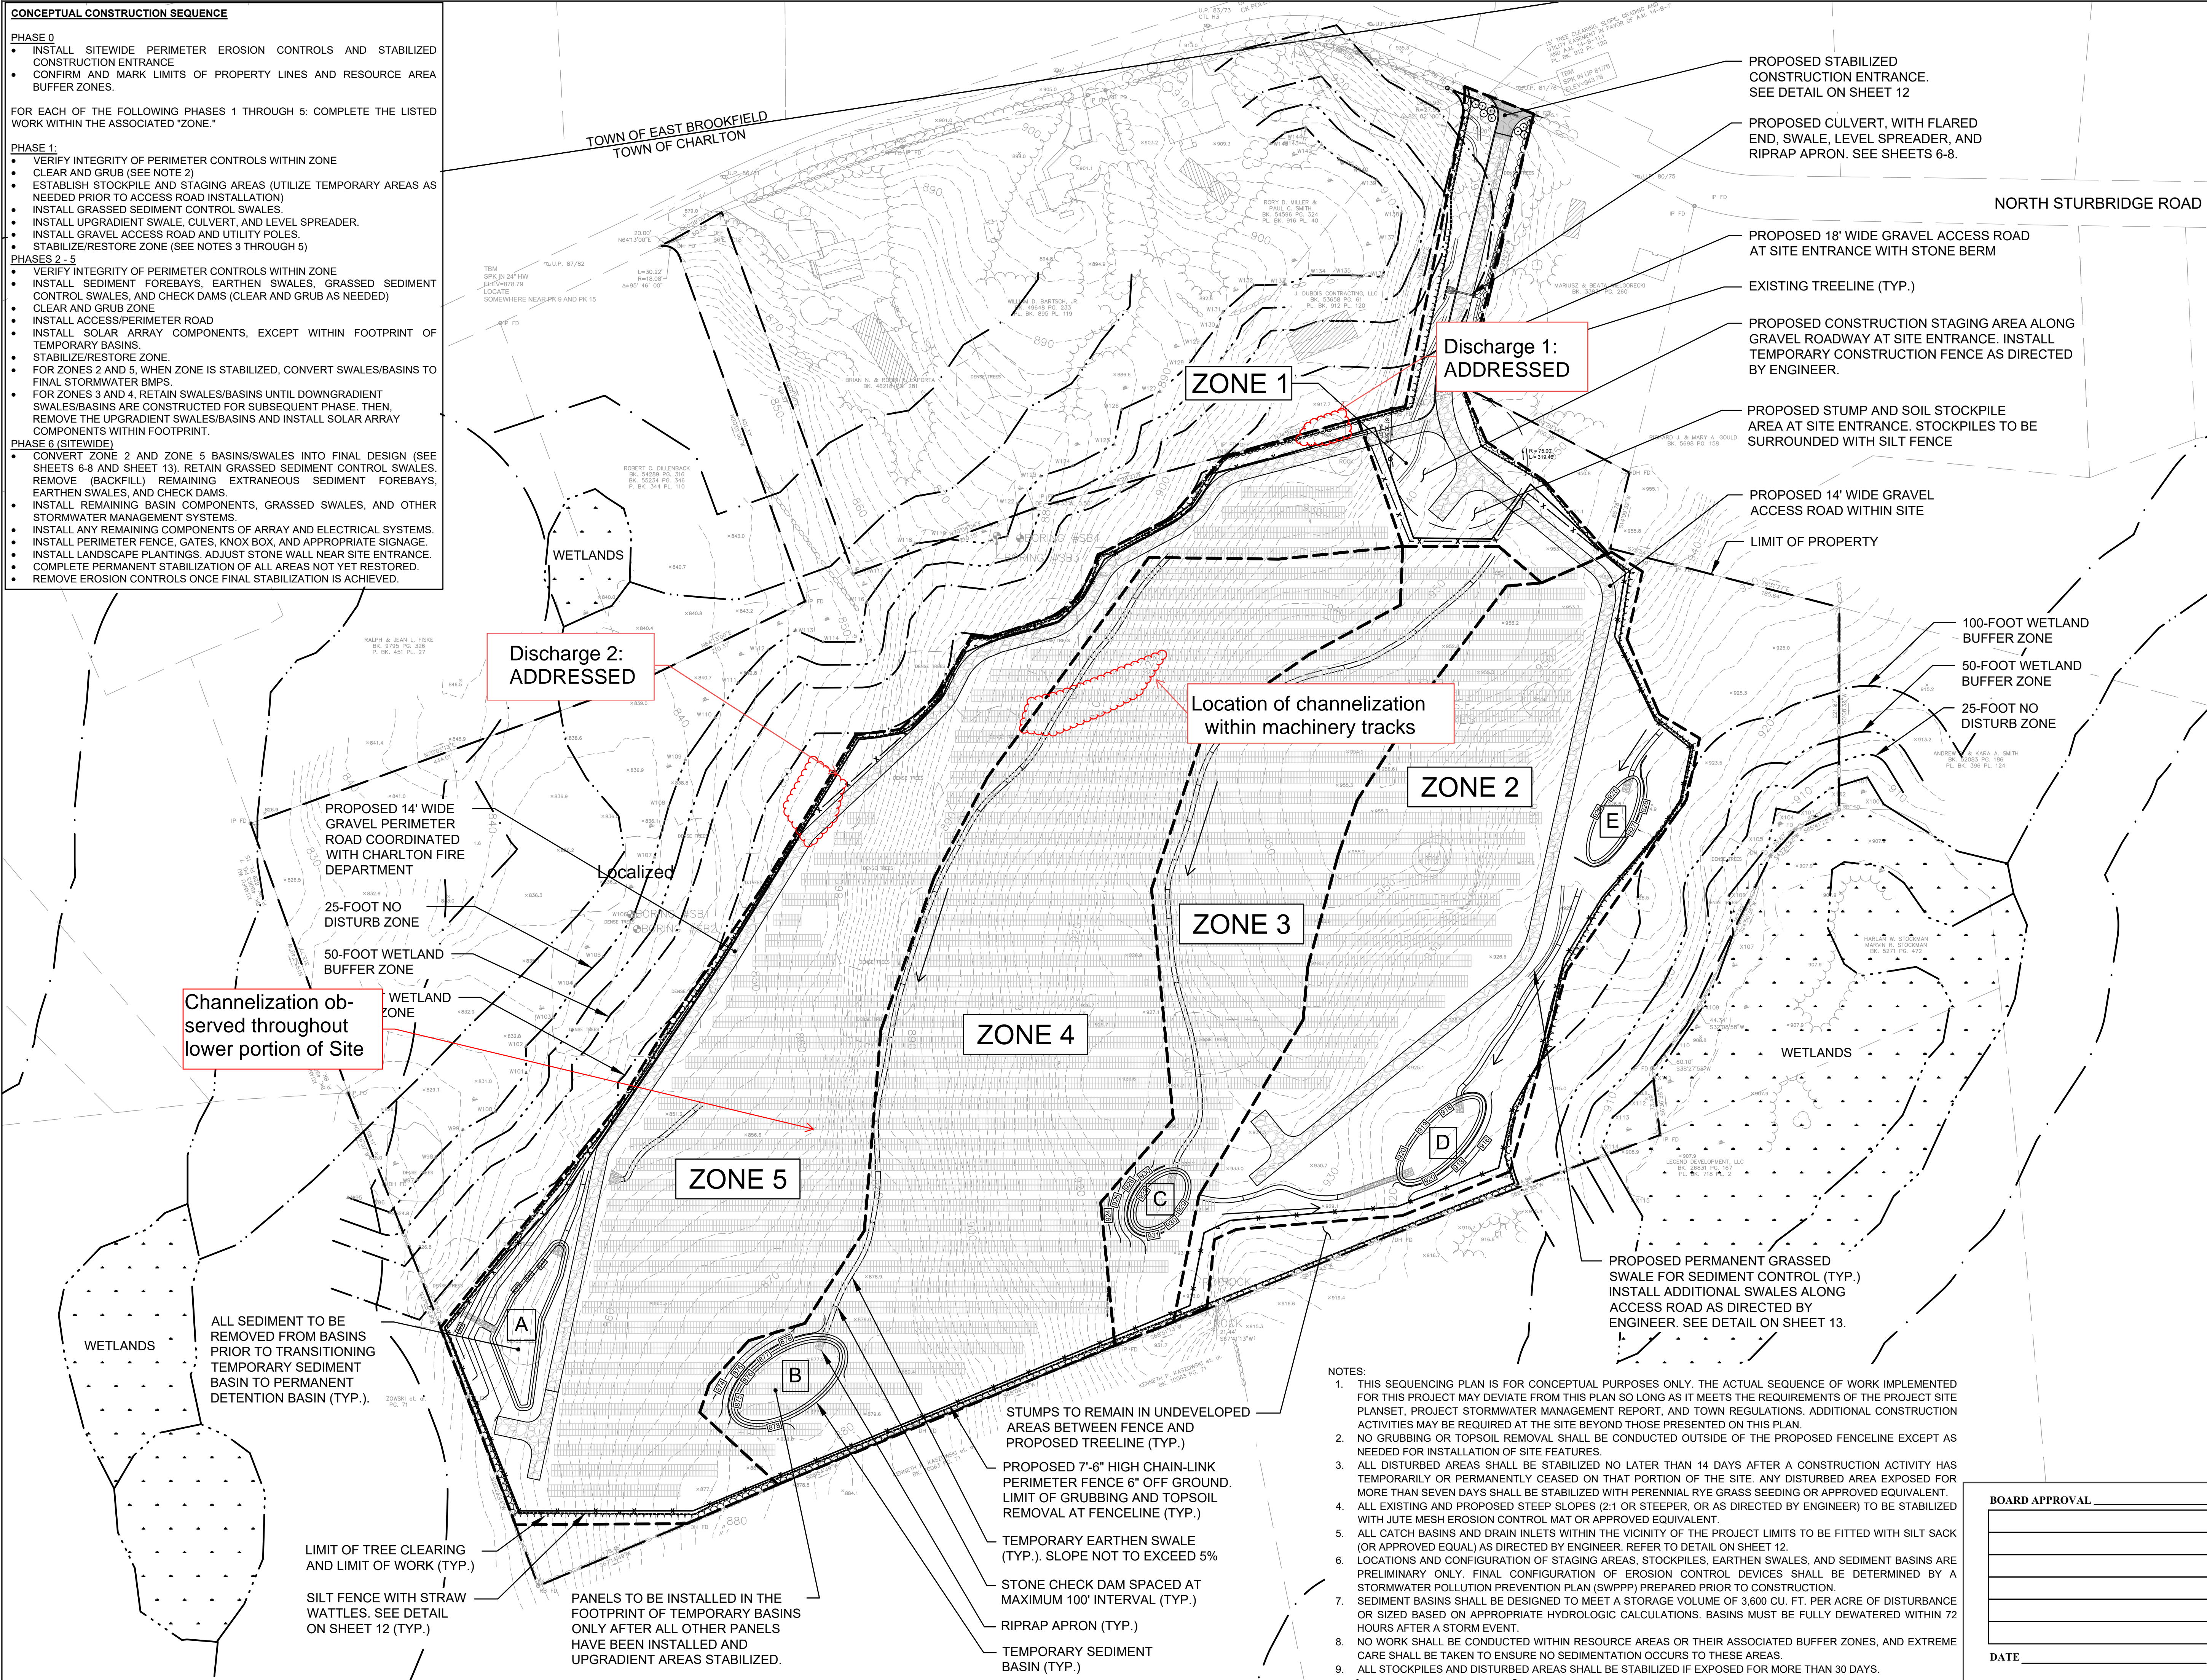
| Stabilization of Exposed Soil (CGP Part 2.2.14) | | | |
|--|---|--|--|
| 2. Informal access road along northern portion of the Site | Straw mulch or hydroseed | <input type="checkbox"/> Yes [Enter date] <input checked="" type="checkbox"/> No | Erosion channels are beginning to form within upgradient portions of the informal access road (Figure 1). The contractor indicated that stabilization by smoothing out soils and seeding or spreading mulch would occur on 7/30/2021. Stabilization of this area has not been initiated. After inspection of the area on 8/24/2021, it was determined that |

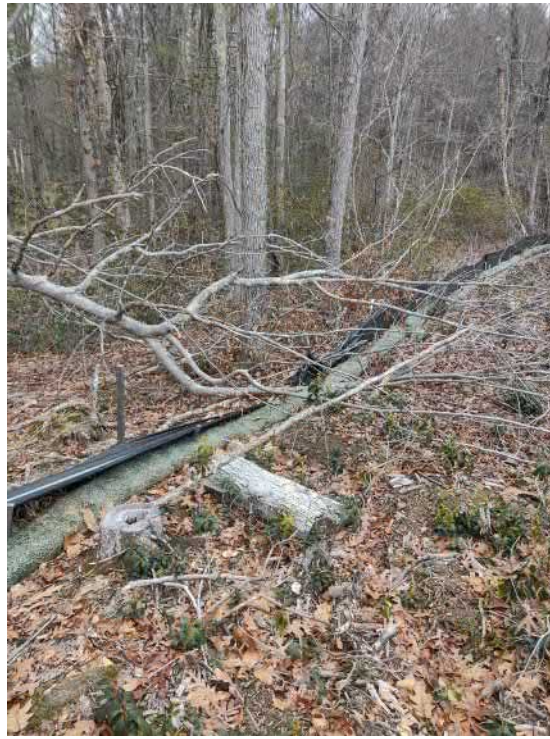
Photo 1

View of tree fallen on northwestern portion of Zone 5.

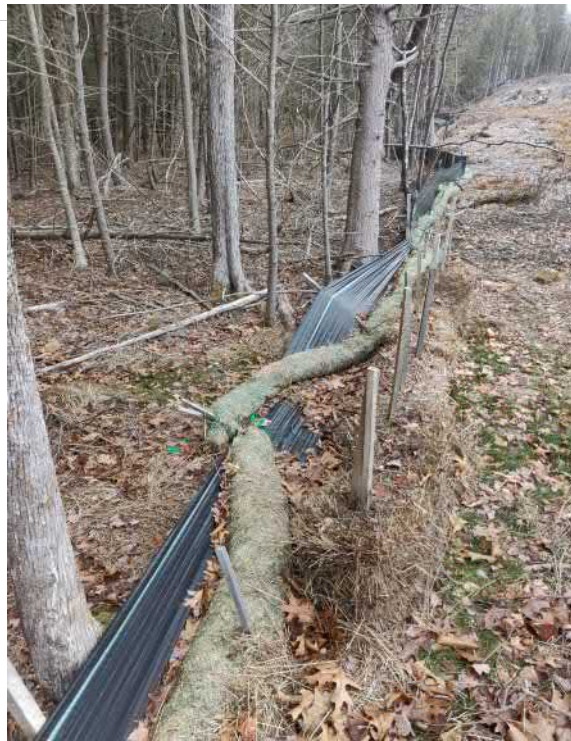
Photo 2

View of area downgradient of Discharge 2—facing north west.

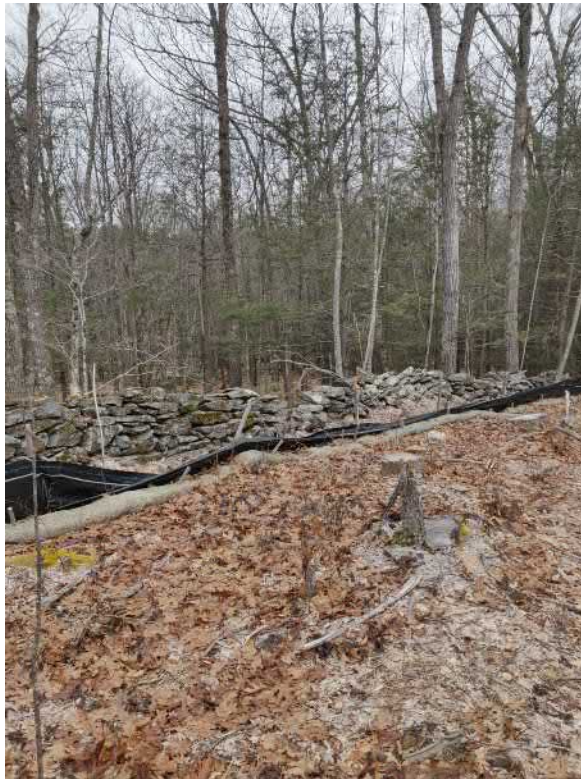
Photo 3

| Type/Location of E&S Control | Maintenance Needed?* | | | |
|---|---|---|---|--|
| | | | 3/15/ 2022 | On 3/15/2022 BETA observed torn silt fence in multiple areas along the perimeter of the Site. No discharge was observed. All of the wattles remain within specification. |

View of the damaged silt fence in southern perimeter of Site —facing south.

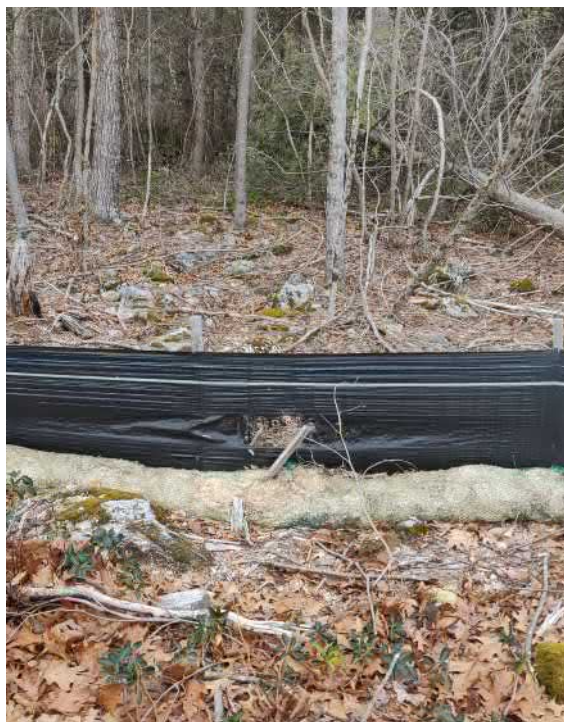
Photo 4

View of damaged silt fence and waddle in eastern portion of the Site —facing east

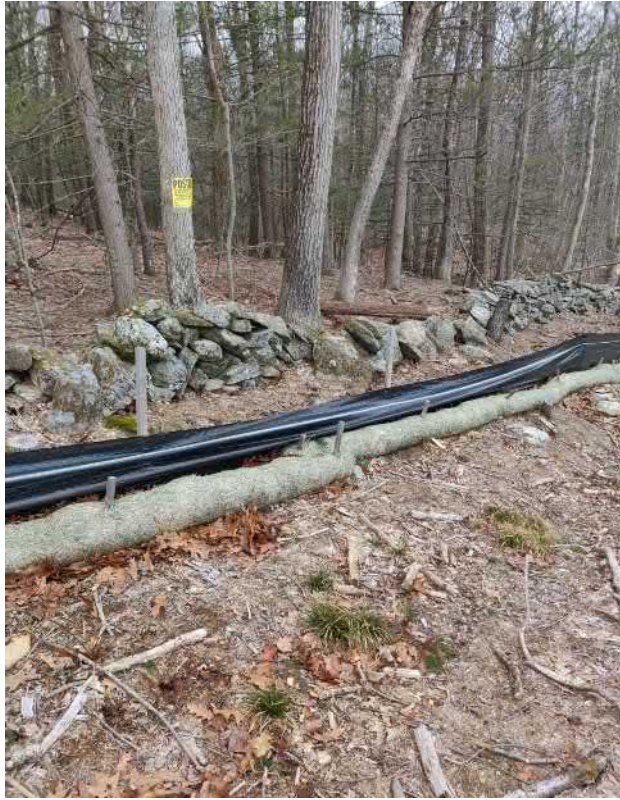
Photo 5

View of the damaged silt fence in eastern portion of Site — facing south east.

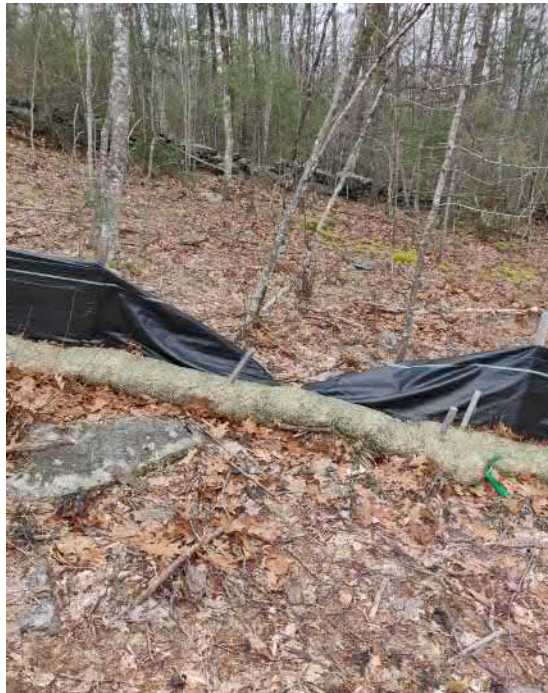
Photo 6

View of damaged silt fence in south east portion of the Site —facing south east

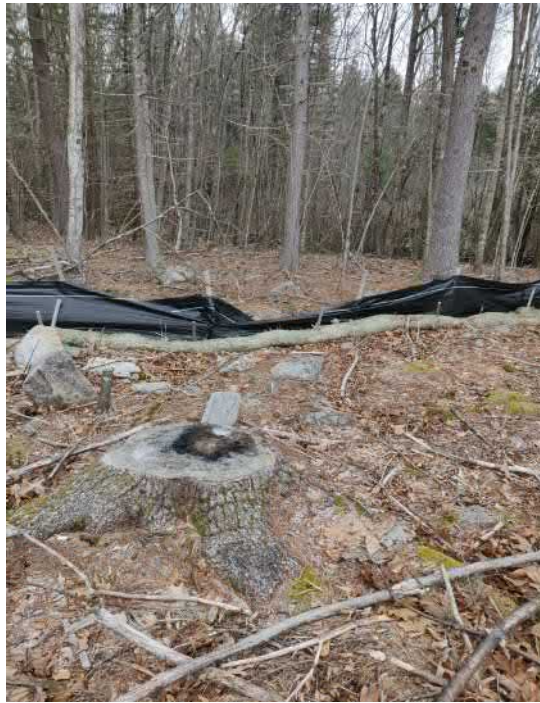
Photo 7

View of damaged silt fence in eastern portion of the Site —facing east

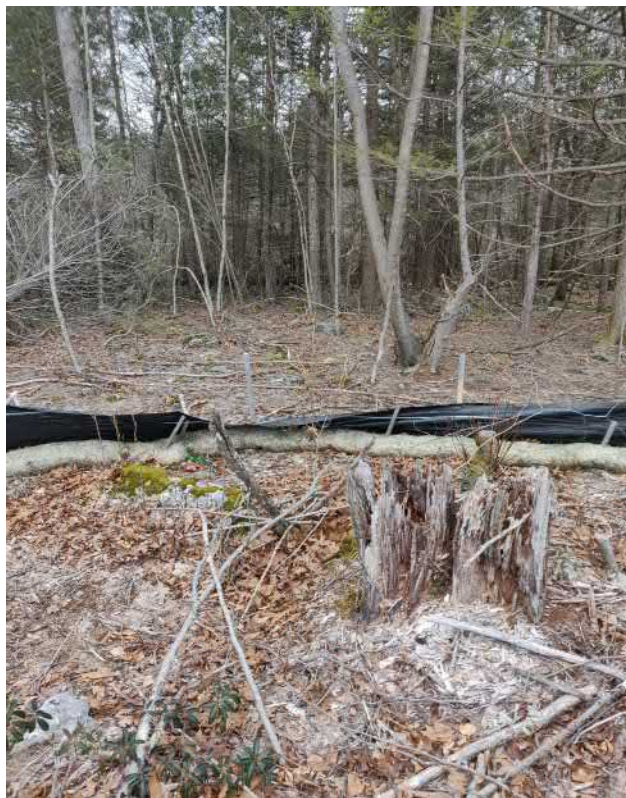
Photo 8

View of damaged silt fence in eastern portion of the Site —facing east

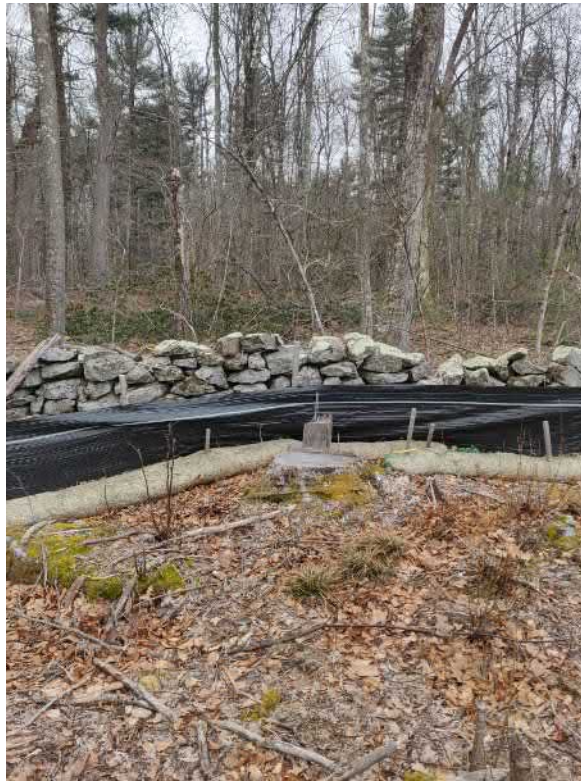
Photo 9

View of damaged silt fence in eastern portion of the Site —facing east

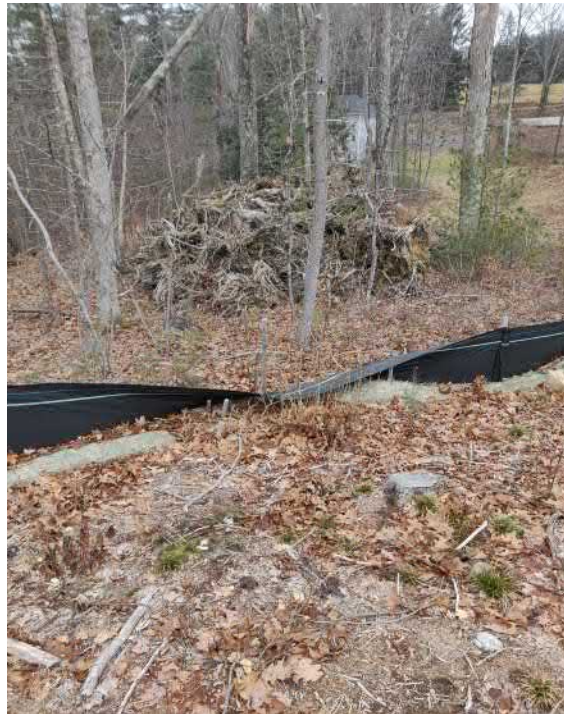
Photo 10

View of damaged silt fence in north western portion of the Site —facing north west

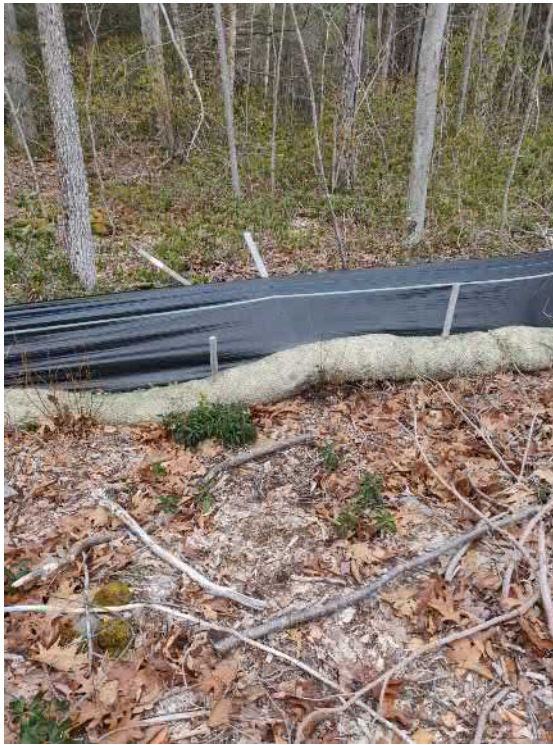
Photo 11

View of damaged silt fence and waddle in eastern portion of the Site —facing north east

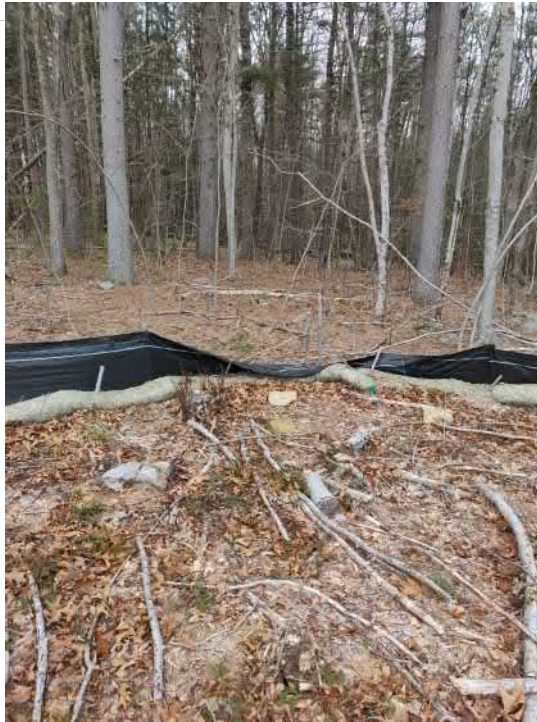
Photo 12

View of damaged silt fence and waddle in south eastern portion of the Site —facing south east
