Inspection Report for North Sturbridge Road Solar Facility NPDES ID No.: MAR10031G

NPDES ID No.: MAR10031G Inspection Date: 03/15/2022

PHOTOGRAPHIC DOCUMENTATION
North Sturbridge Road Solar Facility
Charlton, Massachusetts
Photographs Documented 03.15.2022

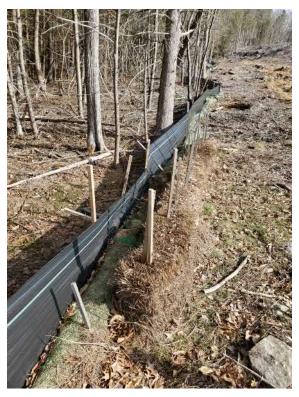
Photo 1

View of area downgradient of Discharge 2—facing north west.

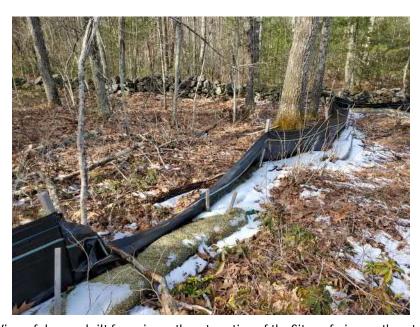
Photo 2

View of damaged silt fence in south east portion of the Site —facing south east
