| | | | General Inf | ormation | | | | | | |
|---|---|--|---|---|---|---|--|--|--|--|
| Inspection Location | | North Sturbridge Road Solar Fac | cility – Entirety of Site | (0 North Sturbridge Road, Cha | rlton, MA 01507) | | | | | |

Inspection Report for North Sturbridge Road Solar Facility NPDES ID No.: MAR10031G Inspection Date: 03/24/2022

PHOTOGRAPHIC DOCUMENTATION North Sturbridge Road Solar Facility Charlton, Massachusetts Photographs Documented 03.24.2022

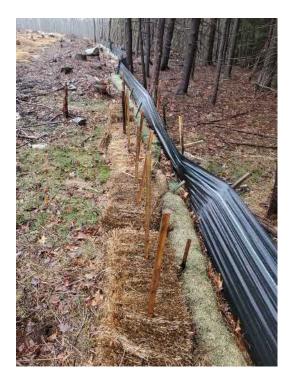
Photo 1

View of area downgradient of Discharge 2—facing south west.

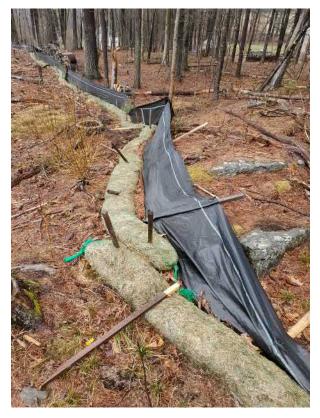
Photo 3

| Condition and Effectiveness of Erosion and Sediment (E&S) Controls (CGP Part 2.2) | | | | | | | |
|---|---|---|---|--|--|--|--|
| Stabilized Construction Entrance (Site Entrance – Access Road) Stump and Soil Stockpile Area Dust Controls Jute Mesh (Steep Slopes) Temporary Seeding | No No N/A N/A No | No N/A N/A No | 3/15/ 2022 3/24/2022 | On 3/15/2022 BETA observed torn silt fence in multiple lo- cations along the perimeter of the Site. The silt wattles are still serving their intended purpose but require main- tenance. On 3/24/2022 BETA observed damaged silt fence in the southeast corner and northern portions of the Site. No evidence of discharge was observed. | | | |

View of damaged silt fence in northern portion of the Site—facing north west.

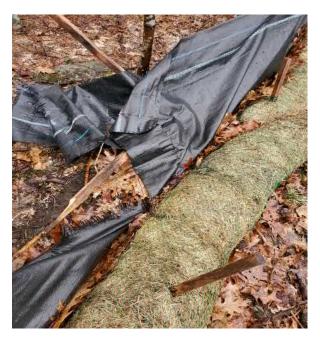
Photo 4

View of damaged silt fence in south east portion of the Site —facing south east
