Inspection Report for North Sturbridge Road Solar Facility NPDES ID No.: MAR10031G

Inspection Date: 04/1/2022

PHOTOGRAPHIC DOCUMENTATION North Sturbridge Road Solar Facility Charlton, Massachusetts Photographs Documented 04.1.2022

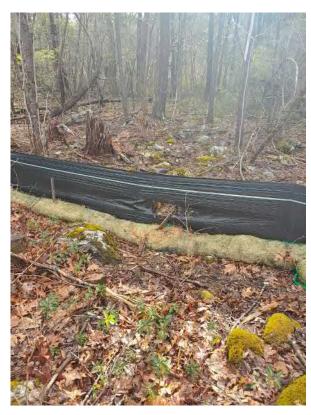
Photo 1

View of damaged silt fence in north east portion of the Site —facing north east

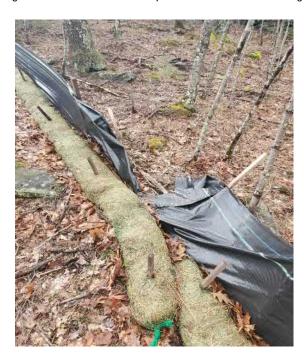
Photo 2

View of damaged silt fence in south east portion of the Site —facing south east
