Inspection Report for North Sturbridge Road Solar Facility

NPDES ID No.: MAR10031G

Inspection Date: 03/24/2022

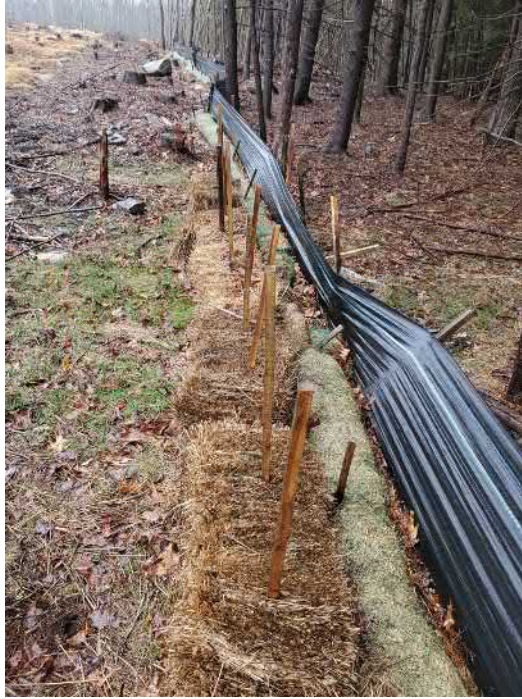
Photo 1

View of area downgradient of Discharge 2—facing south west.

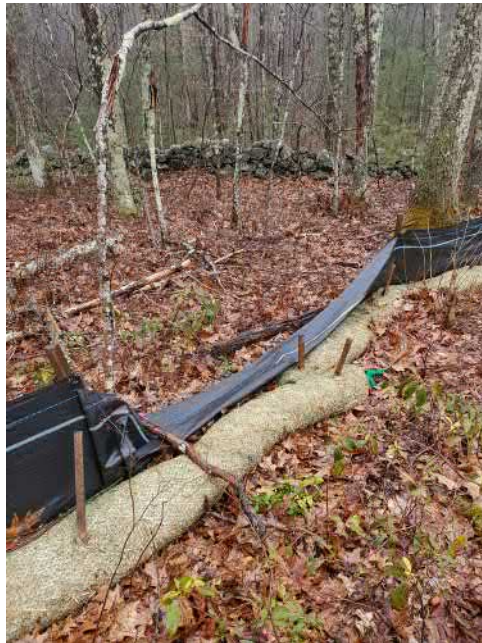
Photo 2

View of damaged silt fence in south east portion of the Site —facing south east

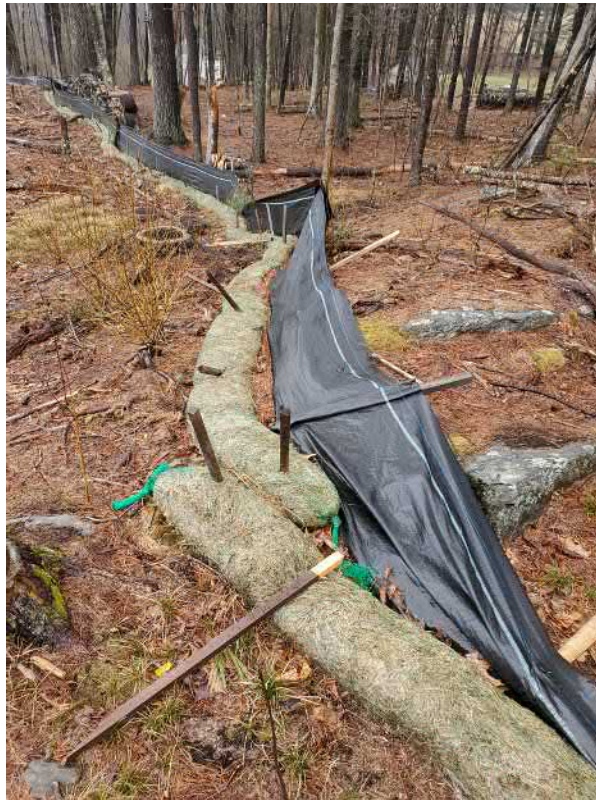
Photo 3

View of damaged silt fence in northern portion of the Site—facing north west.

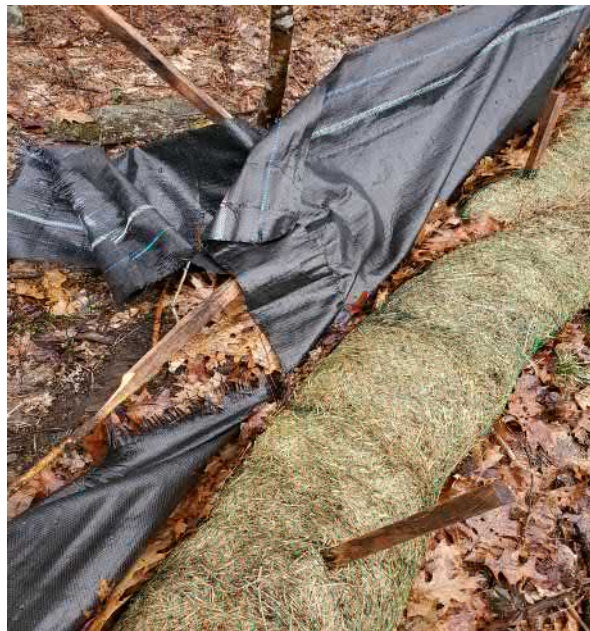
Photo 4

View of damaged silt fence in south east portion of the Site —facing south east
