Inspection Report for North Sturbridge Road Solar Facility

NPDES ID No.: MAR10031G

Inspection Date: 04/8/2022

PHOTOGRAPHIC DOCUMENTATION
North Sturbridge Road Solar Facility
Charlton, Massachusetts
Photographs Documented 04.8.2022

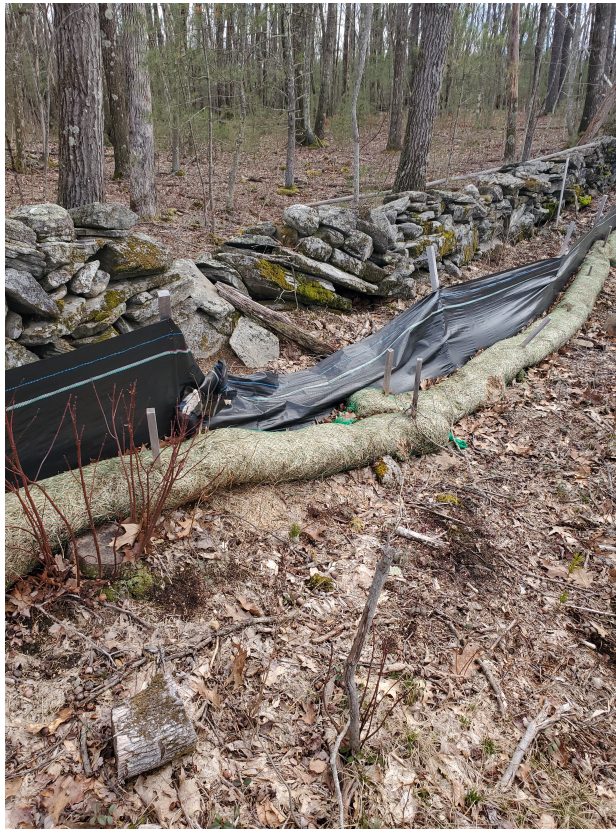
Photo 1

| Type/Location of E&S Control | Maintenance Needed?* | Corrective Action Required?* | Date on Which Maintenance or Corrective Action First Identified? | |
|---|---|---|--|---|
| 1. Silt Fence and Straw Wattles | Yes | No | 4/08/2022 | On 4/8/2022 BETA observed damage to the wattles in the northeast and eastern corners of the Site, damage was first observed on 3/15/2022. BETA also observed the silt fence to be partly torn in the southeastern corner of the Site, damage was first observed on 3/27/2022. General maintenance is needed for the entire silt fence. No evidence of discharge was observed. |

View of damaged silt fence in eastern portion of the Site —facing southeast

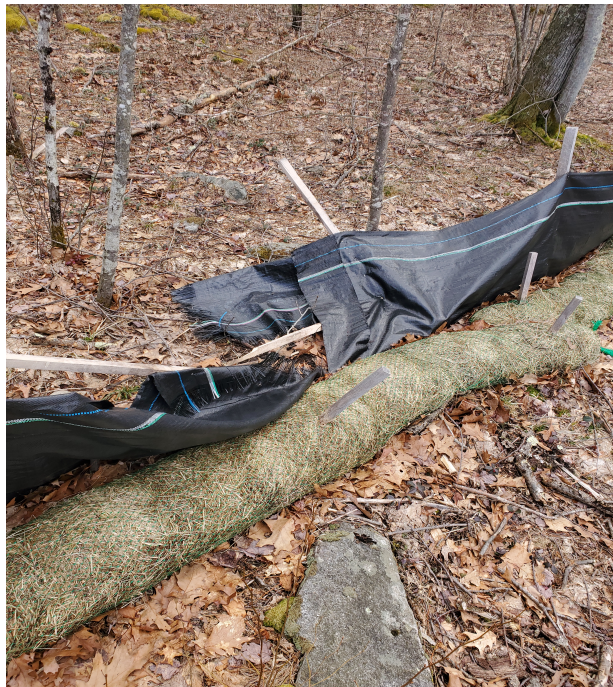
Photo 2

View of damaged silt fence in southeast portion of the Site —facing southeast
